# Independent Monitor Community Report

2009 Operational Period

Community Report by the Independent Monitor of the  
McArthur River Mine, November 2010

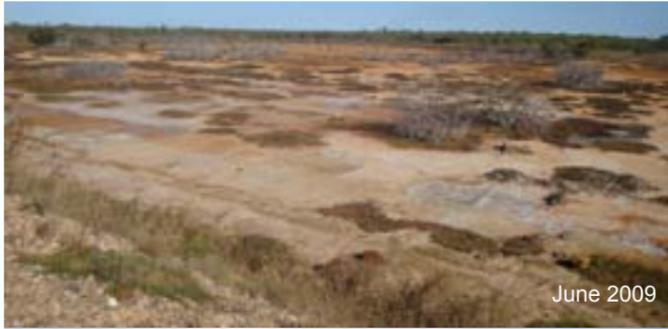
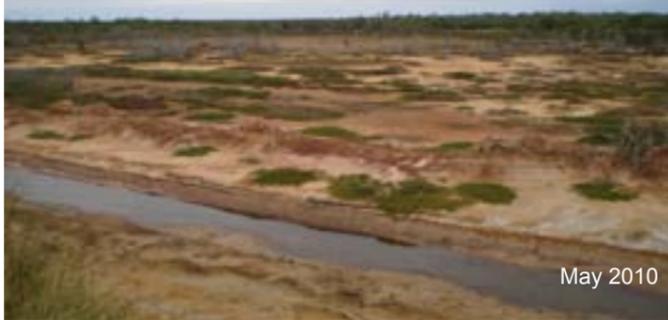
Last year we noticed significant vegetation die-back immediately outside the dredge spoil ponds at the Bing Bong Port Facility. The dredge ponds are built to hold marine sediments (spoil) dredged from the Bing Bong swing basin. It was evident that the vegetation dieback was being caused by saline seepage leaking from the salty spoil, through the degraded pond walls and onto the surrounding plain.

June 2009

May 2010

**Top:** Salt-affected land and vegetation outside of the Bing Bong Dredge Spoil ponds in June 2009. **Bottom:** The same area in May 2010 after the installation of a perimeter spoon drain, which is seen in the foreground. Vegetation is seen to be regenerating outside of the spoon drain.

MRM has since installed an outer spoon drain, which drains the saline seepage from the spoil back to sea. Previously-eroded pond walls have also been re-constructed, however due to the poor quality of construction materials, seepage through the pond walls is expected to continue. MRM will be completing additional capital works at the dredge spoil ponds before the commencement of the 2010/2011 wet season.

Although seepage continues, the spoon drain appears to be successful in re-directing saline seepage back to sea and allowing vegetative regeneration in the previously-affected areas. We will continue to monitor the success of vegetation in this area. Further geotechnical assessments of the dredge spoil walls have also been recommended.

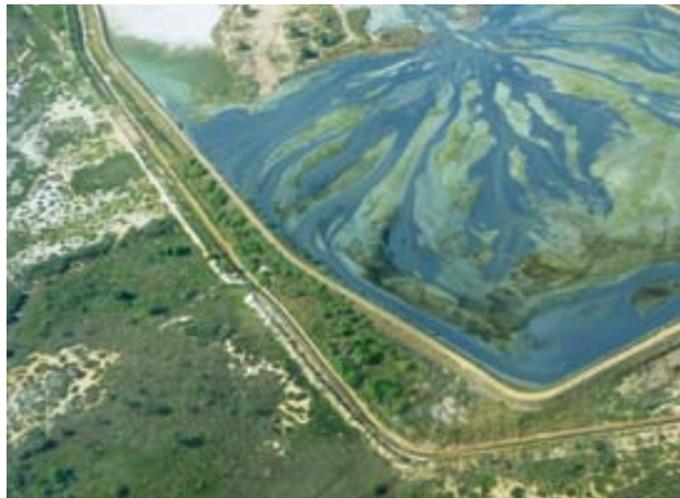
Aerial view of the northern-most Dredge Spoil pond with perimeter spoon drain, and dredged material and sea water radiating from the central deposit point in the middle of the spoil pond (May 2010).

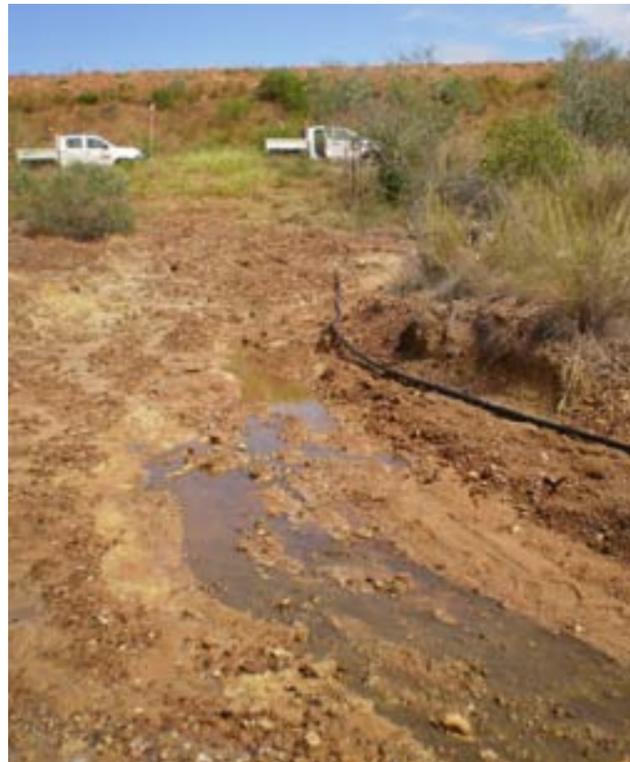
Although leachate is still being expressed at the toe of Cell 1, and is draining towards Surprise Creek, (see picture below), we commend MRM for undertaking additional mitigation measures over the past year, including:

Leachate draining from the base of TSF Cell 1 towards Surprise Creek. A sump has been constructed to collect some of this leachate, but more work is needed (May 2010).

- a sump to intercept surface leachate draining towards Surprise Creek;
- electromagnetic survey to identify key areas of conductivity and likely seepage from the Cell;
- ongoing advice and investigation from external consultants;
- cessation of pumping reclaimed leachate back on top of Cell 1; and
- continuation of the clay capping (which will be completed before the 2010/2011 wet season).

- geochemical assessment of the tailings in Cell 1;
- increased quantitative monitoring rather than qualitative;
- installation and monitoring of piezometers within the TSF embankments; and
- completion of the clay capping of Cell 1 to limit rainfall infiltration.

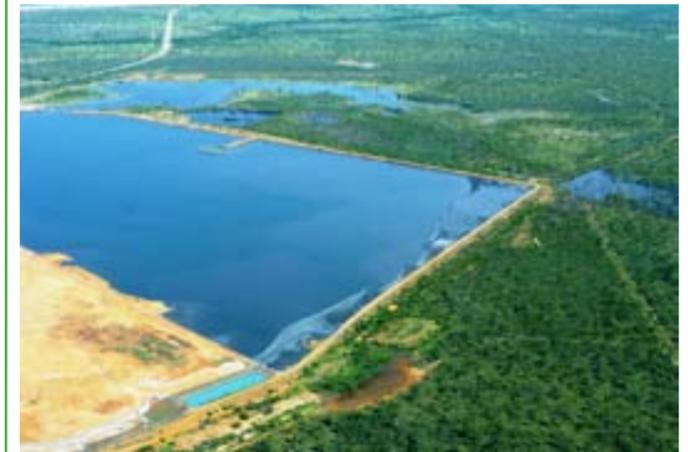
The Independent Monitor is concerned about the amount of water being stored within the TSF Cell 2, which is currently receiving tailings waste from the Mine. This excess water storage poses the risk of overtopping the TSF walls or causing the embankment to fail all together. We recommend that the water stored in this Cell be reduced, and that MRM increase quantitative geotechnical monitoring within the embankments.

There is a large volume of water being stored in TSF Cell 2 as seen above. The water management dam (top left of the photo) receives excess water spillover from Cell 2, but the amount of water stored, in the Cell should be reduced (May 2010).

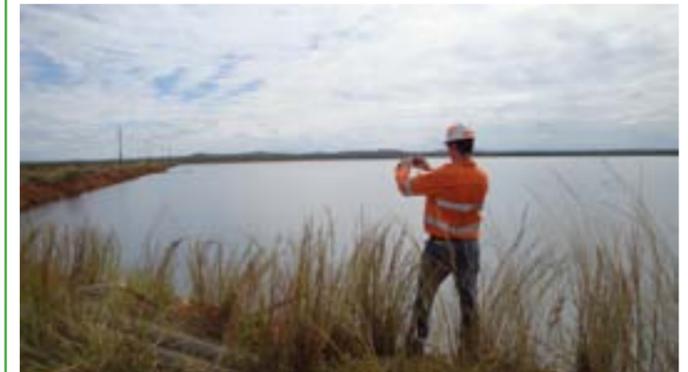
Independent Monitor team geotechnical engineer inspecting the excess water storage in TSF Cell 2 (May 2010). As seen above, at the time of our inspection, there was only approximately 1 metre of freeboard available in Cell 2. The available freeboard should be increased to reduce the risk of overtopping.

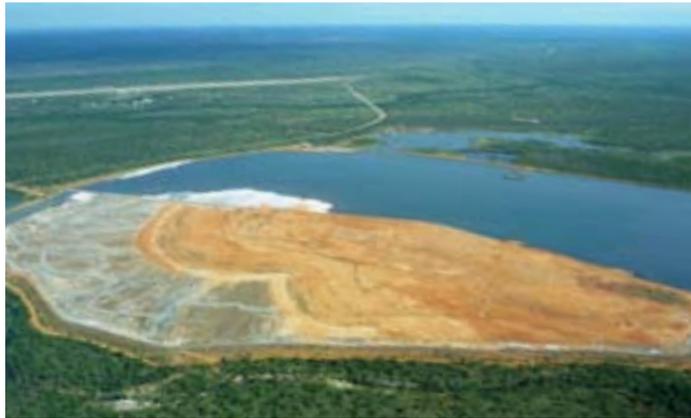
The clay capping of TSF Cell 1 was approximately 60% complete during our inspection in May 2010, as seen above. The rest of the capping is to be completed by the 2010/2011 wet season to reduce infiltration of water through the exposed tailings and reduce dust generation.

Next audit we will request as-built reports for Cell 1, and evidence that the clay cap has been tested to meet design specifications.

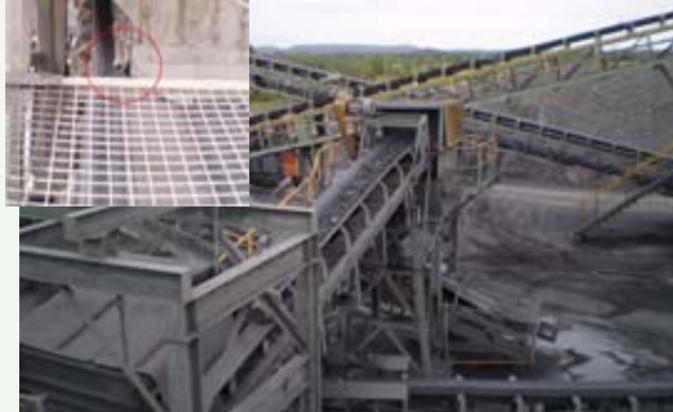
Our primary concern regarding dust at the mine site is the dust generated by the ore crushing plant. The plant, which is a system of conveyors and crushers, has recently been upgraded with double-lipped rubber liners to reduce dust escaping from the sides of the conveyor belts (see photo inset top right). Water sprays are also used throughout the plant, and other dust reduction measures are to be installed.

The ore crushing plant that operates on the mine site is a source of ore dust-generation, which can contaminate soil and water. Steps are being taken to limit dust from this facility.

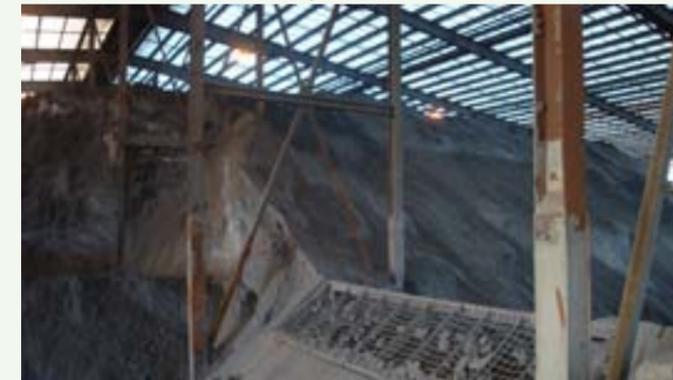
Fugitive dust migration from the Bing Bong Port concentrate storage shed also continues to be of concern. The roller doors of the concentrate storage shed remain open at all times due to potential sulfate gas build-up within the shed. This practice increases the opportunity for dust to escape from the shed and contaminate surrounding soil, sediments and seawater.

Zinc concentrate is stored within the Bing Bong concentrate storage shed while awaiting loadout onto the Arburri barge for shipment. The doors of the shed remain open to limit gas build-up that corrodes shed infrastructure. However, the open doors also allow concentrate dust to escape and spread via the wind to potentially contaminate soil, water or and sea sediments. This past year, damaged sections of the warehouse corrugated iron roof were replaced with fibreglass roofing that is resistant to the corrosive gases. The upgrade of the roof will assist in reducing dust emissions at the load out facility

MRM have advised that they are exploring upgrades to shed ventilation so that the doors can remain shut. We commend MRM for undertaking a recent dust audit at Bing Bong, which we will review next year.

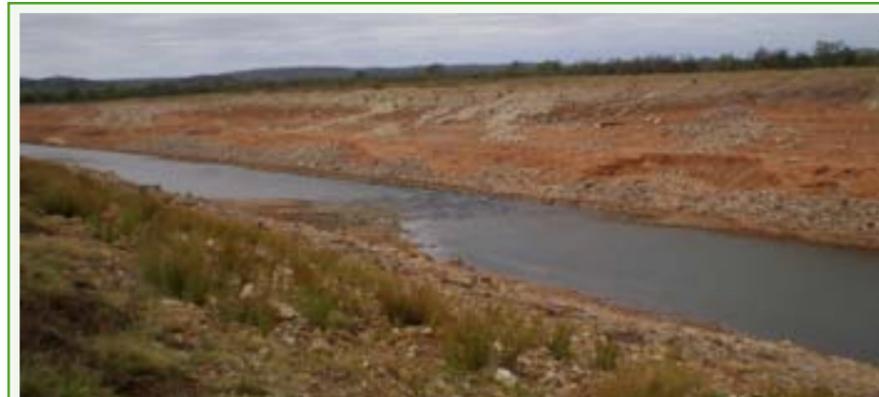
Minor slumping erosion and scour can be seen along the McArthur River diversion channel. Vegetation establishment, may help stabilise the banks of the diversion throughout the wet season floods. (May 2010)

Sedimentation and erosion photograph monitoring at intervals along the diversions is considered acceptable, however we also recommend that opposite bank photographs also be taken. Further, we recommend that current erosion monitoring be combined with Digital Elevation Model (DEM) data to provide a clearer and more comprehensive picture of erosion and sedimentation along the diversions.

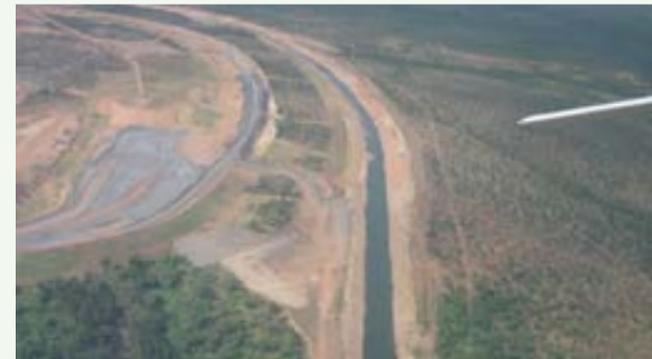
The above photograph shows the upstream end of the McArthur River Diversion, and the cut off section of the old McArthur River channel to the bottom left. During times of flood, water passes overland between the two.

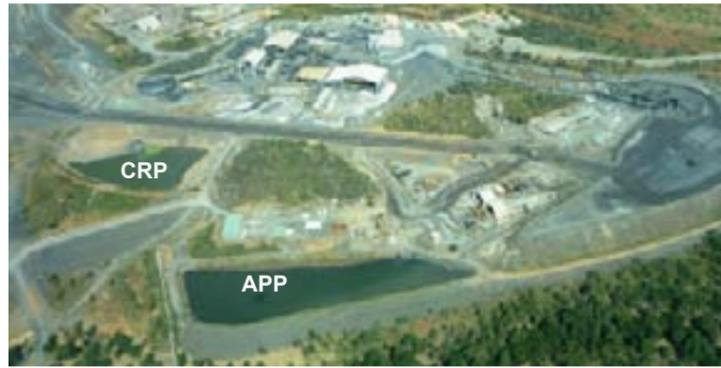
Monitoring of artificial surface waters is undertaken at all water dams across the Mine site and at Bing Bong on a monthly basis. The above photograph shows the Concentrator Runoff Pond (CRP) and Anti Pollution Pond (APP) at the Mine site. The 2009 data collected by MRM indicated that the CRP may be leaking, and MRM have proposed investigation and mitigation strategies in response. (May 2010).

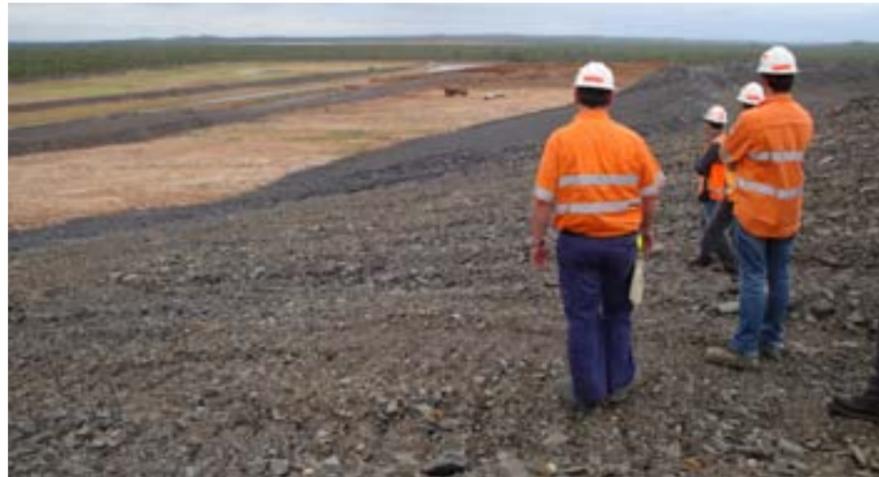
The Independent Monitor team inspected the progress of the Overburden Emplacement Facility in May 2010. The OEF receives waste rock or 'overburden' from the mine pit. Some of the waste rock has the potential to form acid if it is exposed to water and air, so the proper placement of 'potentially acid-forming' and 'non-acid forming' rocks is essential to avoid environmental damage from releasing acid into the environment.

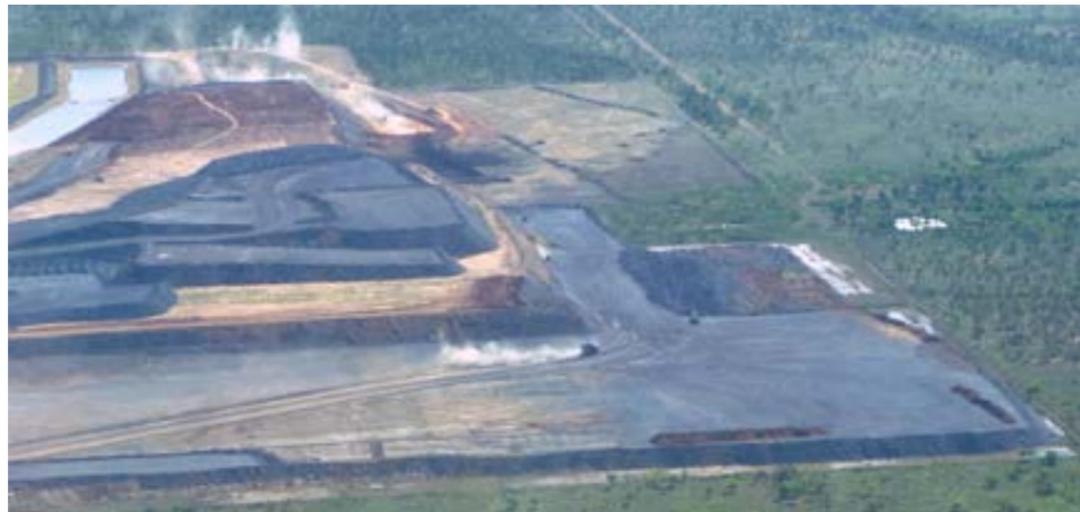
This year we saw sufficient evidence that the clay is being tested before it is placed at the OEF; however, we have not seen any documented evidence that testing is undertaken after placement. We will again request MRM to provide this next year.

The clay layer that lines the base of the OEF is an essential part of the OEF design. The clay acts as a barrier to stop the migration of any acid production that may occur within the OEF waste rock. It is essential that the chemical and physical nature of the clay is tested before and after it is placed at the OEF to ensure its suitability. (May 2010).

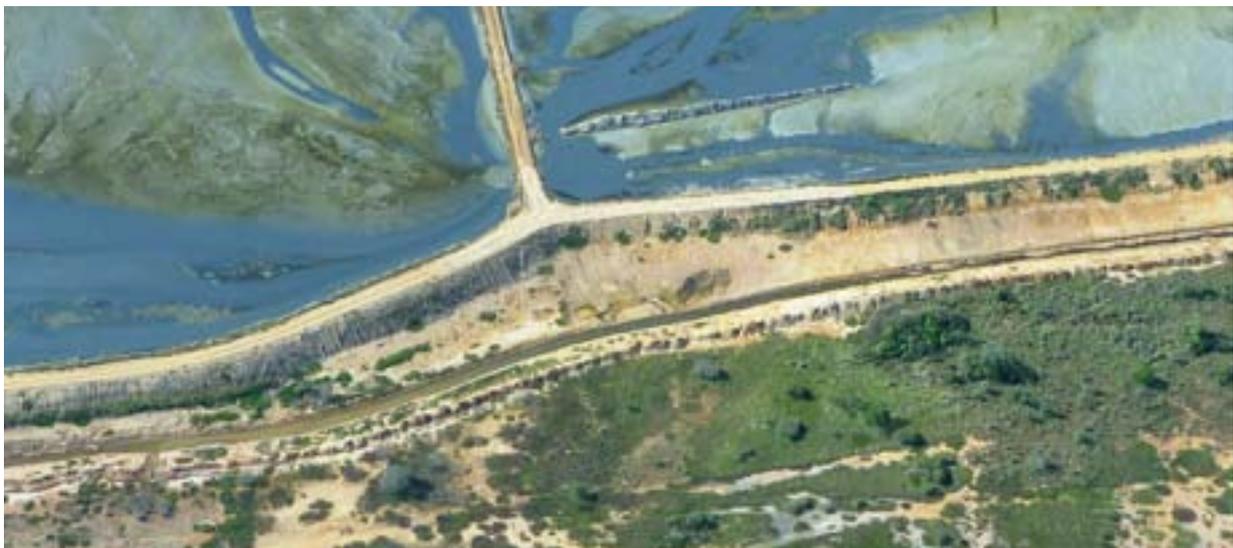
We will continue next year to monitor many of the issues identified during this audit and previous audits, such as the regeneration of salt-affected vegetation outside the Bing Bong dredge spoil ponds. It is anticipated that the recently-constructed perimeter spoon drain (as seen above) will help mitigate this issue. (May, 2010)
