Independent Monitor Community Report

2011 Operational Period

Community Report by the Independent Monitor of the
McArthur River Mine, November 2012

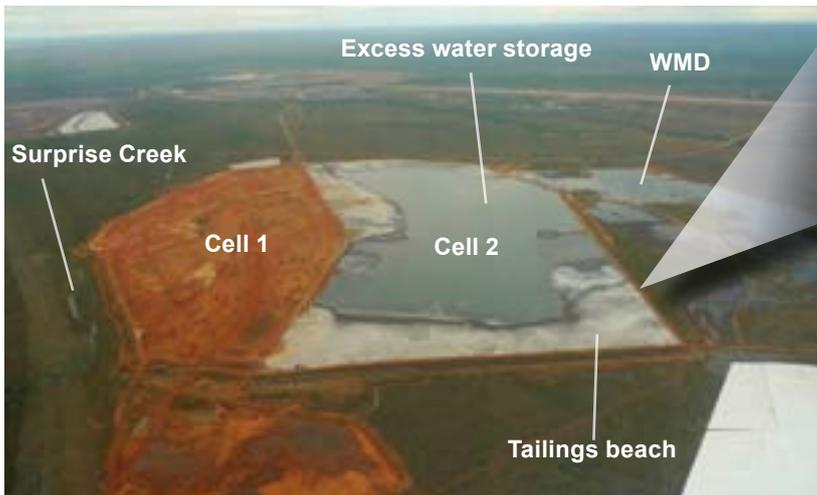
Above: Aerial photograph of the TSF taken in late May 2012. Note: WMD (Water Management Dam) holds fresh water.

The volume of water held in the TSF remains to be an issue. While the volume of water stored on Cell 2 remains significant and there is no clear picture of water balance, the risk of overtopping during wet season remains a serious concern. We note that the site inspection occurs after the wet season when water levels are high in the TSF. Throughout dry season, water levels are reduced through evaporation and recycling efforts by MRM. MRM have begun works to raise the height of the walls at the TSF, which will increase the capacity of Cell 2. These works will need to be reviewed in the next Independent Monitor audit.

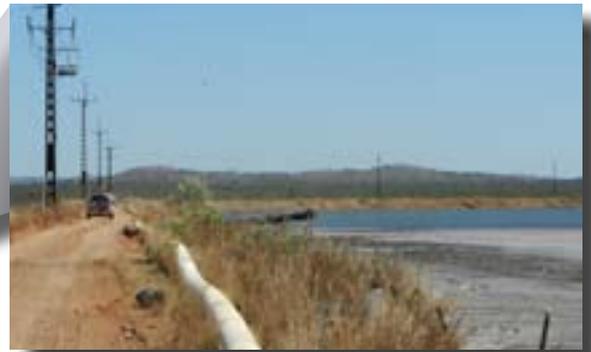
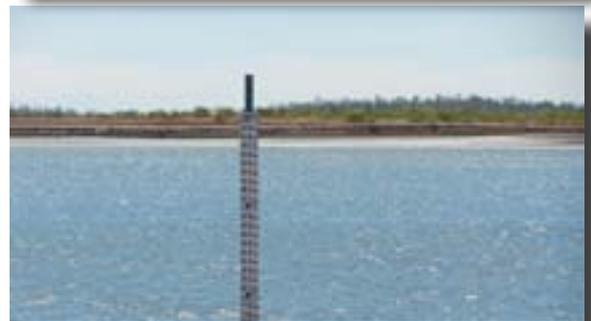
Top: Photo taken along the southern wall of TSF Cell 2 in May 2012. This wall will be raised to increase the capacity of Cell 2. Bottom: The level of water in Cell 2 at inspection is still of concern.

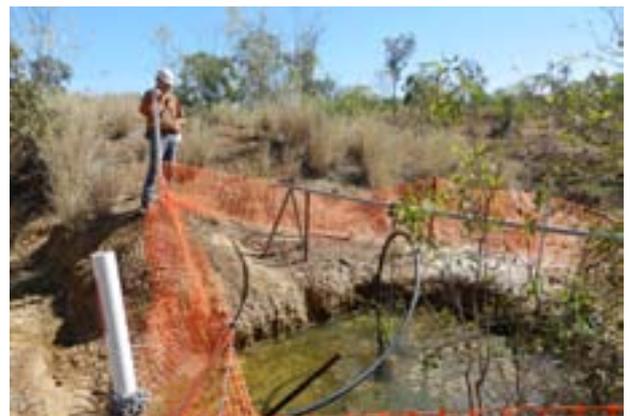
Salt deposition was again observed at Surprise Creek as a result of seepage from the TSF and doesn't appear to have decreased substantially. Despite this, a frog and macrophytes were observed during the May inspection within the seepage recovery sump, a possible indicator of improved water quality.

Seepage recovery sump between TSF Cell 2 and Surprise Creek, where a frog and macrophytes were observed. This indicates that the seepage water may be fresher than in previous years.

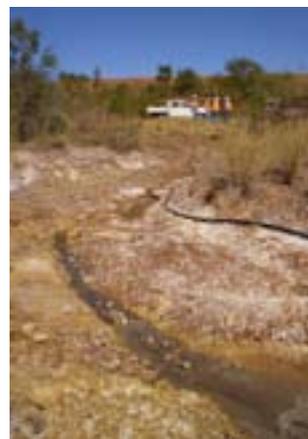
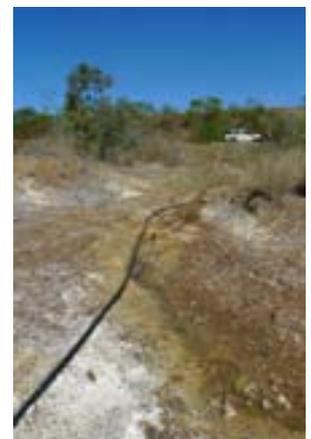
Seepage from the TSF Cell 1 into Surprise Creek remains a significant concern. MRM continues to investigate this issue. Independent Monitor notes that it is likely that a paleochannel connects the seepage area at TSF Cell 1 near Surprise Creek with the up-gradient Water Management Dam (WMD) (south of TSF Cell 2). MRM have not yet undertaken any investigatory works to prove this theory.

In May 2012, the seepage from the TSF Cell 1 appeared to be fresher than in previous years, as evidenced through the presence of algae and grasses along the drainage line.

Planning for the long term acidification of tailings and mitigation of acidic seepage is likely to be the most significant issue for mine closure relating to the TSF. The Independent Monitor recommendation is that further investigation should:

- identify where the seepage originates from;
- design a tailings seepage and closure management system that includes the evaluation of the possibly reprocessing the tailings from TSF Cell 1; and
- investigate and discuss when and where seepage will occur from TSF Cell 2, and what the likely impacts will be.

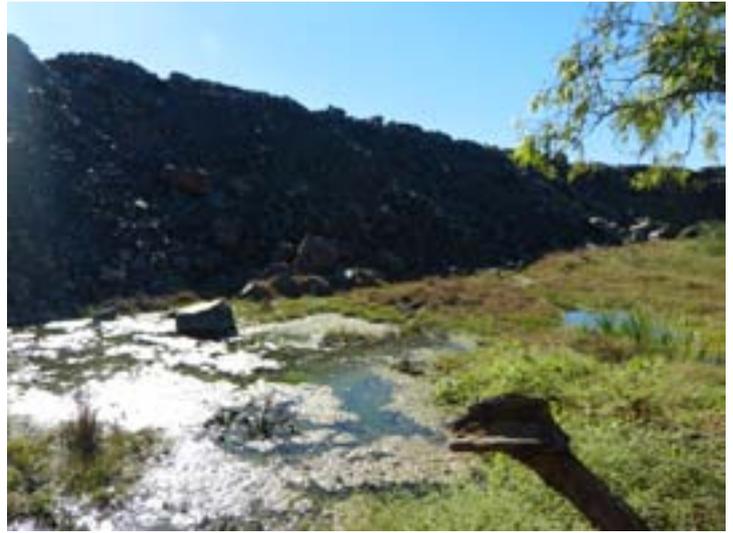
An area of seepage has been flowing from the north eastern toe of the Overburden Emplacement Facility.

The OEF was inspected as part of the Independent Monitor site inspection in May 2012. Seepage was observed in an area at the north eastern side of the OEF. This seepage was seen to be flowing down a natural drainage line and is being collected in a sump. The origin of the seepage has not yet been determined by MRM. The Independent Monitor has recommended that MRM undertaken investigatory works to assess the origin of the seepage and the likelihood of the seepage becoming acidic in future.

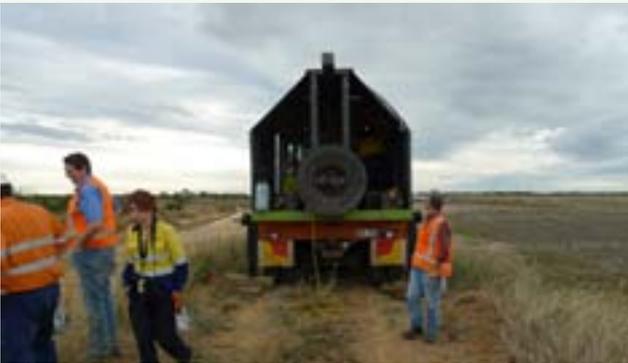
Geotechnical investigation was underway at the Bing Bong dredge spoil walls during the Independent Monitor's May 2012 site inspection.

Significant improvements at the dredge spoil ponds have been made recently. We note that in-situ geotechnical testing was being carried out during the 2012 site inspection. Pond walls have been reshaped in damaged areas and vegetation is taking hold to stabilise the walls. Also, the surface water management has been addressed to some extent with drainage paths being created from cell to cell.

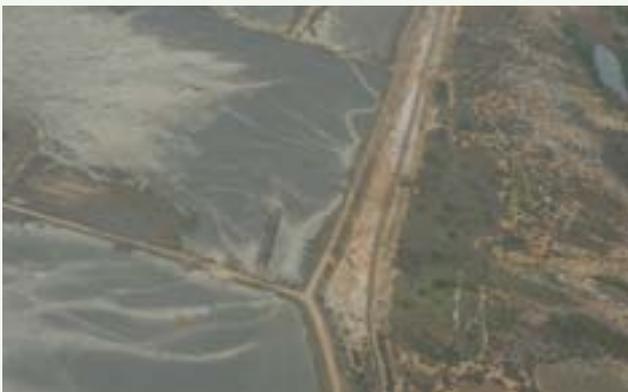
Overall, the general trend is positive with significant improvement having been made. However, outstanding issues remain such as the poor condition of some dredge spoil pond walls, with very deep erosion observed on the outer embankment slopes in 2012. Also, the storage capacity for further dredge material is questionable and should be assessed by MRM before further dredging occurs. Further, a water management design should be carried out allowing for a water balance model. Lastly, regular monitoring should be included as part of the operations at Bing Bong, particularly during the wet season.

Left: Aerial view of the Bing Bong dredge spoil pond, spoon drain and outer area, which has been affected by saline seepage.

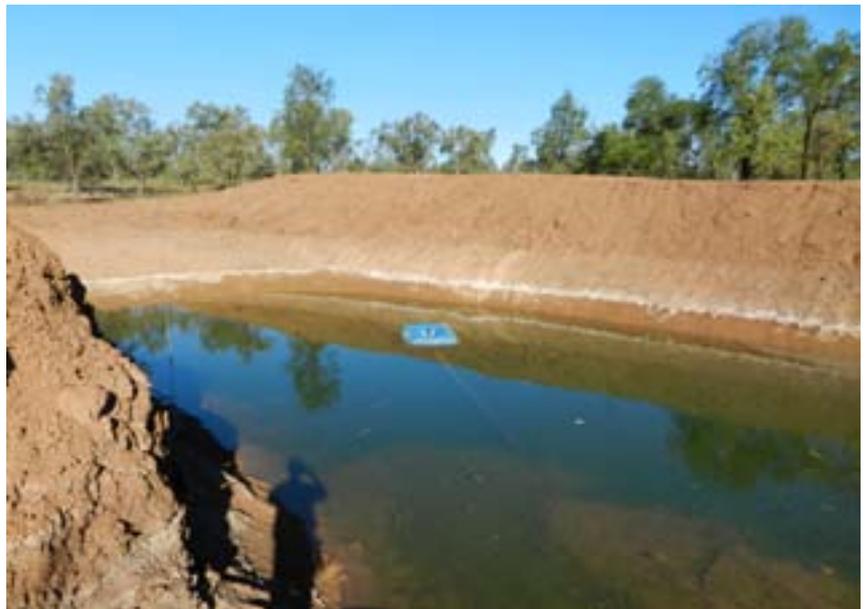
Seepage flowing from the toe of the OEF is collected in a sump and is pumped to an onsite containment dam - see previous page for details.

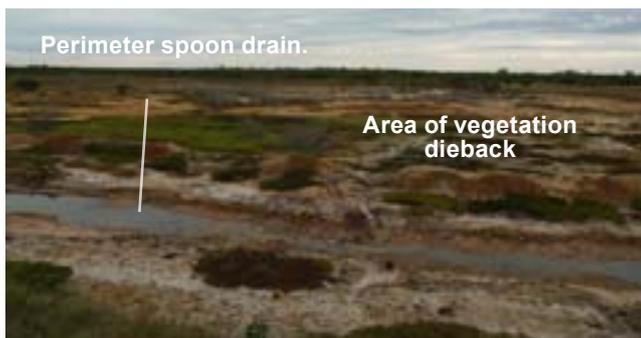
Vegetation dieback outside the spoon drain does not appear to have recovered yet, although improvements have been seen since the addition of the spoon drain, which diverts saline seepage from the spoil ponds out to sea.

Area of vegetation dieback outside the Bing Bong dredge spoil ponds, which has previously been affected by saline seepage from the ponds.

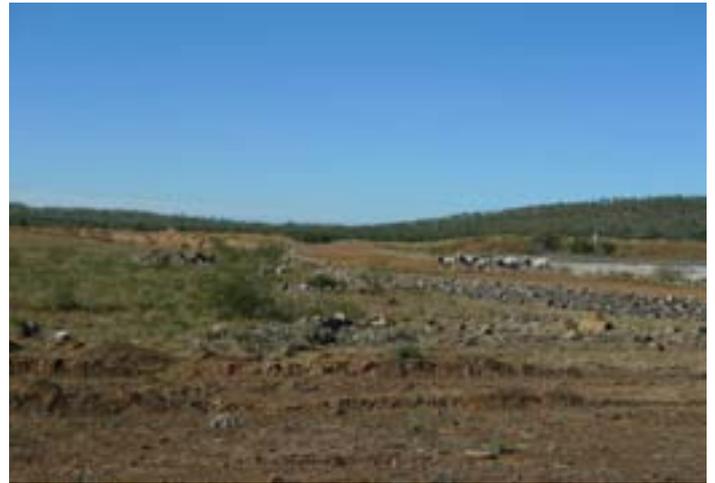
Cattle and donkeys still pose a problem at the mine site, as they continue to cause erosion and damage tubestock, which is particularly problematic in areas undergoing revegetation.

As results indicate that both the presence of Cane Grass and the structure of cattle exclusion fences play a substantial role in the number of bird species found in an area, the Independent Monitor advises that MRM continue to concentrate efforts of established Cane Grass stands, ensuring fencing is complete and stock are mustered out of the exclusion areas as soon as practical.

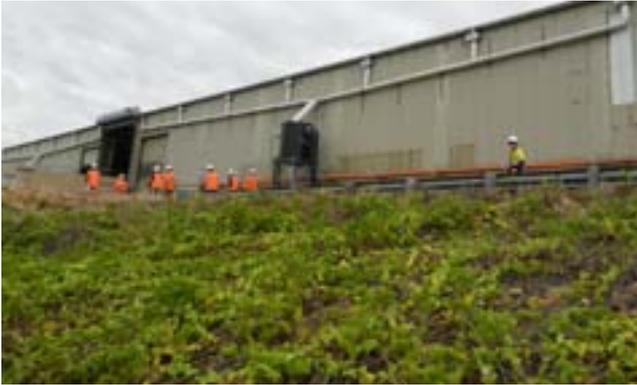
Water tanks have been installed around the Bing Bong concentrate storage shed to capture the first flush of rain water and divert consequent rainfall to sea, rather than to onsite storage

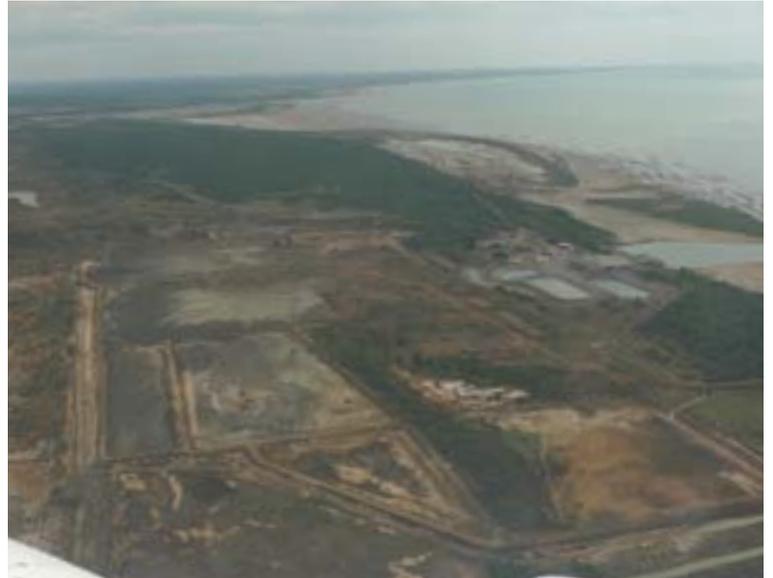
Aerial photograph of the Bing Bong port facility, which now has three surface water runoff ponds to contain contaminated runoff water.

The Independent Monitor also considers (based on the May 2012 site inspection) that surface water management at the Bing Bong port facility has been improved significantly from the previous review. This is due primarily to:

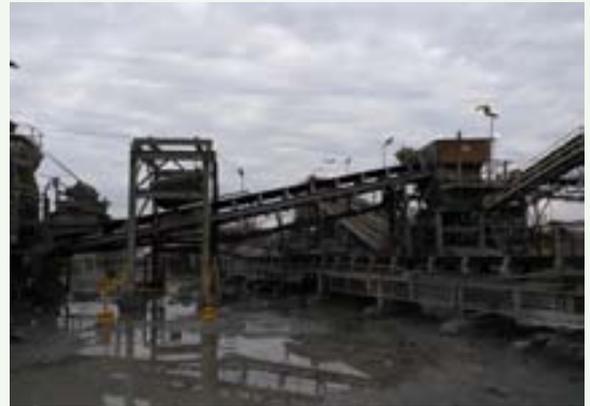
As in previous years, the highest zinc and lead dust concentrations correspond to locations near the PACRIM / ROM pad area. This remains unacceptable. The Independent Monitor agrees with MRM's assessment that mitigation measures appear to be having some positive effect in reducing the lead/zinc concentrations particularly at some monitoring locations nearby the PACRIM / ROM pad since 2009.

Dust suppression at the 'Pacrim' crushing plant has improved this audit period with the addition of sprays along the conveyor system. The IM noted a visual decrease in dust from this plant. Note the wet foreground from water sprays. Note though levels have come down, measured dust levels and lead is similar to previous years.

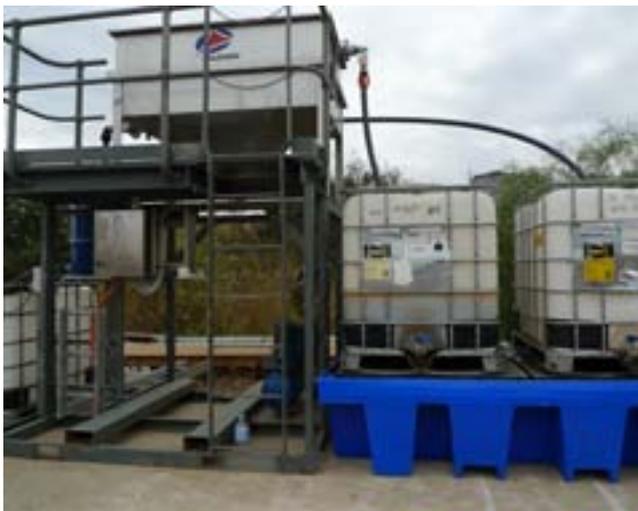
Groundwater treatment system used to recover diesel product from the impacted groundwater.

Following the spill, 5-10m³ of diesel-impacted soil was taken to the TSF. Groundwater has been affected by the spill. Impacted groundwater is being pumped to the surface to extract the diesel product (see photo left). This will be followed up next year.

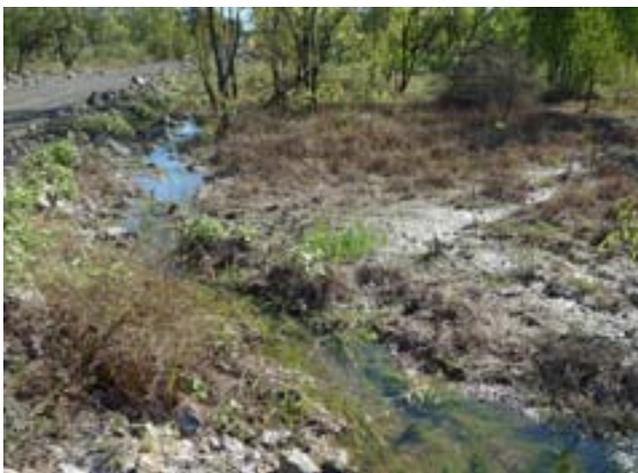
Surface expression of seepage from the Northern OEF.

MRM have correctly identified the OEF as a potential source of groundwater contamination. The OEF will influence underlying groundwater due to the weight of the facility increasing hydraulic pressure on aquifer pore space, as well as through potential seepage impacts. These occurrences are particularly important to the south of the OEF (potential discharge to Barney Creek), but will be picked up from static water levels over time in monitoring bores, as well as changes in water chemistry in these bores and in Barney Creek.

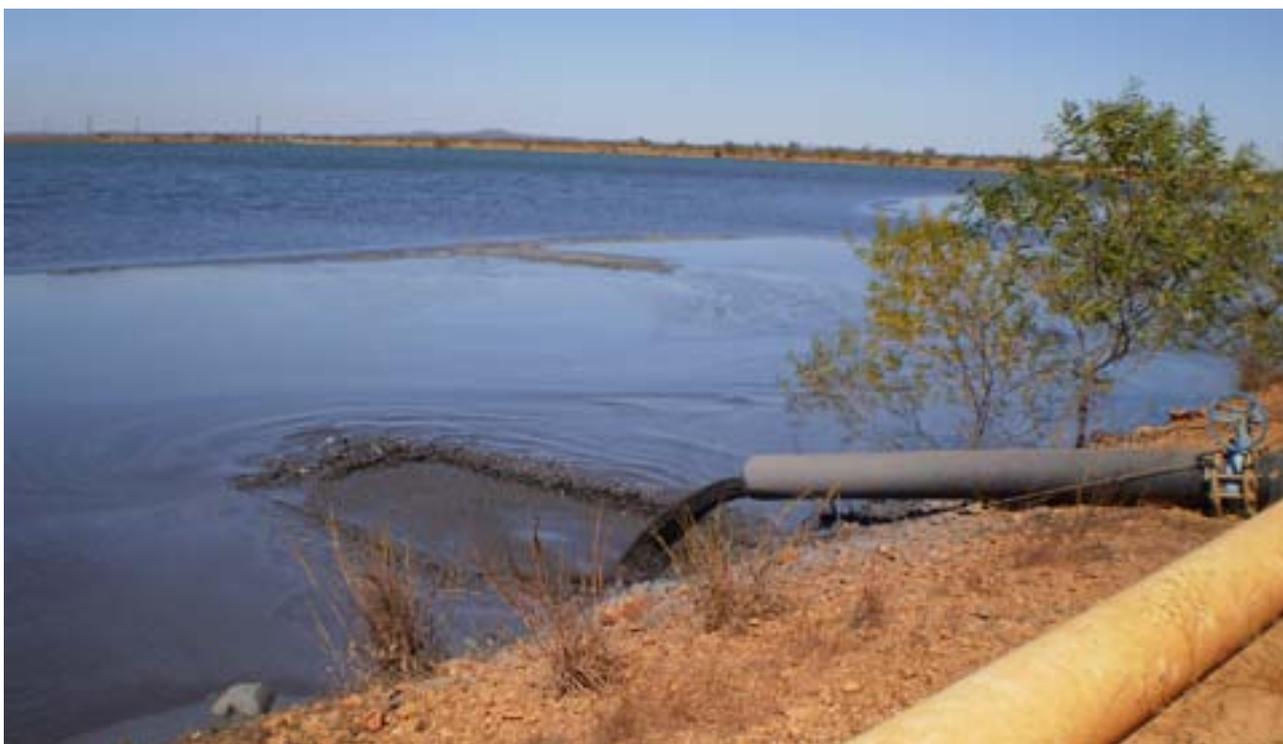
The second non-compliance relates to the method of deposition of tailings in the TSF. MRM made the commitment that "tailings will be deposited sub-aerially in thin layers to maximise the density of the tailings beach against the embankment, providing a low permeability beach of tailings between the decant water pond and the perimeter embankment", however, in 2011, the IM noted that tailings were being deposited aqueously (into water), rather than sub aerial deposition. It is noted that MRM states that subsequent depositions does not appear to be impacting consolidation and final density of the tailings.

Aqueous deposition of tailings in TSF Cell2 observed by the IM during the May 2011 site inspection.
