# Independent Monitor **COMMUNITY REPORT**

**McARTHUR RIVER MINE**

November 2015

# Environmental Performance 2014

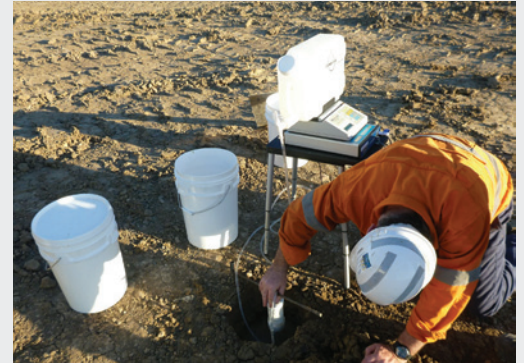
*Testing whether the clay covering waste rock is watertight*

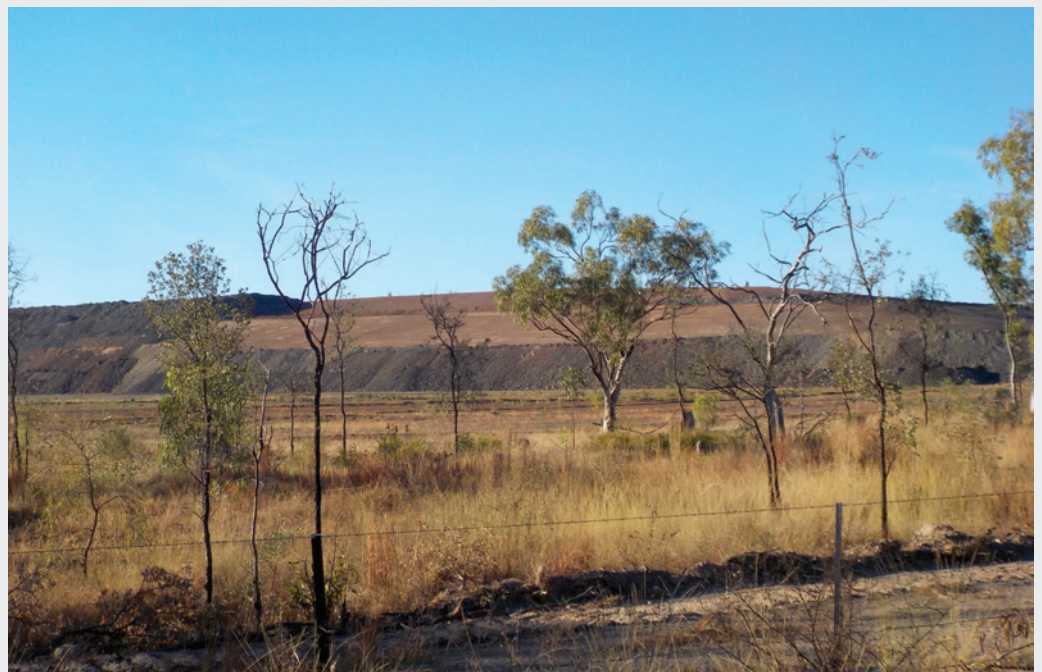
*The Northern Overburden Emplacement Facility viewed from the Carpentaria Highway*

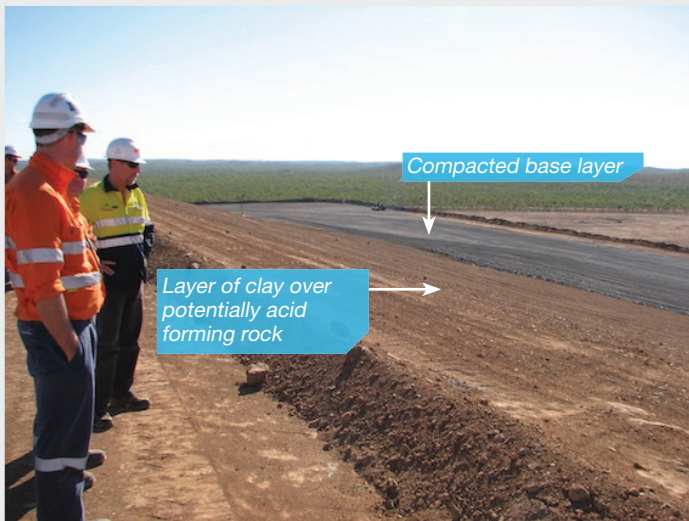
Waste rock with interim clay capping

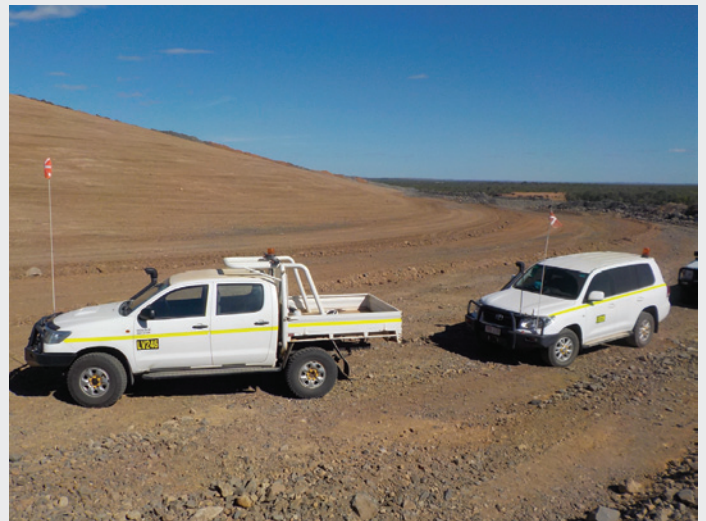
Rock capped with a layer of clay to protect it during the wet season

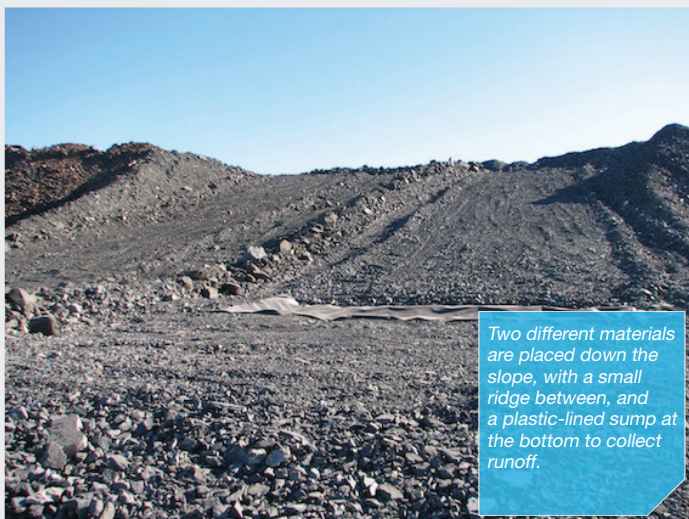
Cover erosion and runoff trials

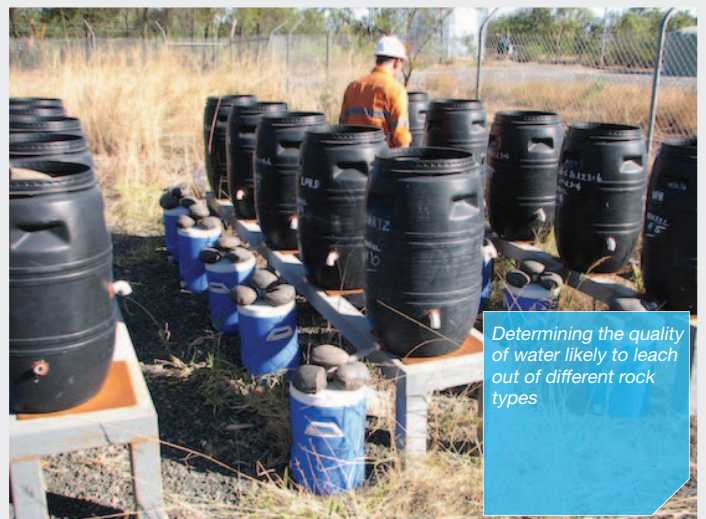
Leaching trials

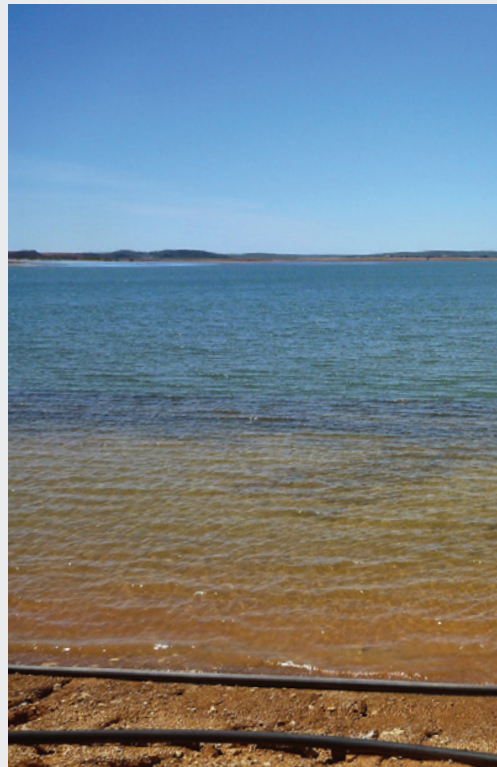
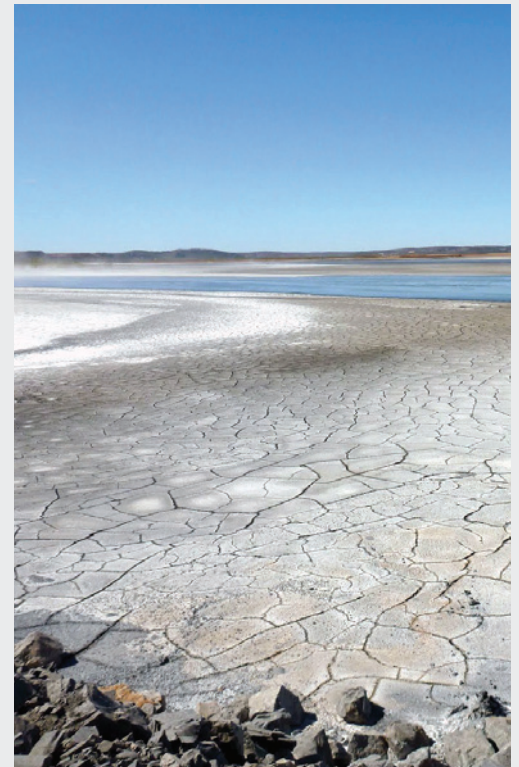
The IM notes that in 2014, MRM have ceased using the TSF as a water storage facility. As per the photos below, this practice – along with a below-average wet season – has allowed the tailings to dry out and form a 'beach'.

Dry tailings are denser and stronger, allowing less seepage to escape and putting less pressure on the embankment. This will make the TSF safer.

View across TSF Cell 2 in early 2014

View from the same location in mid-2015

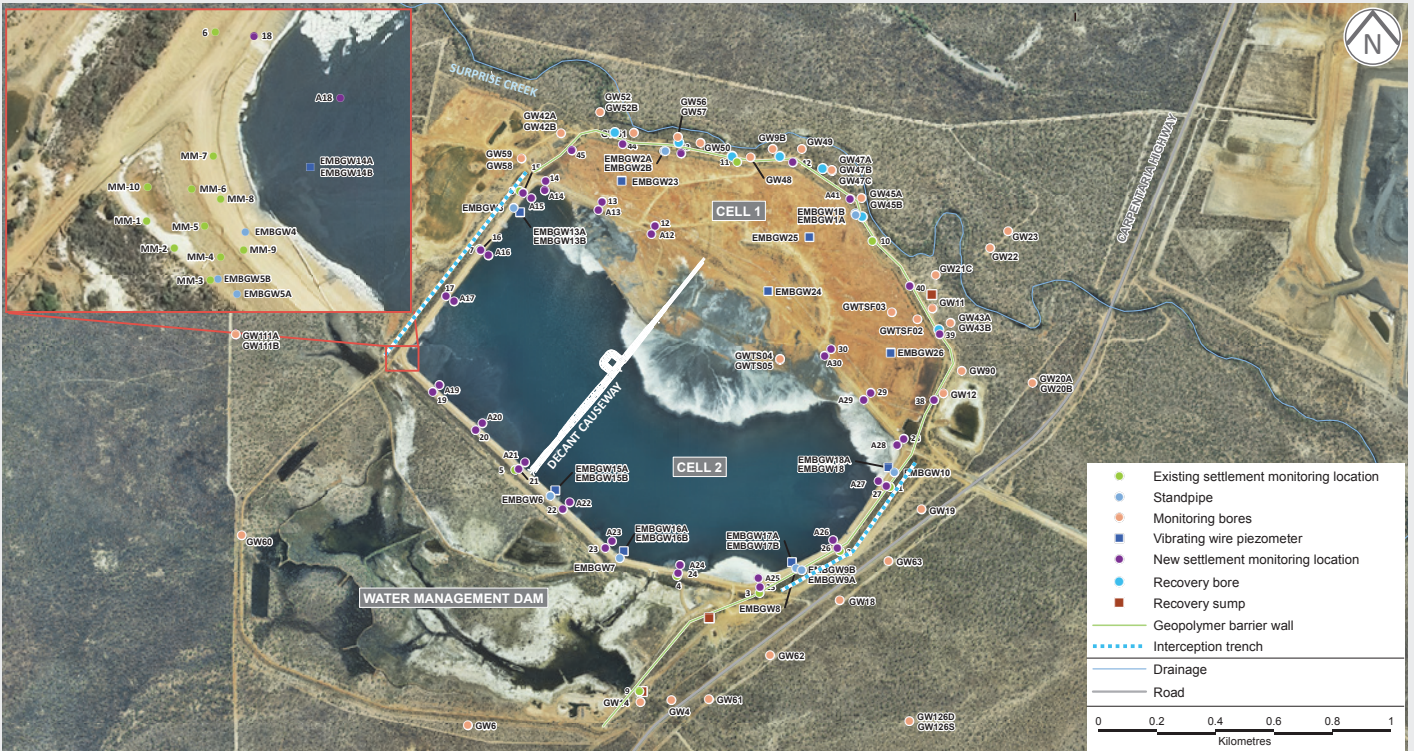
Aerial view of TSF, showing monitoring points and management features  
(Note: The amount of water shown in Cell 2 in this image does not reflect its current state.)

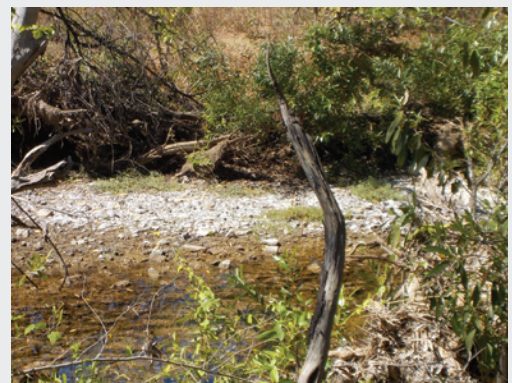
Seepage of saline tailings water from the northern side of TSF Cell 1 into Surprise Creek has been reported by the IM each year since 2007. This was observed to be continuing in 2015, despite the presence of a geopolymer barrier wall and recovery bores.

Seepage at Surprise Creek

- Monitoring of vegetation north of Cell 1 to assess any impacts of the seepage.
- More comprehensive reporting of Cell 1 water management design and operation within the annual mine site water balance report.
- Ongoing review of water quality monitoring to better manage impacts and required actions.

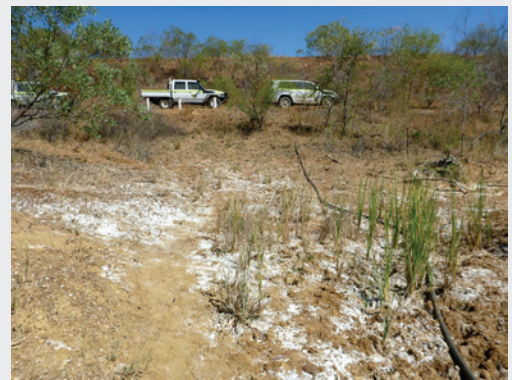
Seepage from TSF Cell 1

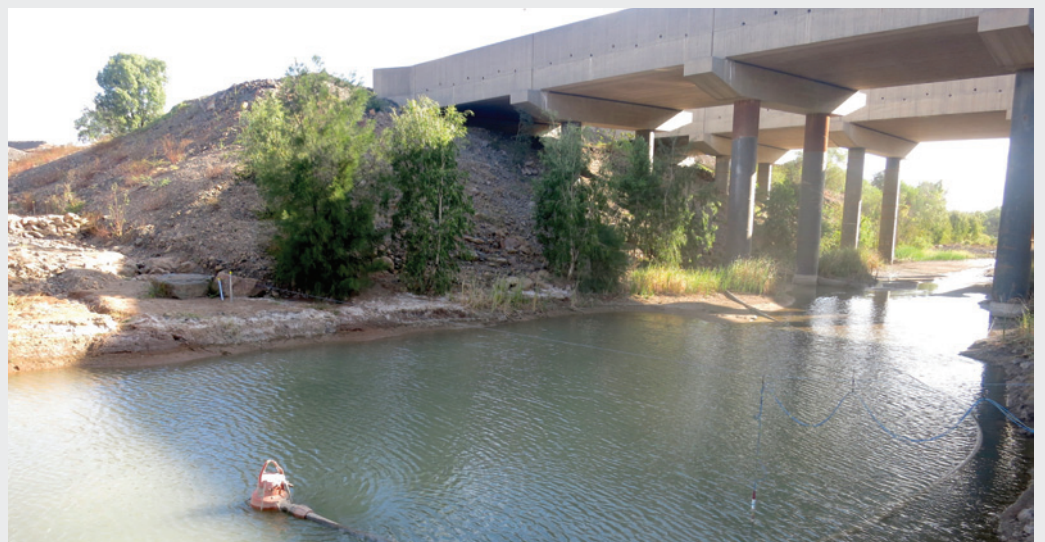
Barney Creek showing haul road bridge and dewatering pump in temporary dam

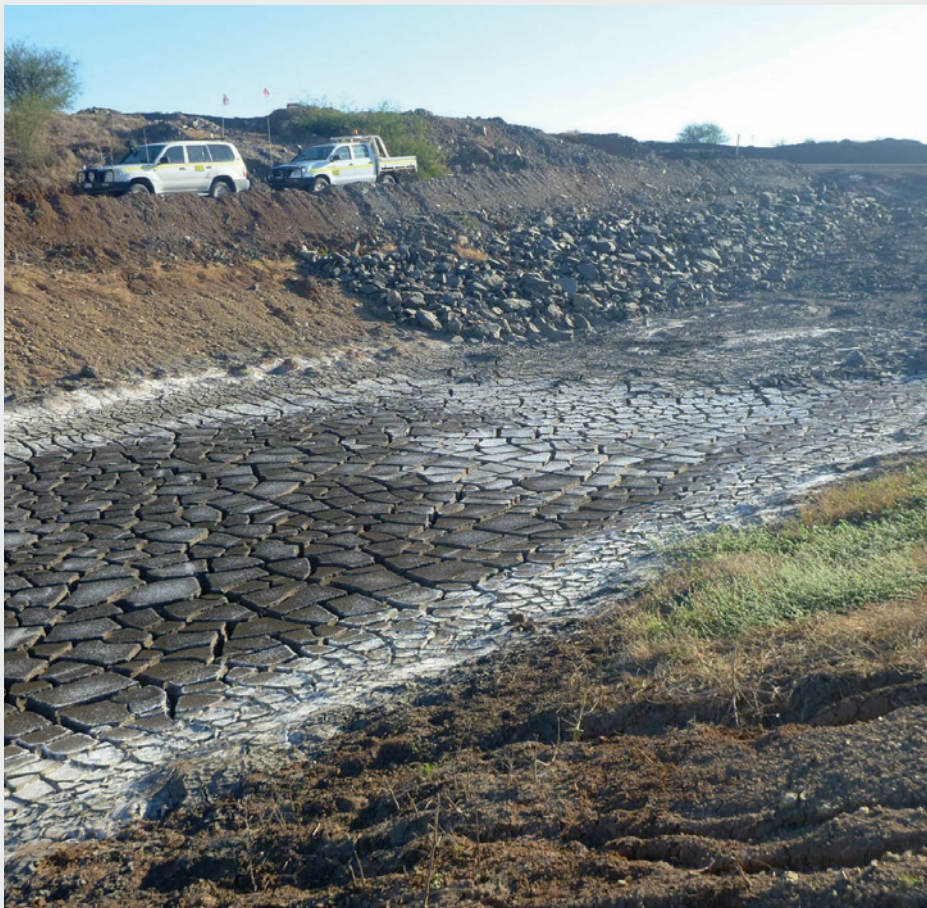
Sediment settlement basin to the southeast of Barney Creek haul road bridge

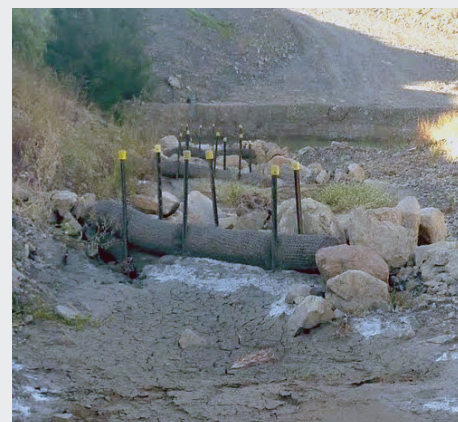
Silt traps in the lower part of the post-settlement runoff channel

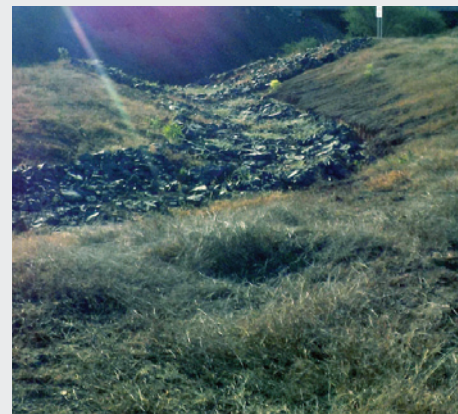
Post-settlement runoff channel

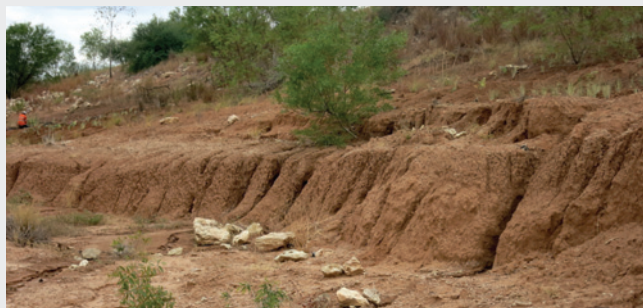
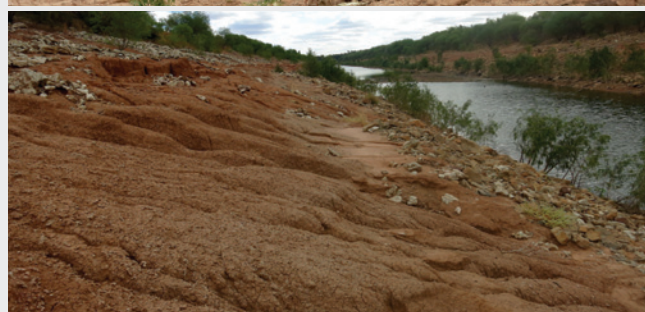
From 2013 to 2014, an average of half a metre depth of soil was eroded from sections of the right bank of the diversion channel.

Bank erosion in the middle section of the McArthur River diversion channel

During 2014, MRM commenced an improved erosion assessment program in its revegetation plots. MRM is undertaking a full landform condition assessment and erosion mitigation strategy for the McArthur River diversion channel, due to be finalised in February 2016.

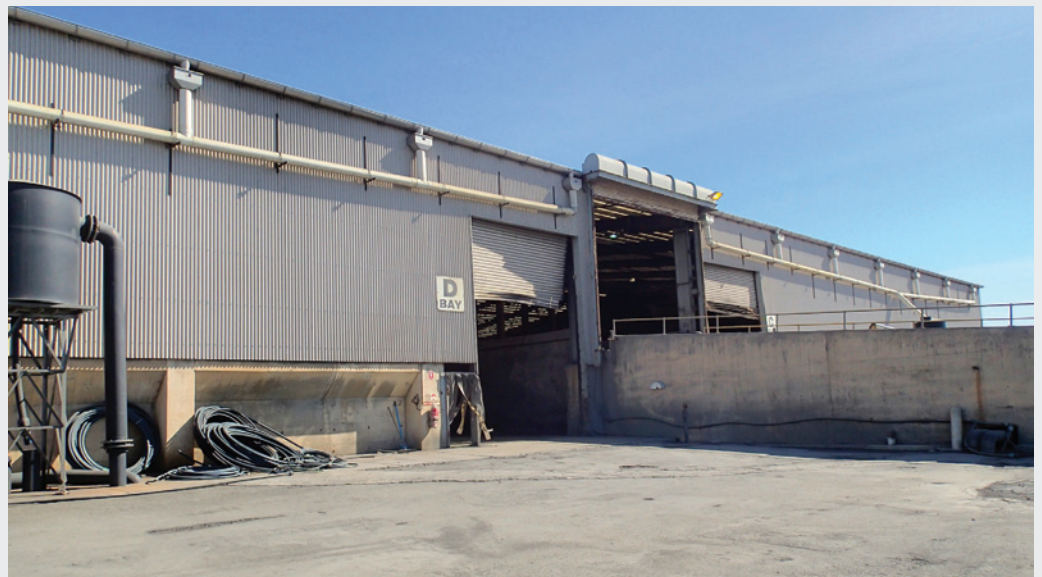
During the IM's 2015 visit to Bing Bong Port, it was noted that some of the usual controls were not operational. Doors on the concentrate shed could not be closed and the dust extraction system was not working.

Doors of concentrate shed not able to be closed

- The doors of the concentrate shed should be repaired so that they can be closed.
- The dust extractor system in the concentrate shed should be repaired.

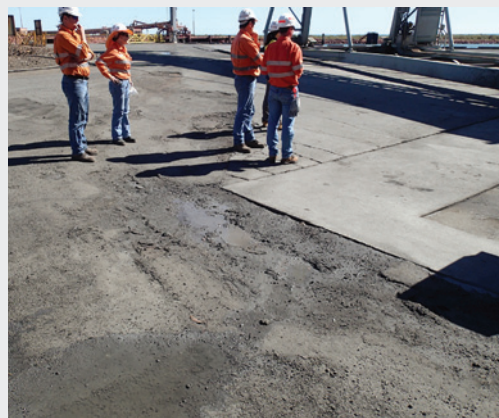
The bitumen surface around the loading facility requires repair

- The bitumen surface surrounding the loading facility should be repaired to avoid future soils, water and/or dust management issues

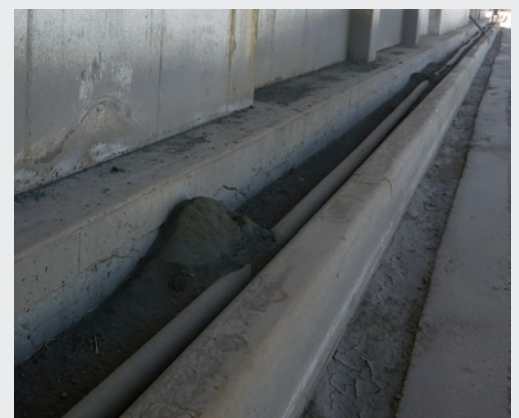
Spillage of dust from concentrate shed
