REPORT NO.

209024

INDEPENDENT MONITOR AUDIT OF THE ENVIRONMENTAL PERFORMANCE OF THE MCARTHUR RIVER MINE – 2008 OPERATIONAL PERIOD

ENVIRONMENTAL EARTH SCIENCES VIC
REPORT TO THE DEPARTMENT OF REGIONAL DEVELOPMENT,
PRIMARY INDUSTRY, FISHERIES AND RESOURCES

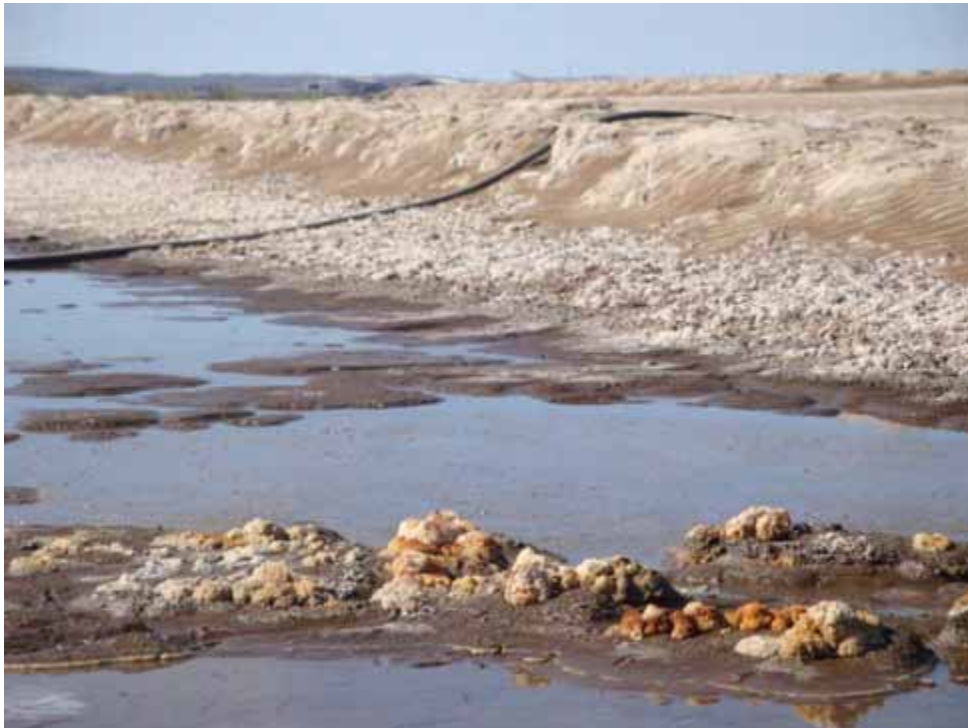
Plate 1 - Iron sulfates along beached areas of ponded water at the surface of TSF Cell 1, indicating acidic conditions (June 2009).

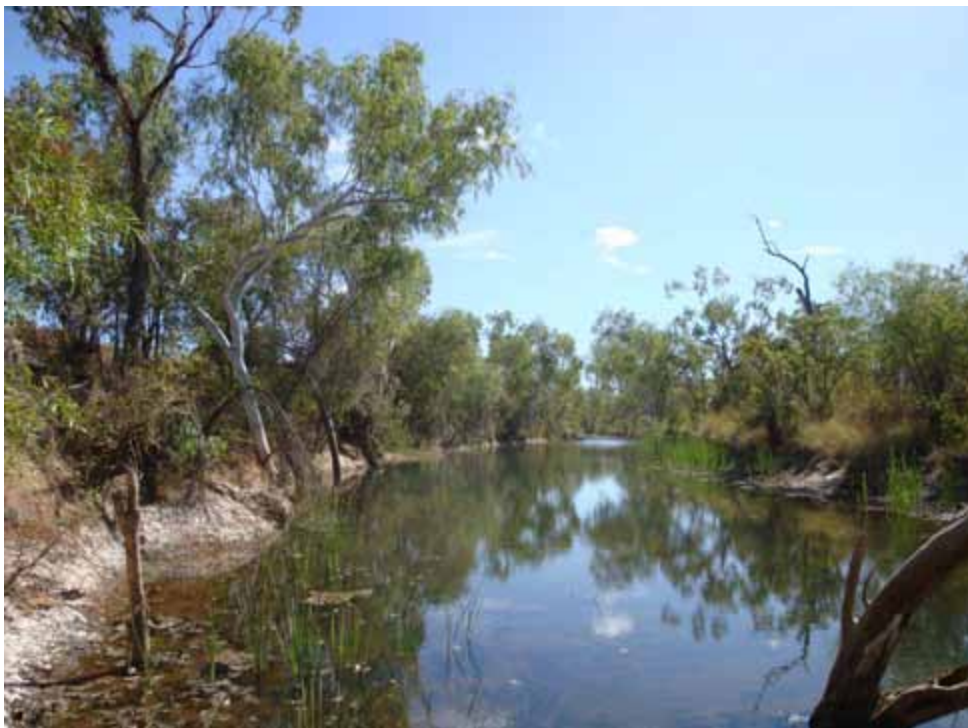
Plate 2 - Salt crystallisation along Surprise Creek. Photograph taken facing up stream (June 2009).

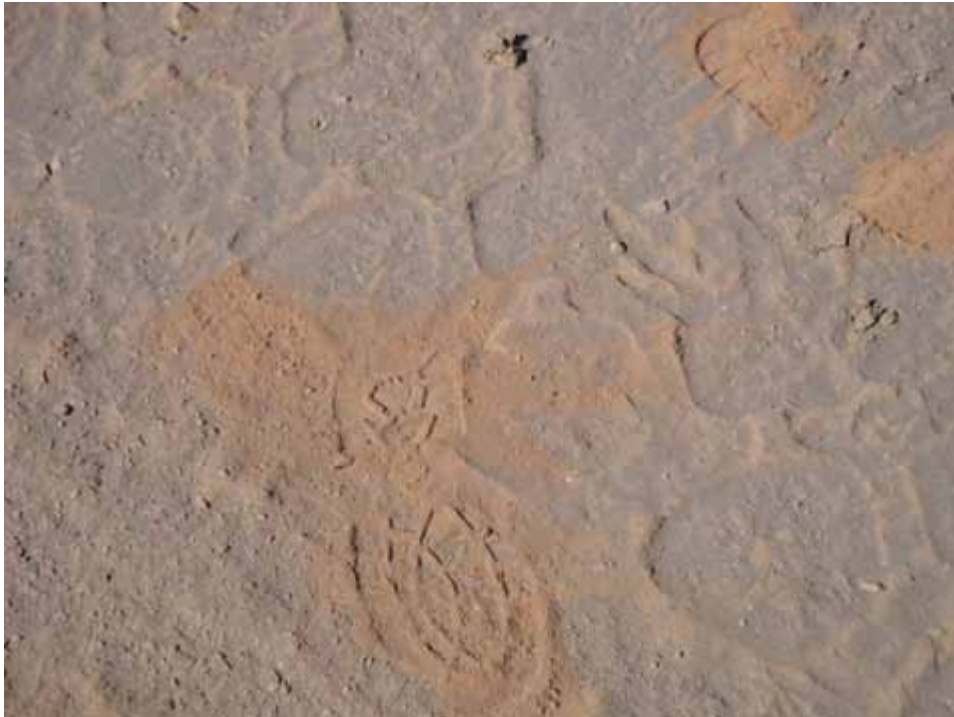
Plate 3 - Layer of dark fugitive dust from ROM pad area, on the access road at the foot of the ROM Pad (June 2009)

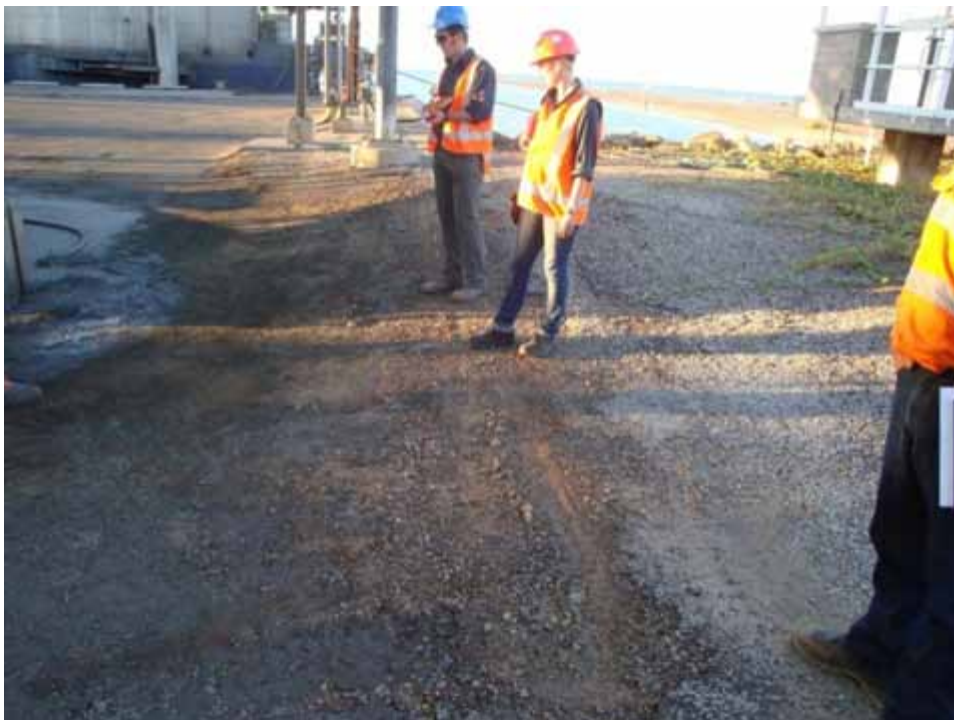
Plate 4 - Area of soil contamination beneath the Bing Bong Port load out conveyor sump/drain where bitumen had eroded expose the soil beneath (June 2009).

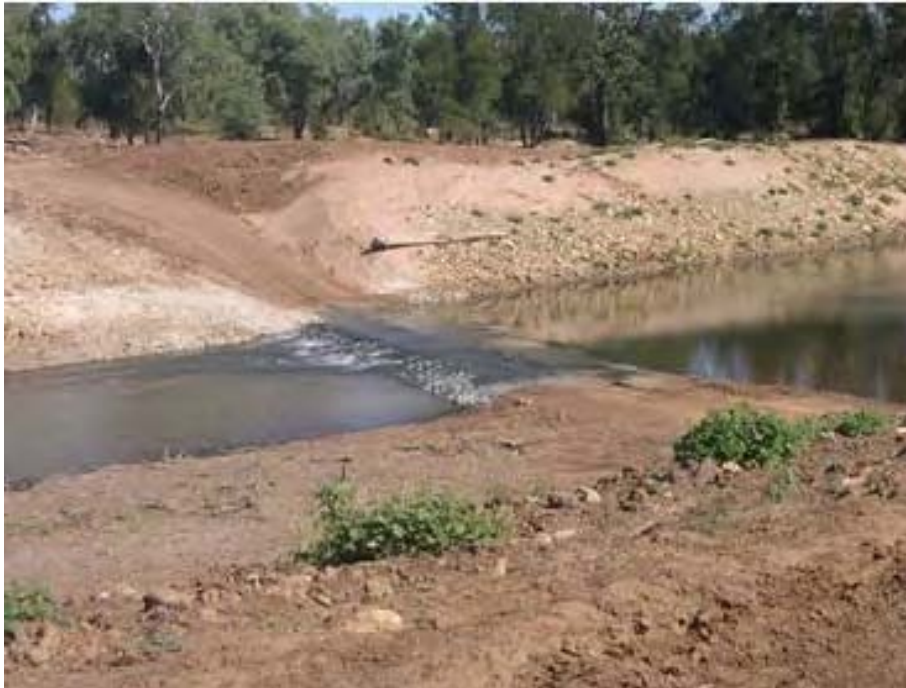
Plate 5 - McArthur River ford crossing. (Note log on bank deposited during wet season flood). (June 2009).

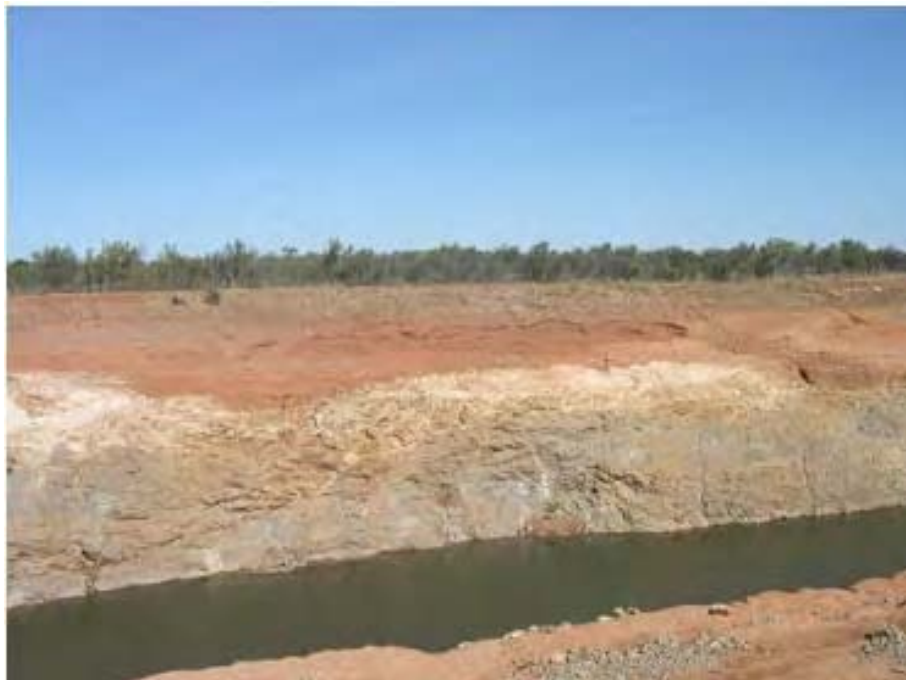
Plate 6 - McArthur River bank erosion/slumping (June 2009).

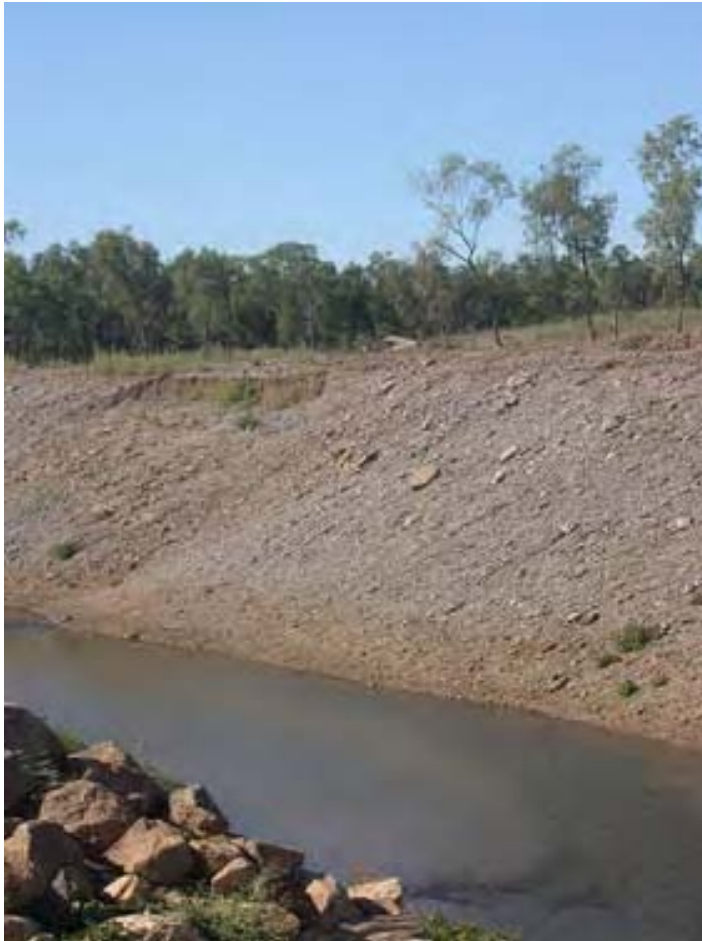
Plate 7 - McArthur River bank erosion/slumping (June 2009).

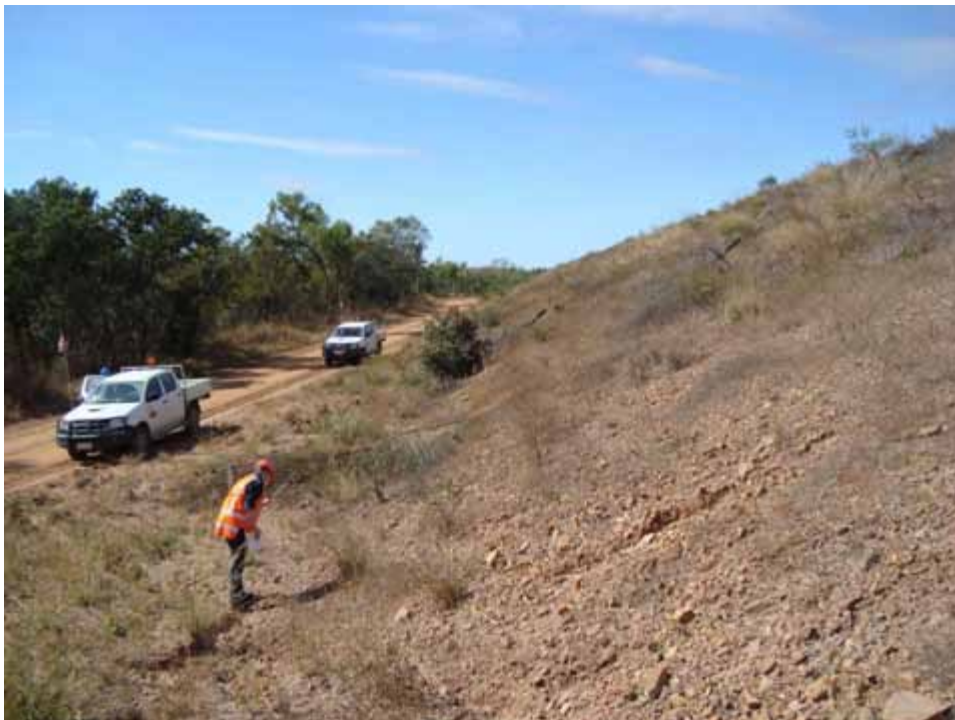
Plate 12 - Cell 1 downstream northern embankment, approximately midway along, adjacent to Surprise Creek (June 2009).

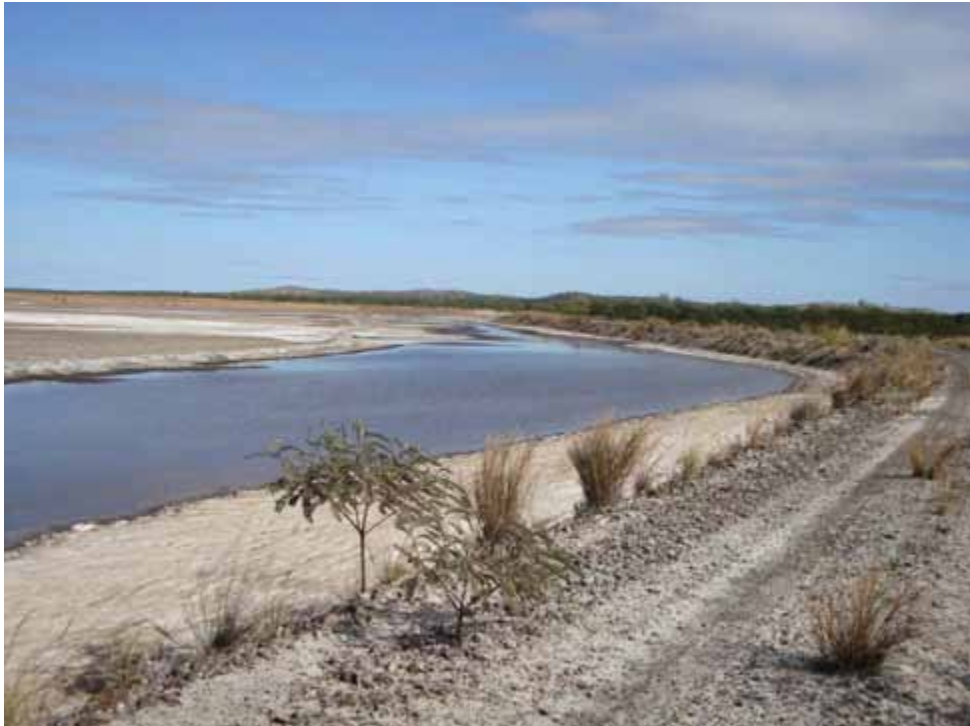
Plate 13 - TSF Cell 1 upstream northern embankment, approximately midway along. Pounded water on top of TSF (June 2009)

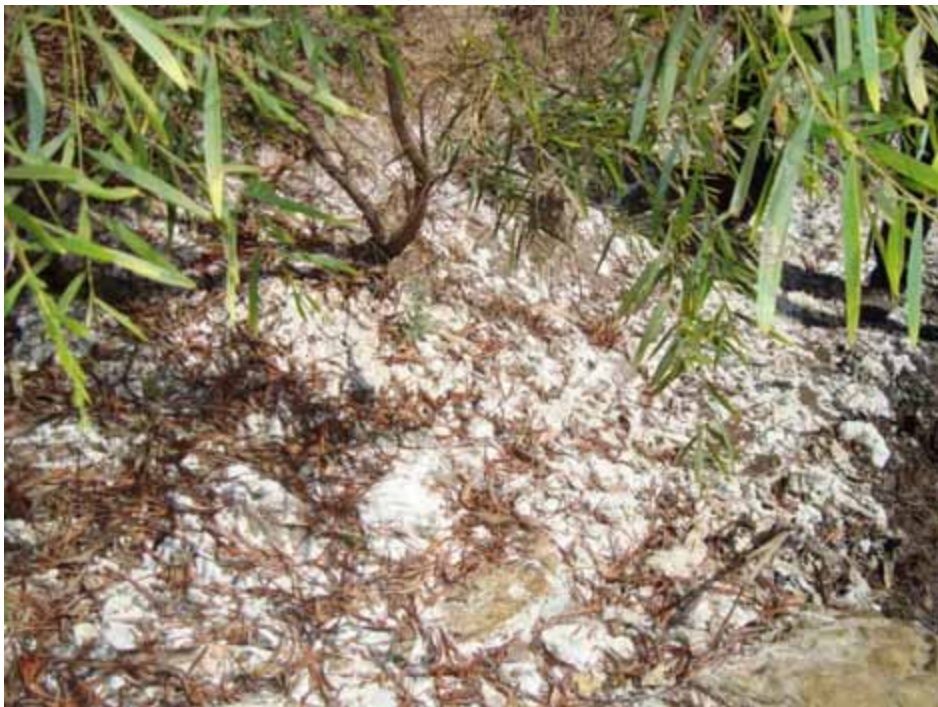
Plate 14 - Surprise Creek channel bank exhibits evidence of continued steady seepage through the presence of salt and iron below northern embankment of Cell1. Closer inspection shows that the rocks have been eroded. (June 2009).

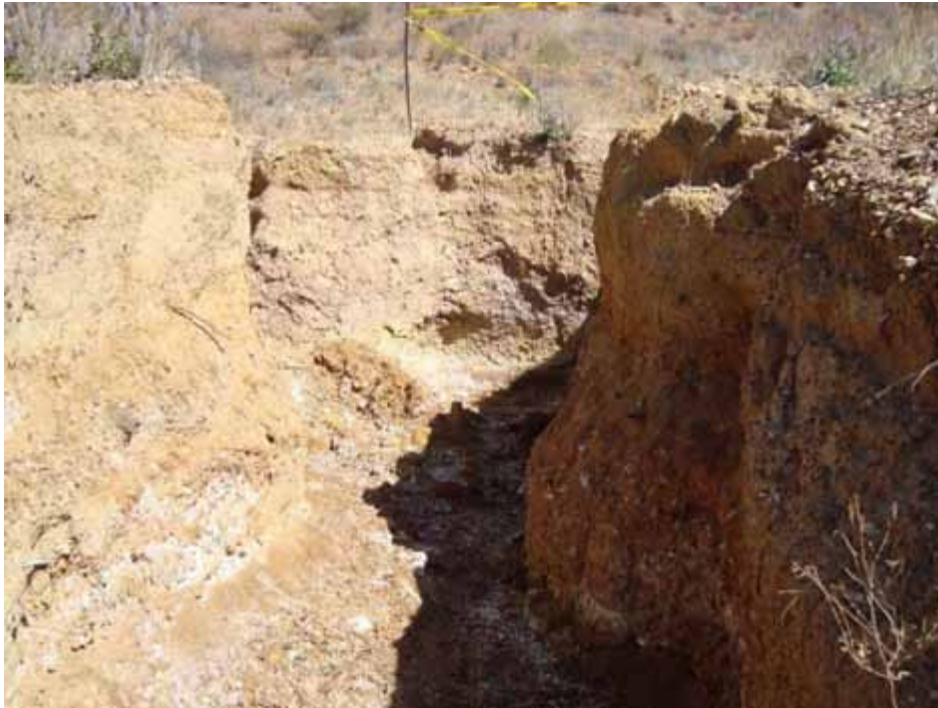
Plate 15 - Washout below TSF Cell 1 northern embankment, approximately midway along. Considerable surface expression of salt (June 2009)

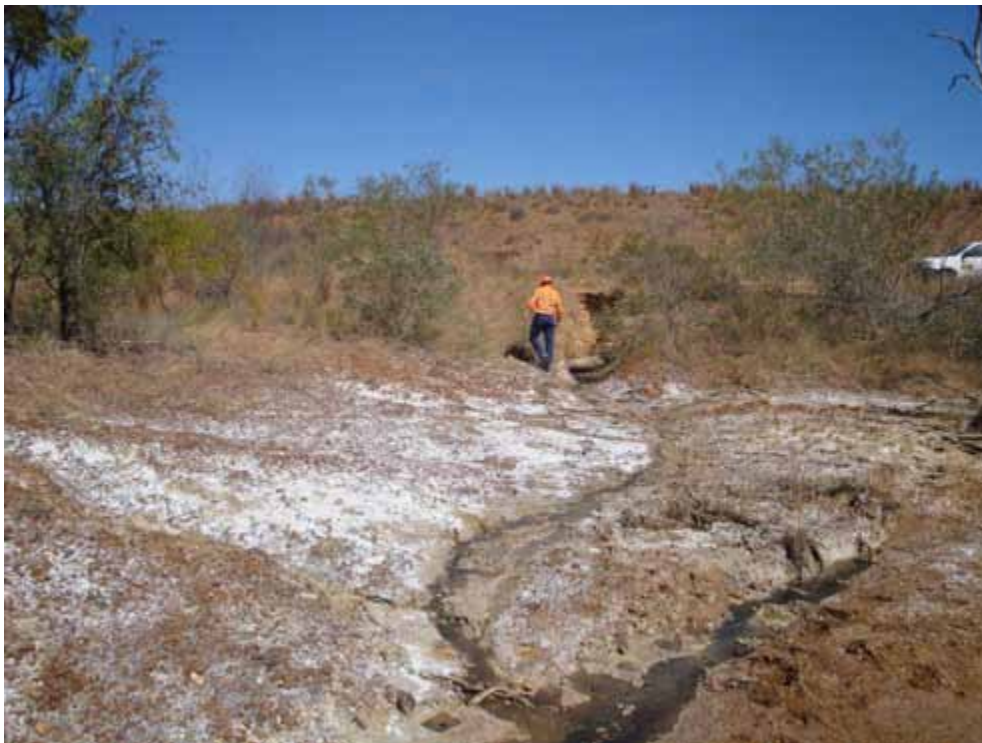
Plate 16 - Extensive surface salt downstream of second erosion gully approximately midway along northern embankment of TSF Cell 1. Seepage possibly along soil/rock interface (June 2009).

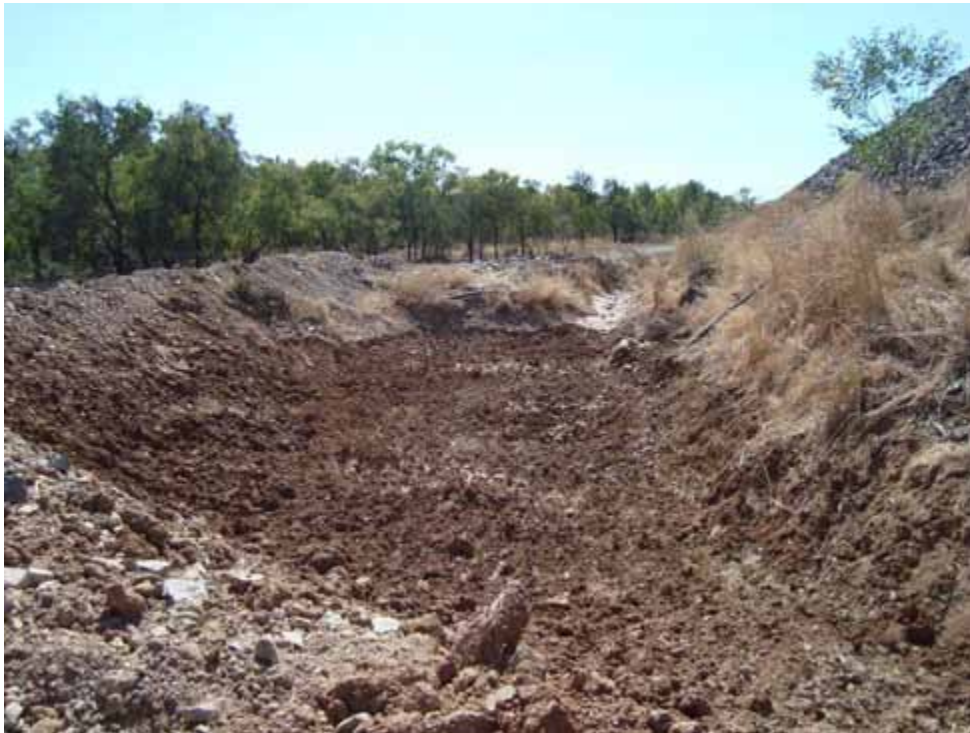
Plate 17 - MRM remediated ROM sump following overtopping during 08/09 wet season (June 2009).

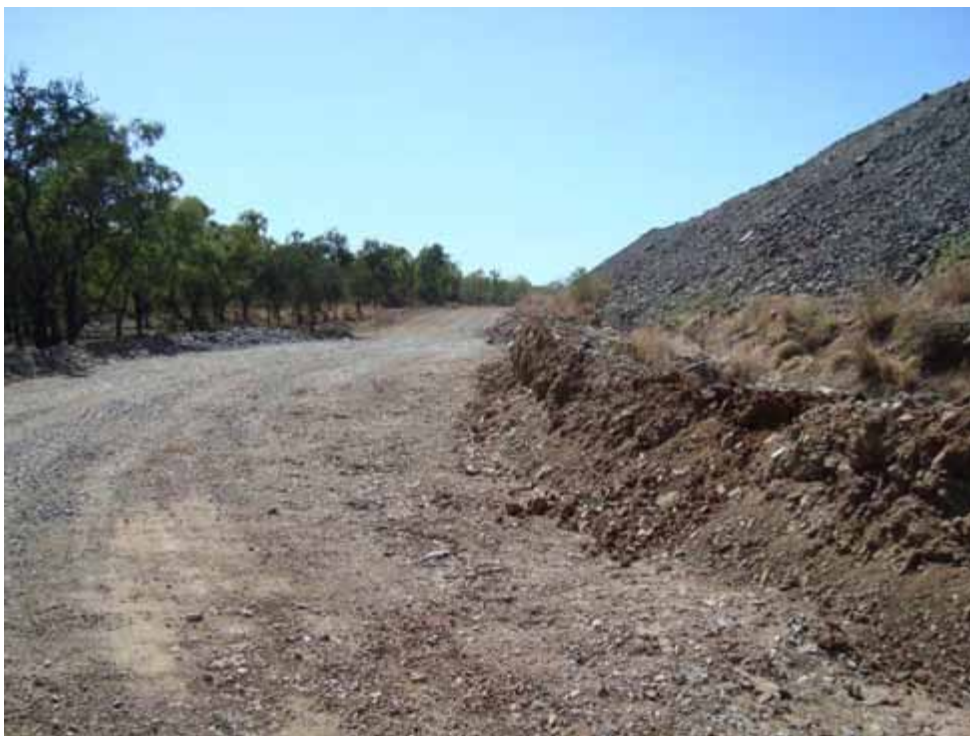
Plate 18 - Reconstructed road after washout that resulted from sump overflow (June 2009).

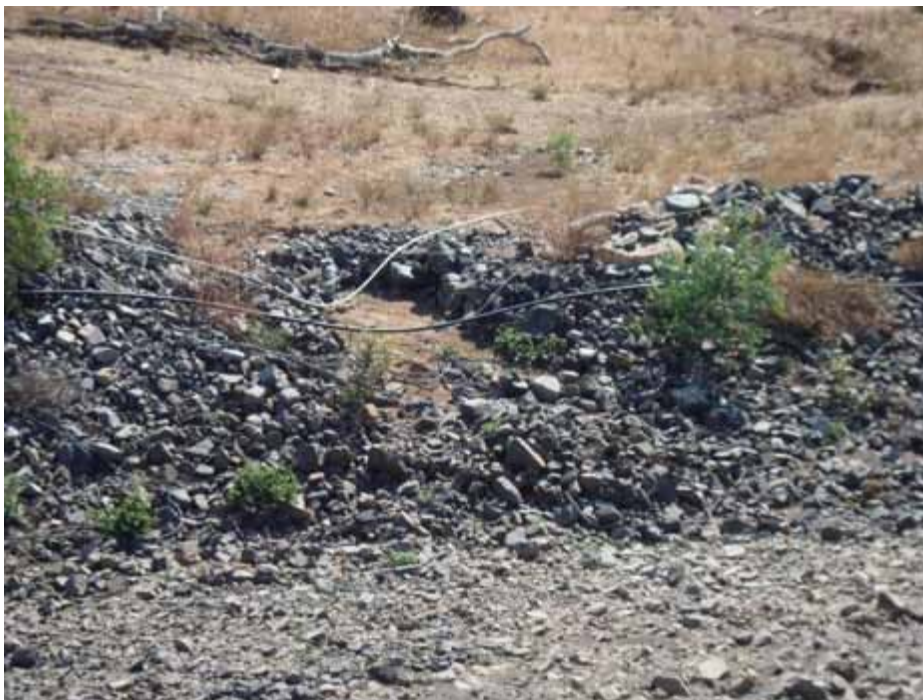
Plate 20 - Minor scour of rock armour can be seen within Barney Creek river diversion channel protection works (June 2009).

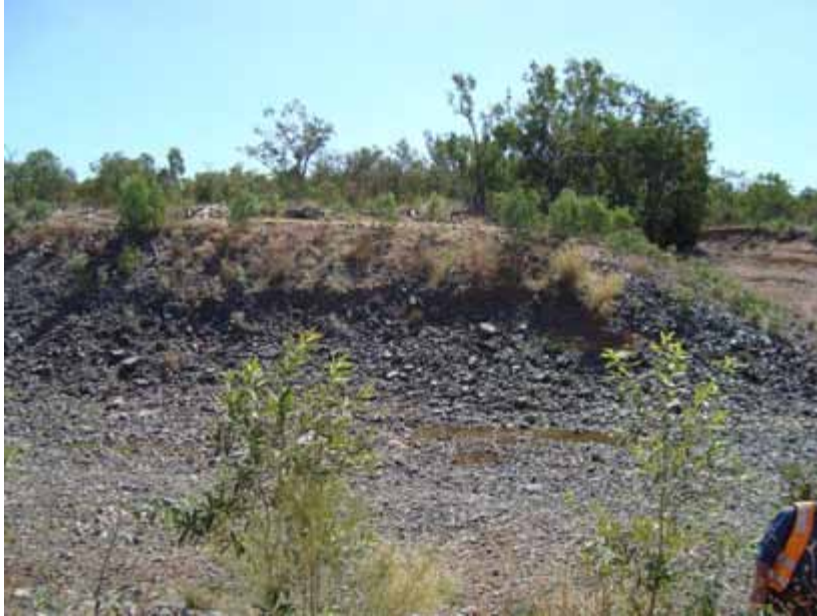
Plate 21 - Minor scour of rock armour can be seen within Barney Creek (foreground) and more advanced bank scour in Surprise Creek (top right corner) (June 2009).

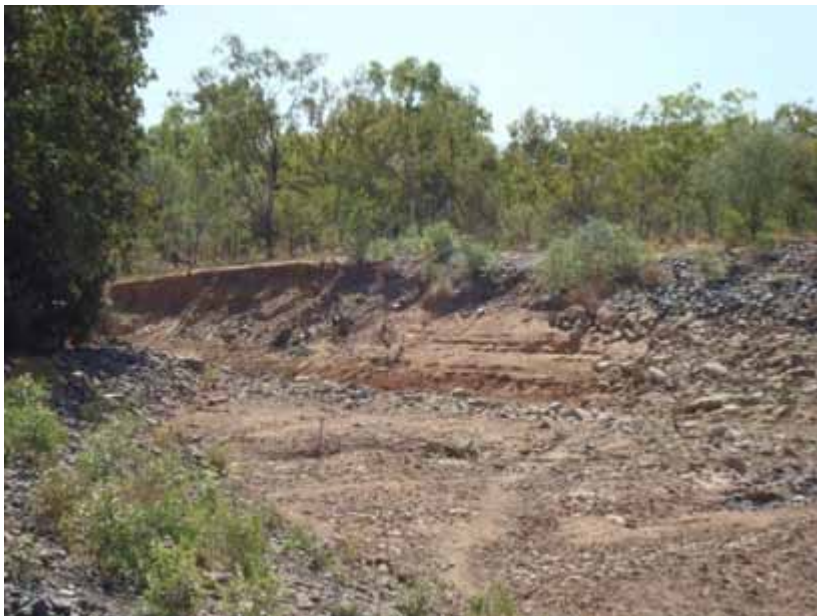
Plate 22 - More advanced scour of Surprise Creek channel bank and resultant bank instability (June 2009).

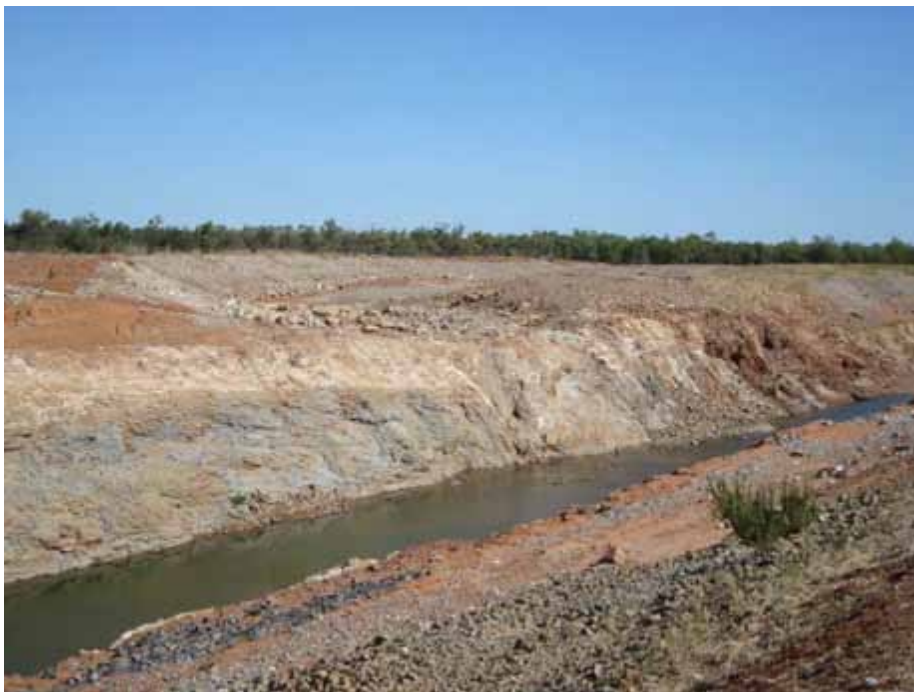
Plate 24 - McArthur River diversion, rockier section, towards upstream end (minor slumping resulting in screen pile in channel) (June 2009).

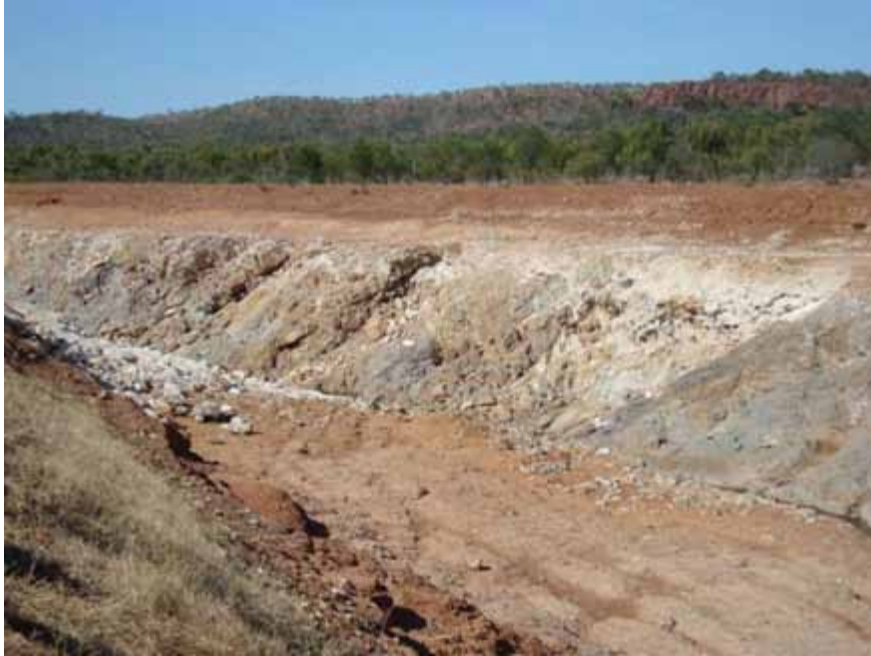
Plate 25 - McArthur River diversion, rockier section, towards upstream end (some minor wedge failures as weaker material has been washed out leaving unstable harder blocks) (June 2009).

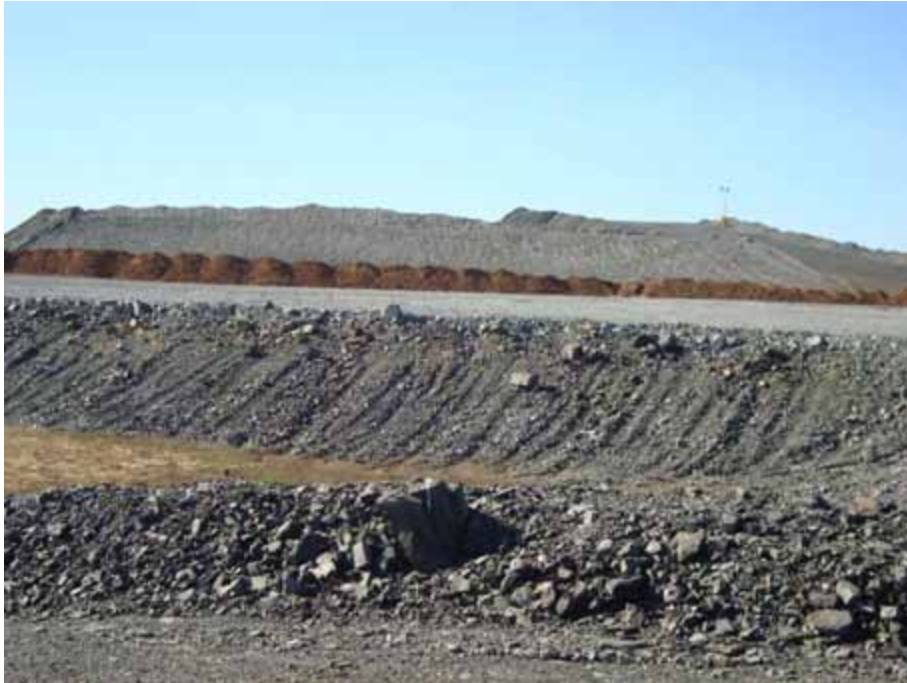
Plate 27 - Overburden Emplacement Facility cell currently under construction. Clay paddock dumped in front of current dump lift (June 2009).

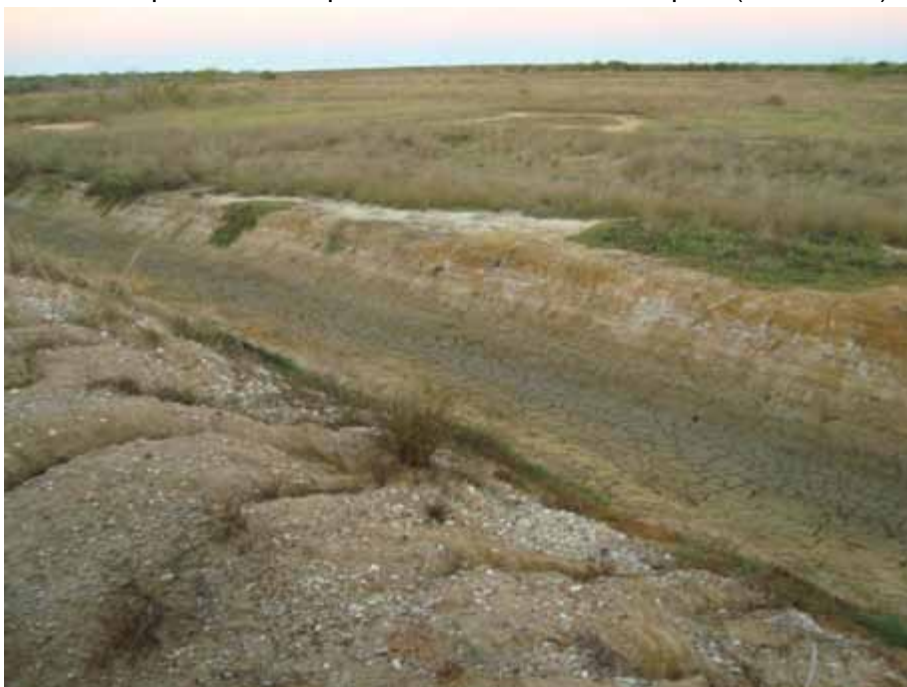
Plate 28 - Bing Bong spoil dump embankment with downstream spoon drain. Embankment deeply eroded and in disrepair (June 2009).

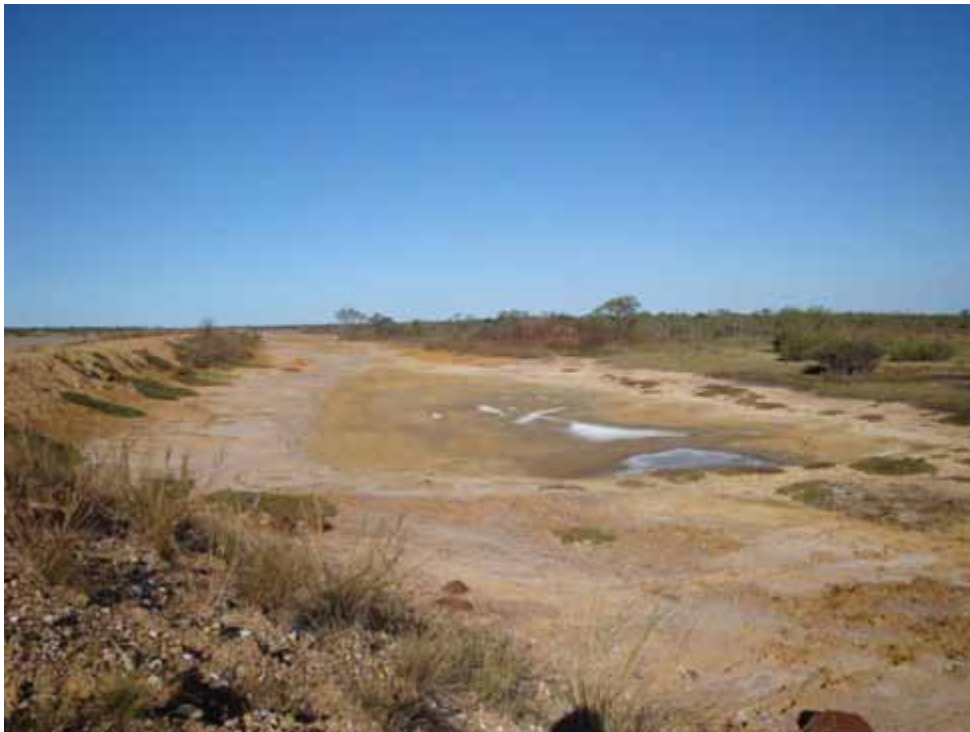
Plate 29 - Bing Bong spoil dump embankment with downstream spoon drain. Embankment deeply eroded and in disrepair. Salt crystallisation deposited from seepage can be seen on the outside of spoil wall (June 2009).
