# Independent Monitor **COMMUNITY REPORT**

**McARTHUR RIVER MINE**

October 2014

# Environmental Performance 2012-2013

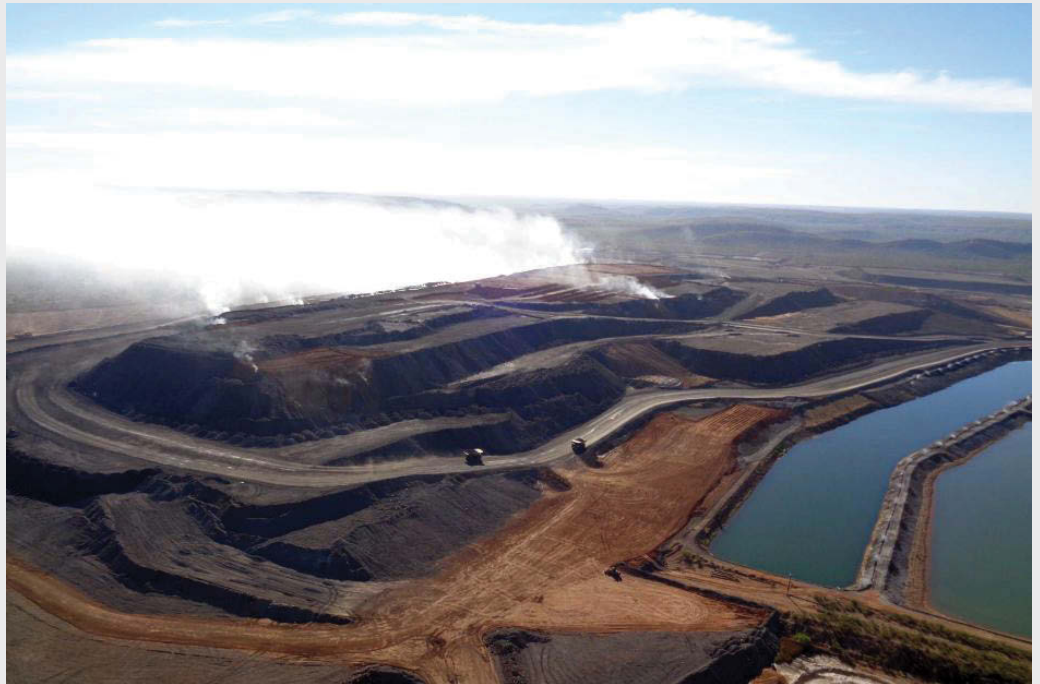
Aside from aesthetic and air quality impacts, fire in the overburden leads to other issues, such as potential instability in the NOEF.

Environmental effects of fire in the NOEF include the potential for subsidence within the overburden, resulting in instability and/or compromising the integrity of the cover.

Failure of the cover due to subsidence will result in infiltration of water into the overburden resulting in acid, saline and metalliferous drainage.

Aerial view of combustion at the Northern Overburden Emplacement Facility  
Source: ABC

- Geochemical assessment and efforts to predict areas of rock with potential to spontaneously combust, to identify these materials before they are mined.
- For materials that are currently burning within the NOEF, spreading these out into thin layers (to cool them) and then recovering with clay.

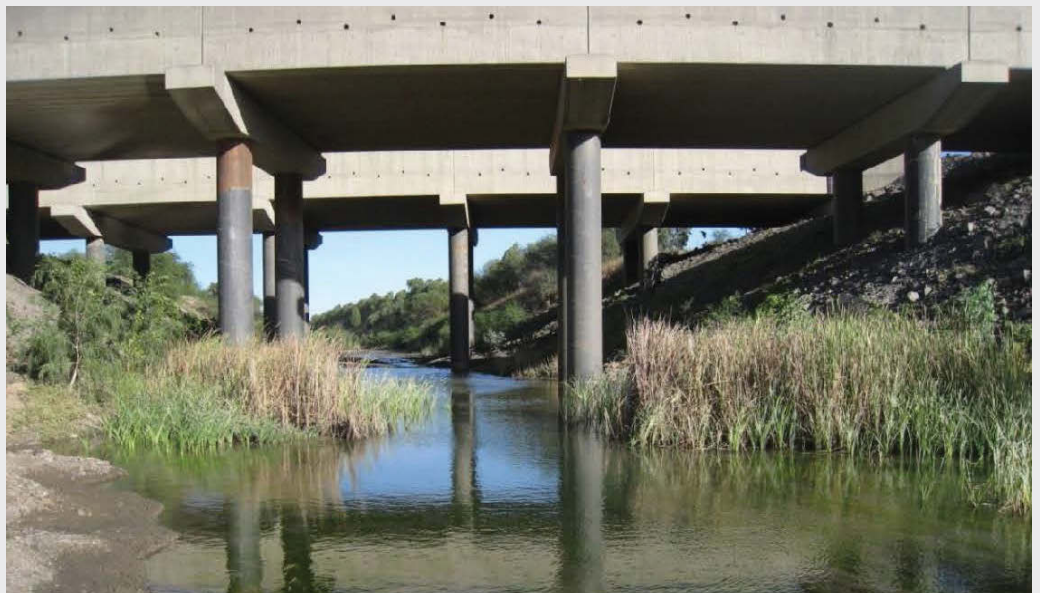
In 2012, two of four rainbowfish and one prawn caught at site SW19 on Barney Creek (site downstream of the bridge, see photo below) exceeded the maximum permitted levels of lead as outlined by Food Standards Australia New Zealand. In 2013, the permitted lead level was exceeded in 9 out of 10 fish caught at SW19.

The lead in fish at SW19 is thought to be due to the location of this site close to Barney Creek bridge, where many haul trucks cross daily.

Sample site SW19 (near Barney Creek bridge) where elevated lead was recorded in fish\*

In August 2014, MRM constructed a sediment management system near Barney Creek bridge. This collects runoff from the haul road and bridge area and removes sediment, before discharging the water to Barney Creek.

MRM has installed a dust measuring device at Barney Creek bridge, which alerts MRM when dust levels are elevated so that dust reduction measures can be implemented.

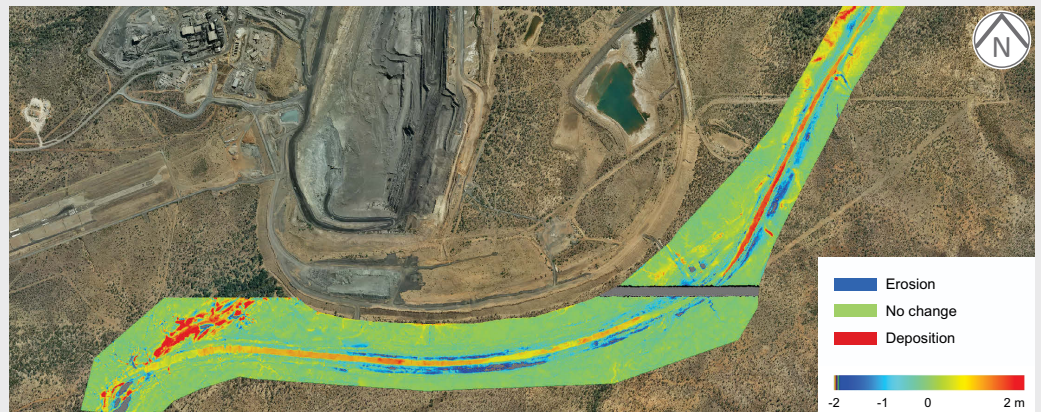
Slow revegetation has contributed to ongoing erosion, and vice versa. In some sections of the diversion channel, erosion of up to 2 m has occurred in the past four years (see figure below).

As such, the channel remains unstable and establishing vegetation in areas with such high levels of erosion will present ongoing difficulties.

McArthur River diversion channel showing change in ground surface level from September 2009 to June 2013

The IM recommends review of the current rehabilitation strategy and the schedule to identify how the revegetation of the channel can be accelerated.

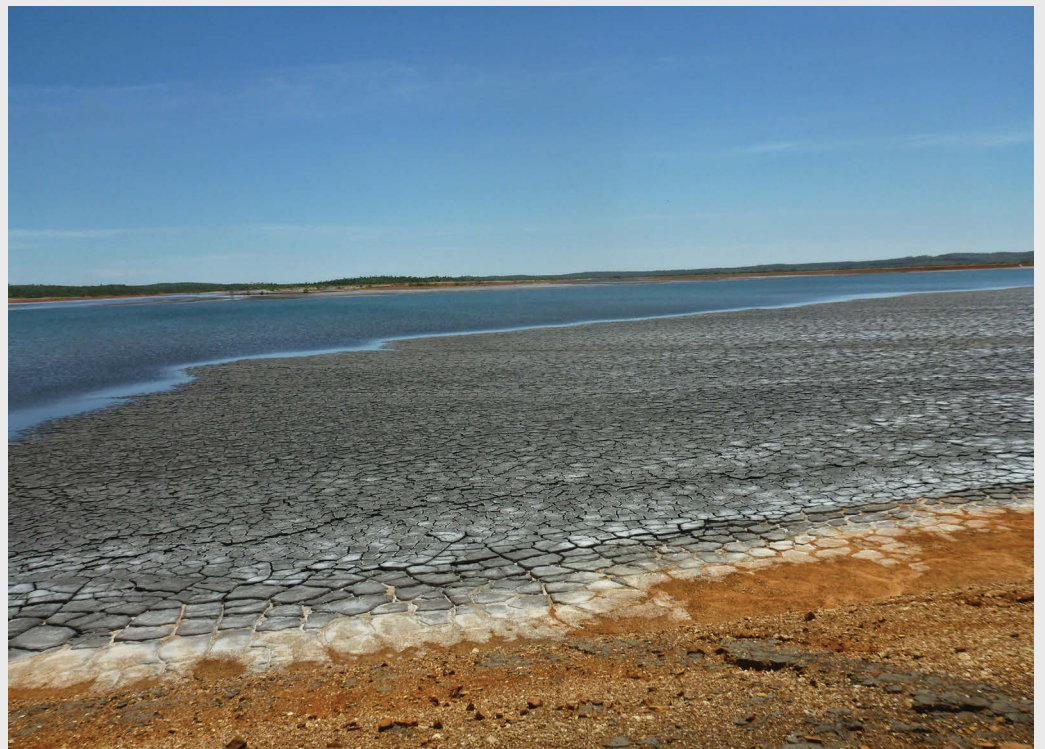
The volume of water stored on the surface of Tailings Storage Facility (TSF) Cell 2 was identified as a concern in the 2011 IM report. This continues to be an issue in 2014, with water observed to be at least 2 m deep along a large part of the Cell 2 southern embankment.

- Increases risk of embankment failure.
- Increases risk of seepage.
- Reduces the volume of water that can be temporarily stored after an extreme rainfall event.
- Has potential to make eventual TSF rehabilitation difficult, if the tailings are not dried out and/or consolidated.

TSF Cell 2, showing the tailings beach

It has previously been recommended (by the IM in 2010 and 2011 as well as the TSF designer) that MRM should install water pressure meters to assess the implications of the elevated water levels and to confirm the dam's ongoing safety.

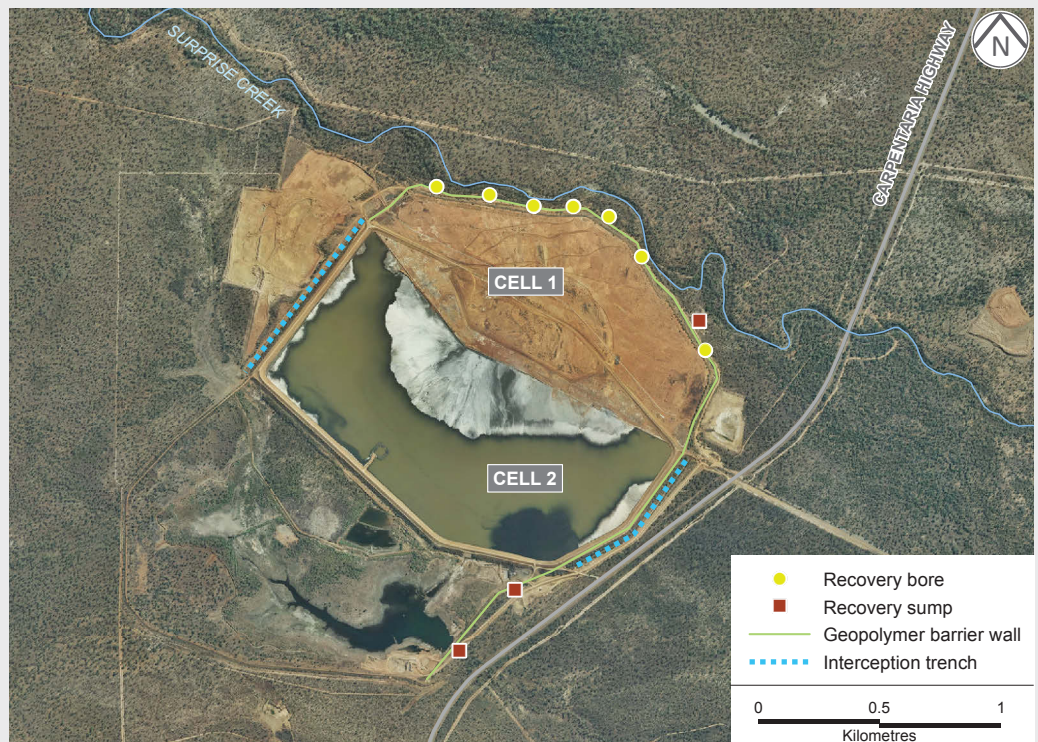
Aerial photo of the TSF area showing seepage control measures

Seepage from TSF Cell 1 and TSF Cell 2 has continued during the period, despite the implementation of the above measures. This may be linked to the excess water stored on TSF Cell 2.

The photo above shows existing measures to manage seepage from the TSF, including a low-permeability geopolymer barrier, interception trenches to the northwest and southeast of Cell 2, and water recovery bores/sumps.

- 2014: improve Cell 1 drainage and undertake monitoring and modelling to inform the management of seepage.
- 2015: install seepage mitigation measures and improve cover drainage as necessary.

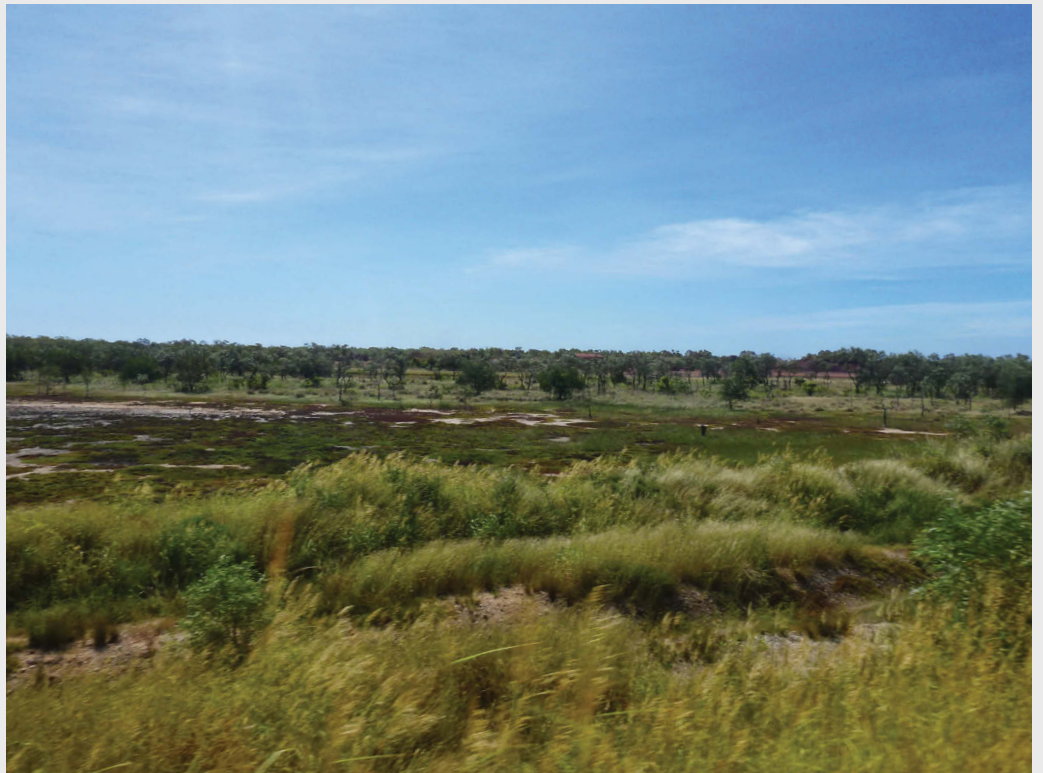
Vegetation adjacent to Bing Bong dredge spoil ponds

In areas just outside of the dredge spoil ponds there has been dieback of vegetation. This may be due to one or a combination of:

- Previous obstruction of a creekline by dredge spoil, causing inundation of trees. This was rectified by 2012.
- Salt runoff and/or leachate draining from the dredge spoil. MRM has undertaken vegetation condition and soil monitoring annually since 2012 and is currently awaiting the 2014 report.
- Seawater remaining against the outside of the drain bund after the tide recedes.

The IM recommends that the outside of the drain bund wall be inspected regularly, to assess if tidal seawater is ponding against the bund and contributing to vegetation dieback from salinity.
