**INDEPENDENT MONITOR AUDIT REPORT –
ENVIRONMENTAL PERFORMANCE OF THE MCARTHUR
RIVER MINE – 2009 OPERATIONAL PERIOD**

**ENVIRONMENTAL EARTH SCIENCES VIC
REPORT TO THE DEPARTMENT OF RESOURCES**

AUGUST 2010

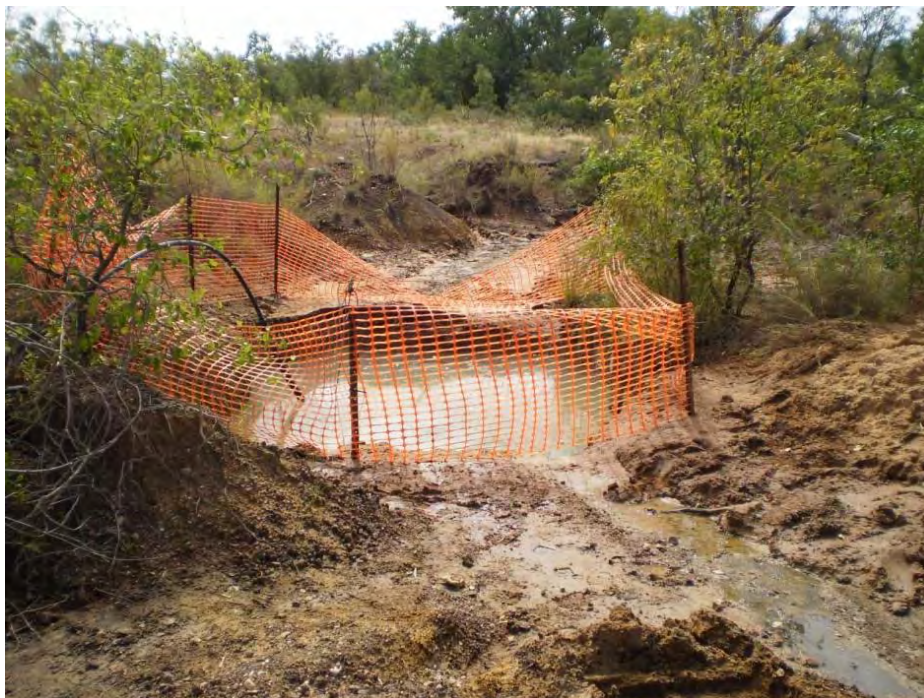
Plate 1 - Sump installed between Tailings Storage Facility Cell1 and Surprise Creek to collect leachate.

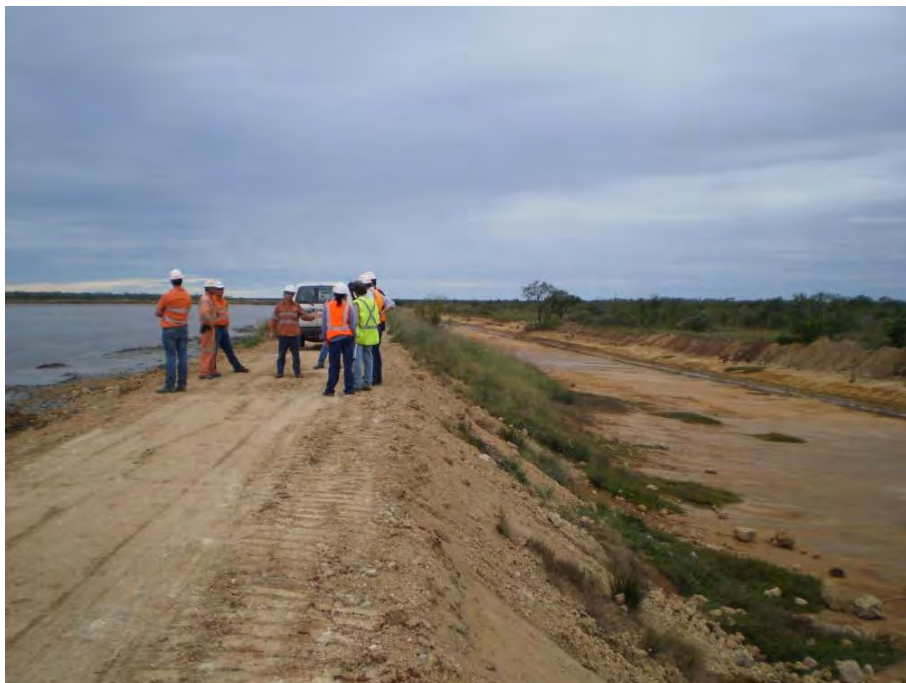
Plate 2 - Remediated Bing Bong Dredge Spoil Pond wall (centre) with newly-constructed outer spoon drain (right) and recently deposited dredge material (Left).

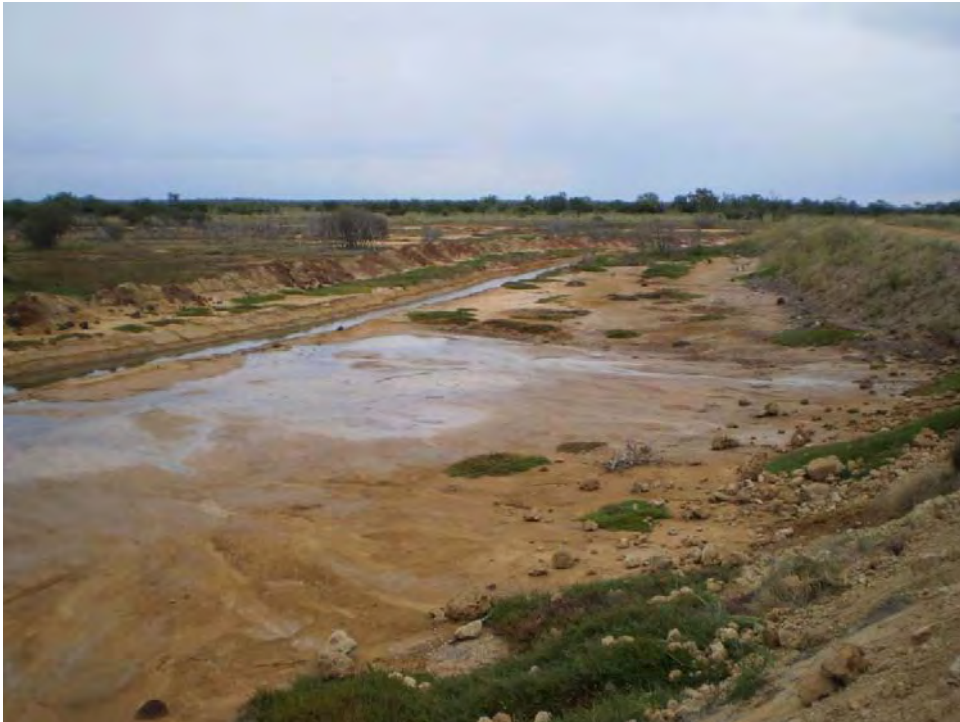
Plate 3 - Saline leachate seeping from Bing Bong Spoil pond wall towards the spoon drain.

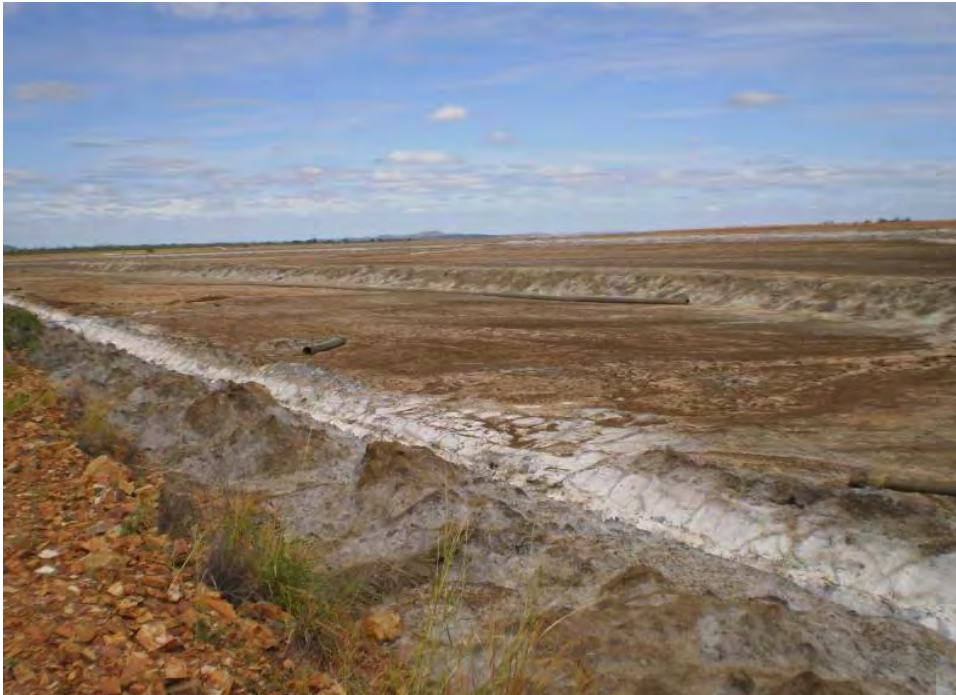
Plate 4 - TSF Cell 1 with incomplete clay capping.

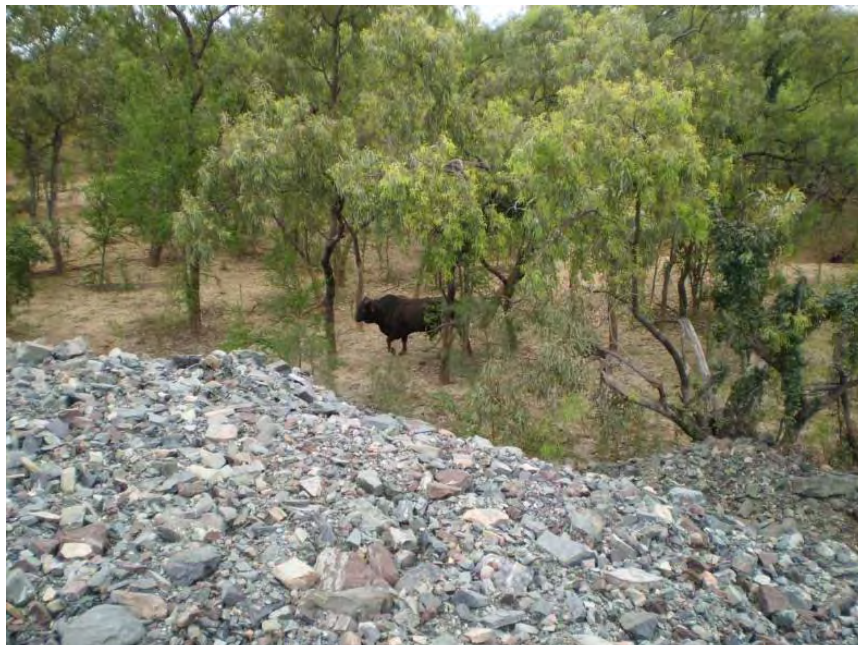
Plate 11 - Cattle foraging along Barney Creek.

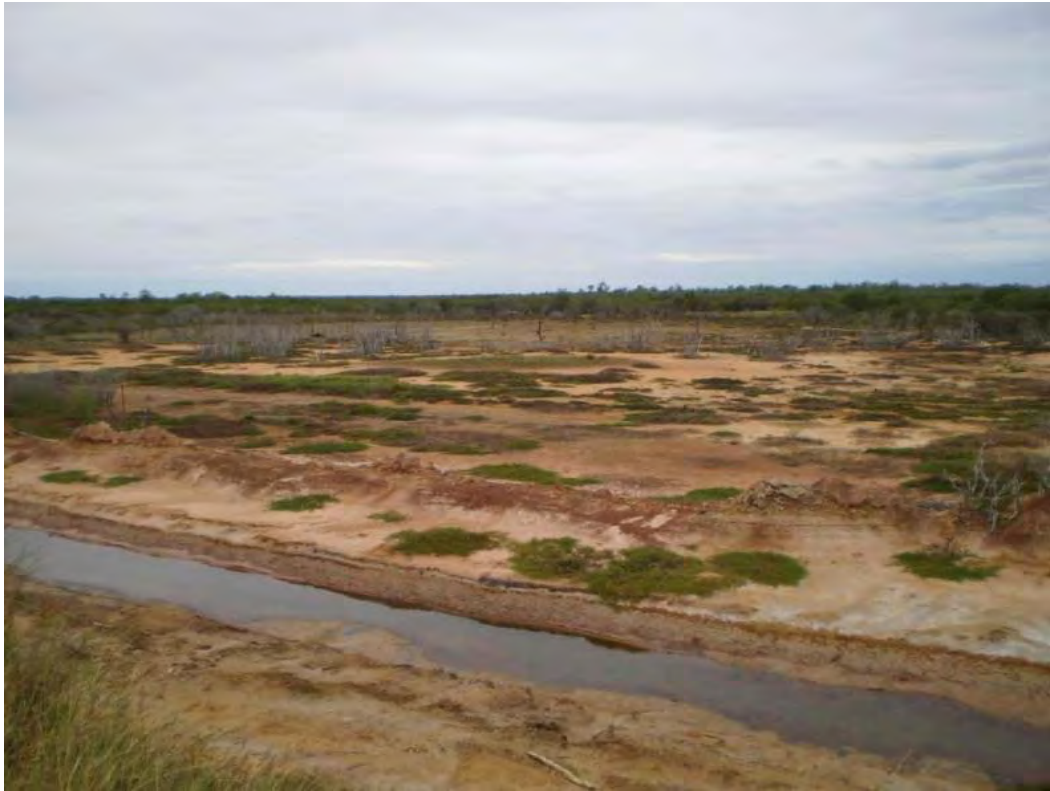
Plate 13 - Outer spoon drain at the Bing Bong Dredge Spoil to direct saline seepage from the spoil ponds to the sea.

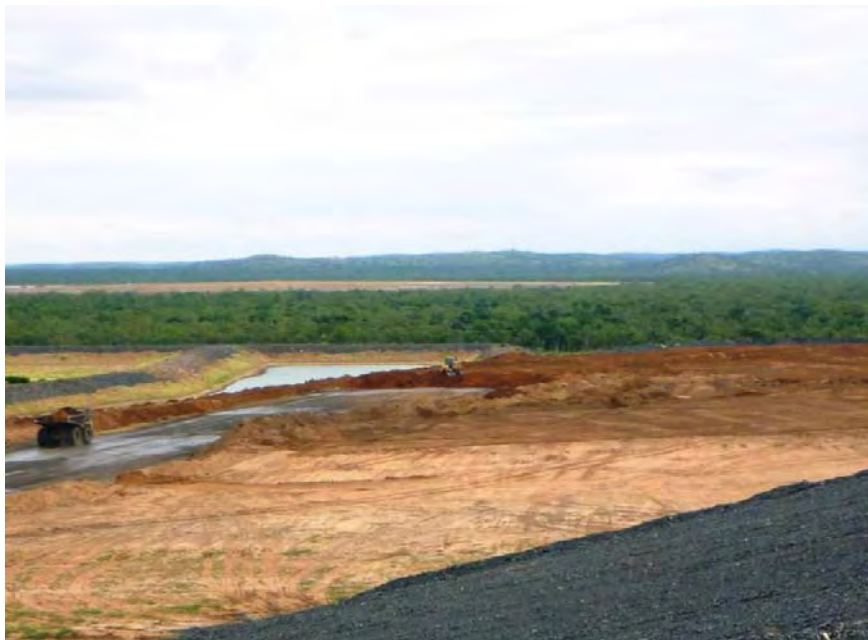
Based on the information provided by MRM, the quality control with regard to the construction of the Overburden Emplacement Facility clay lining continues to be limited. Even though the URS Overburden Emplacement Facility Design Report (URS, 2008) specifies that the contractor responsible for the placement of the clay liner should prepare a Quality Control/ Quality Assurance Plan (QA/QC), no comprehensive geotechnical reports/ documents regarding the foundation preparation or the placed Overburden Emplacement Facility clay liner have been provided to the Independent Monitor for review.

Plate 16 - Facing north-west towards the clay liner being placed for the Overburden Emplacement Facility.

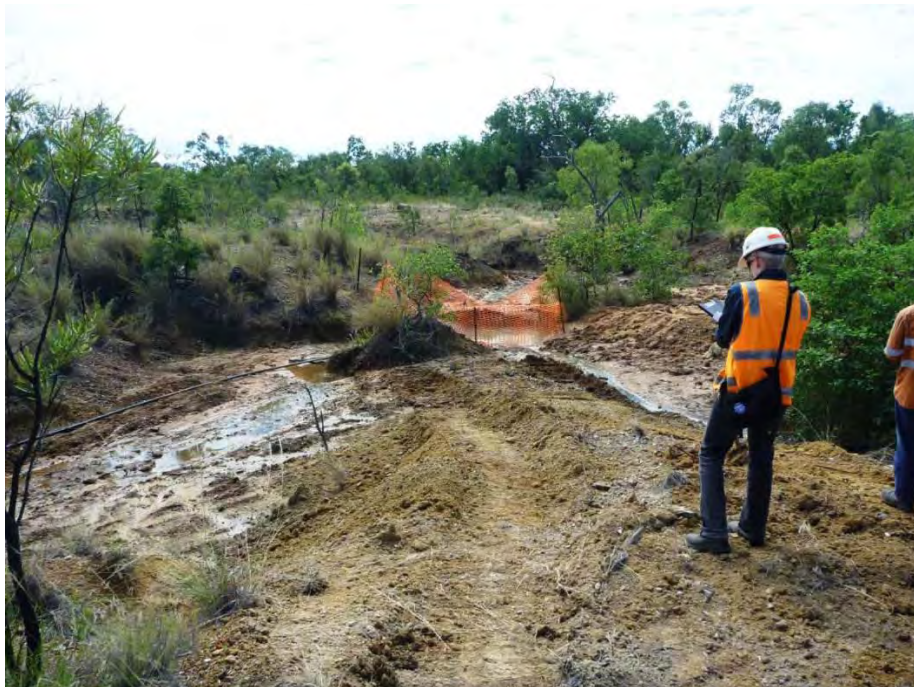
Evidence of seepage (see Plate 17 -) and potential piping (see Plate 18 -Plate 19 -) was noticed along the road between Cell 1 and Surprise Creek. Salt deposits were also noted around these locations, which could indicate that seepage is occurring from Cell 1.

Plate 17 - Seepage expressing into Surprise Creek, northern boundary of TSF Cell 1

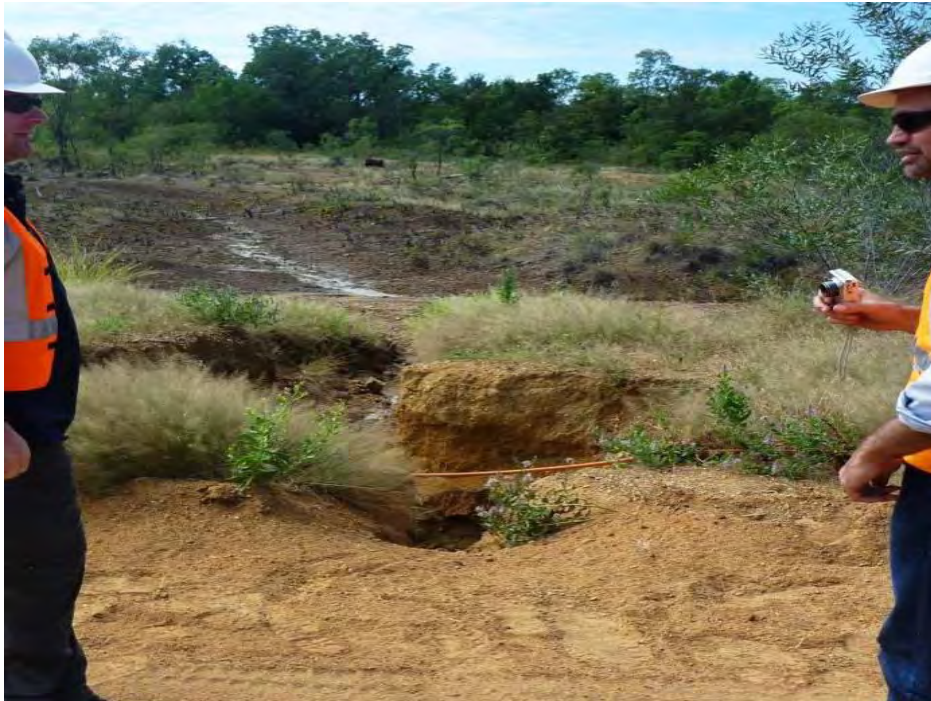
Plate 18 - Evidence of piping erosion on the northern track edge of TSF Cell 1.

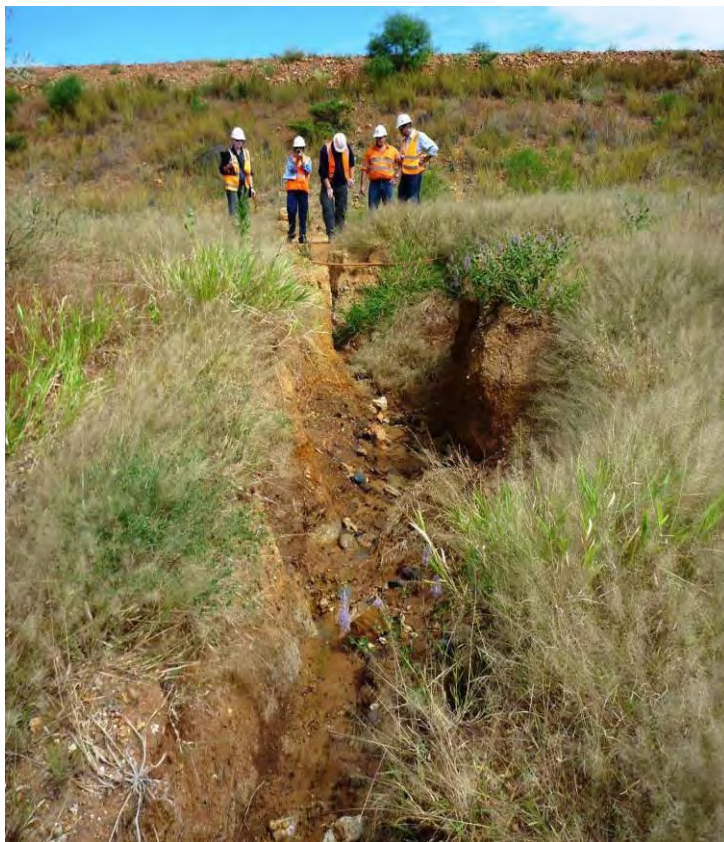
Plate 19 - Plate 7 Erosion Gully taken from reverse angle

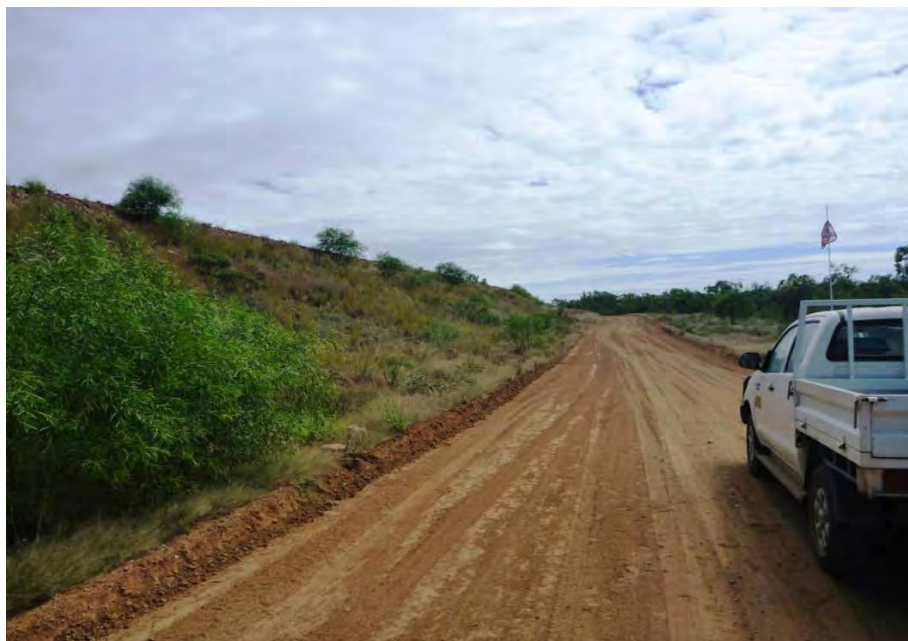
The condition of Cell 1 embankment was observed to be generally good (see Plate 20 -and) and furthermore, trees had been removed from specific embankment areas for the management of the dam, though regrowth has occurred (Plate 21 -)

Plate 20 - TSF Cell 1, Northern embankment looking west

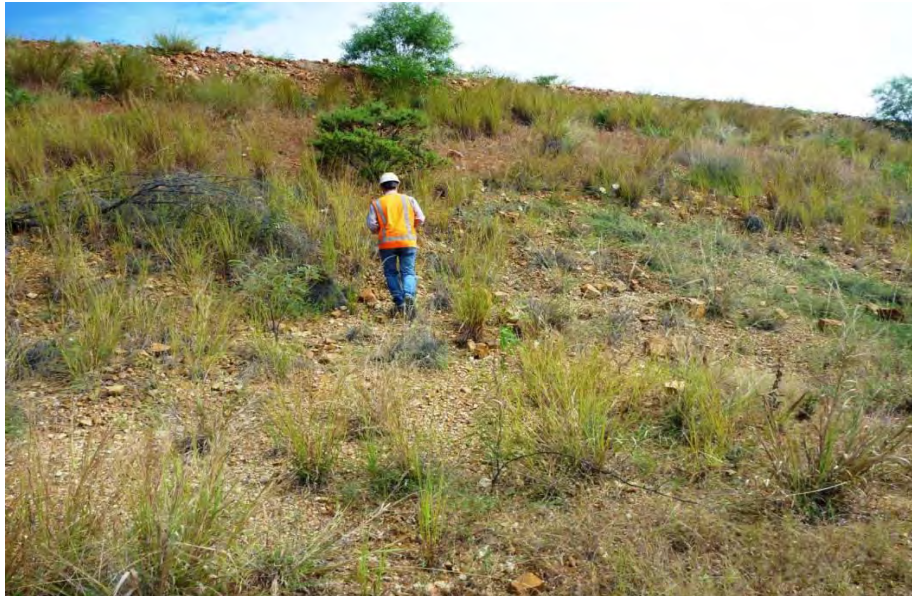
Plate 21 - Some example of the larger vegetation present on the TSF Cell 1 Embankment

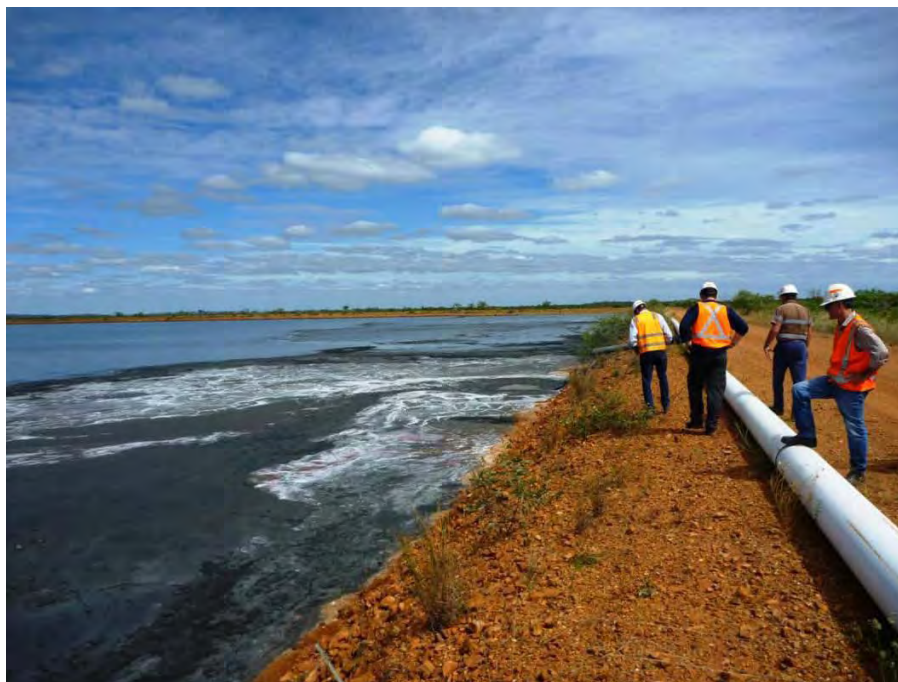
Cell 2 is currently operational and the deposition of tailings occurs from spigots located along the northern, eastern and southern boundaries. Basic deposition principles for the Tailings Storage Facility as adopted by MRM include the development of a beach profile on the northern and eastern embankment (AWA, 2010) (See Plate 22 -)

Plate 22 - TSF Cell 2 western embankment with tailings beach formed against embankment.

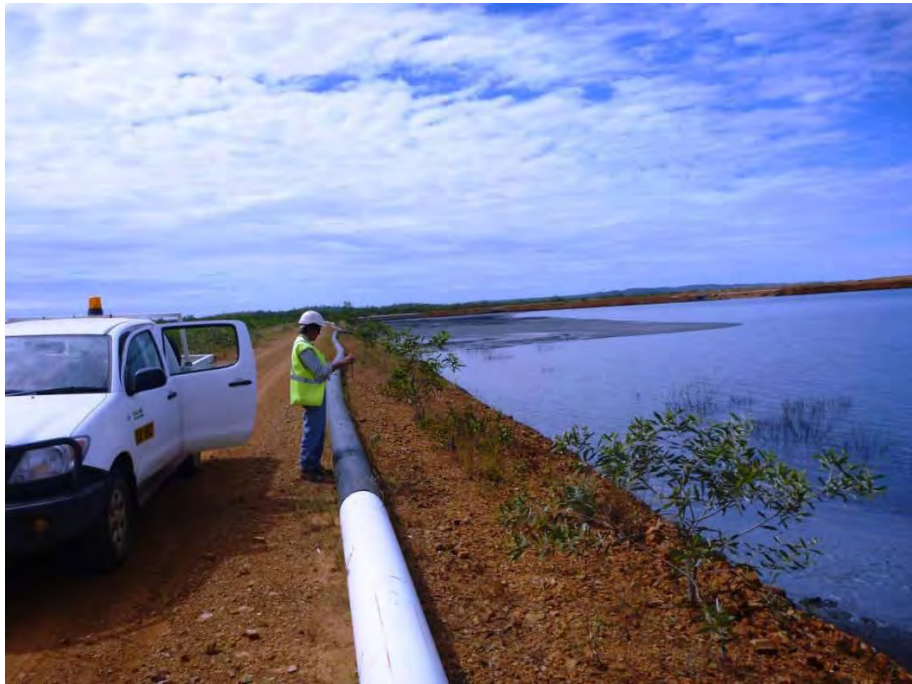
Plate 23 - TSF Cell 2 Western Embankment, showing tailings pipeline and Standing Water against embankment of Cell2.

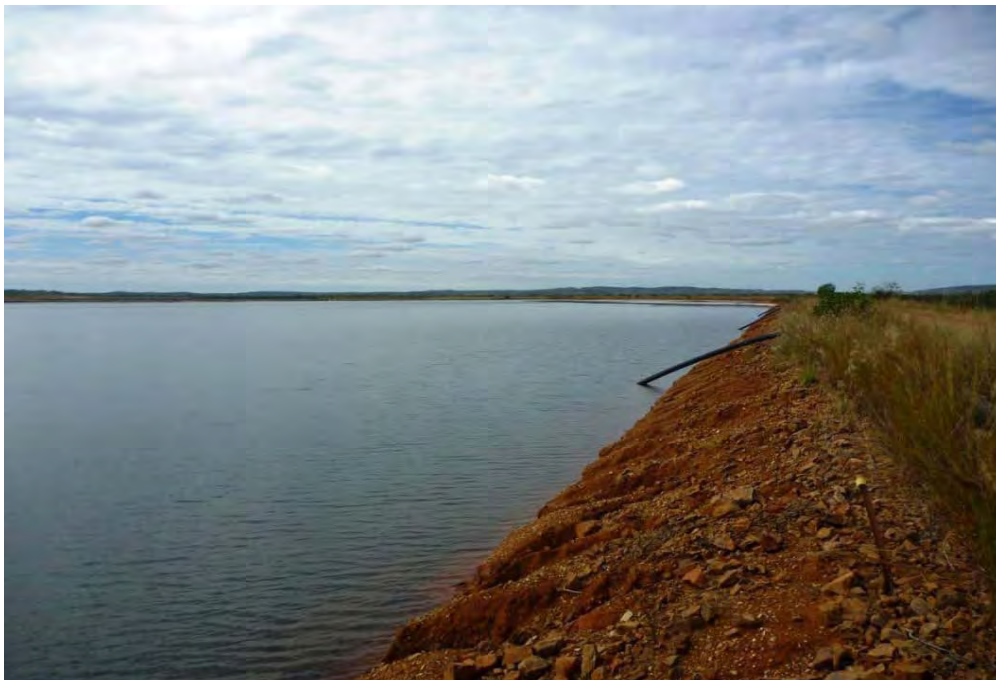
Plate 24 - TSF Cell 2: Deep body of standing water against the embankment with some erosion of the embankment occurring

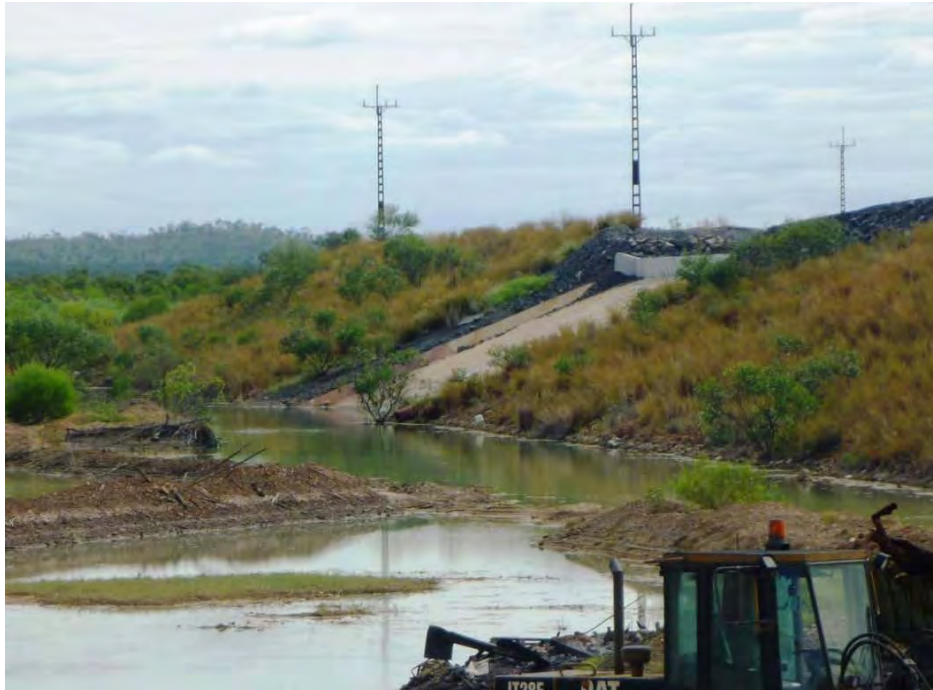
(see Plate 25 -) indicates that the embankment is not performing appropriately as a water storage dam even if that was indeed MRMs intention.

Plate 25 - TSF Cell 2 Spillway. Seepage evident through concrete spillway.

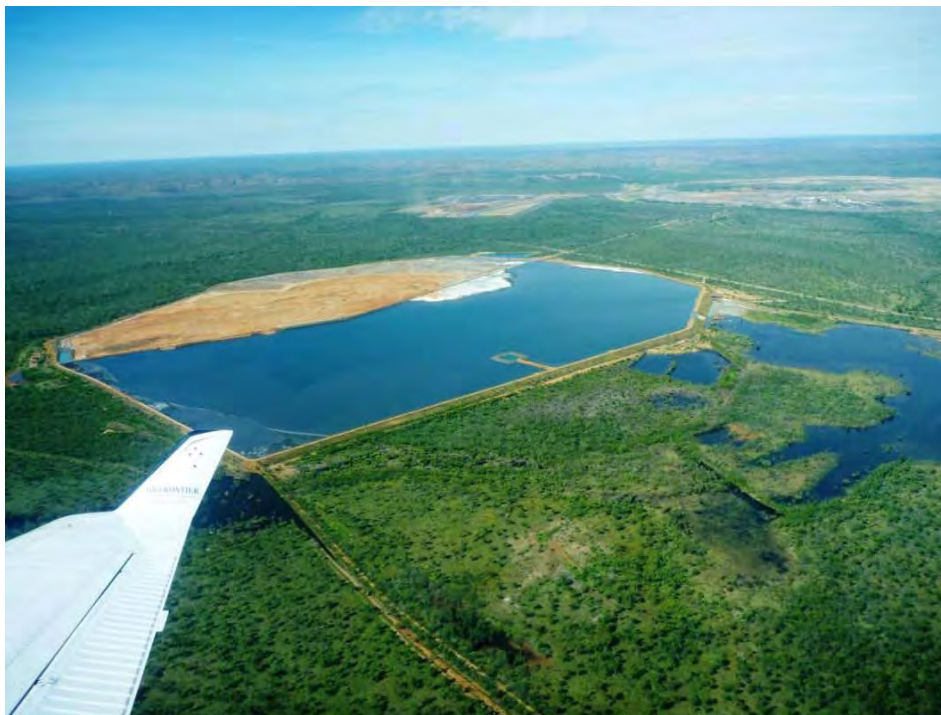
Plate 26 - Standing water very evident within TSF Cell 2. Ponded water near toe of embankment (at wing tip) is a cause for concern

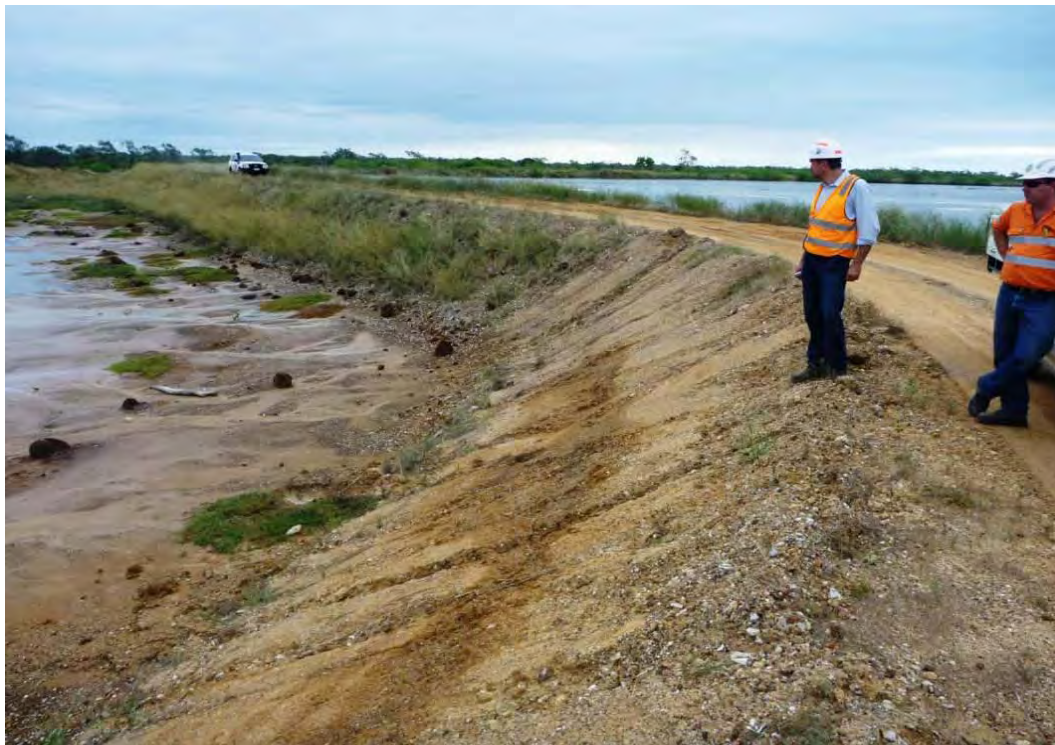
Plate 28 - Bing Bong Spoil Dump. Repaired Section of embankment. Seepage visible on left.

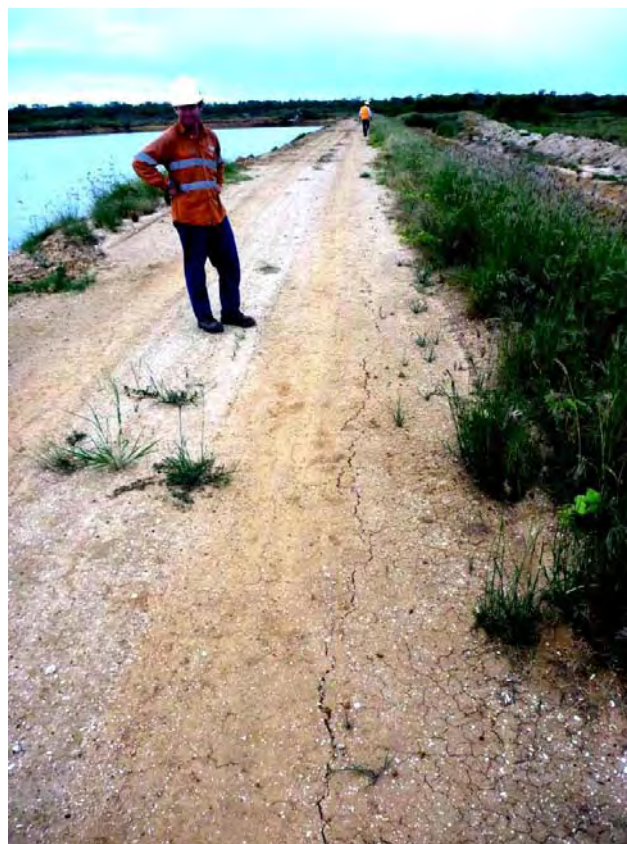
Plate 29 - Bing Bong Spoil Dump. Longitudinal cracking in Eastern Embankment

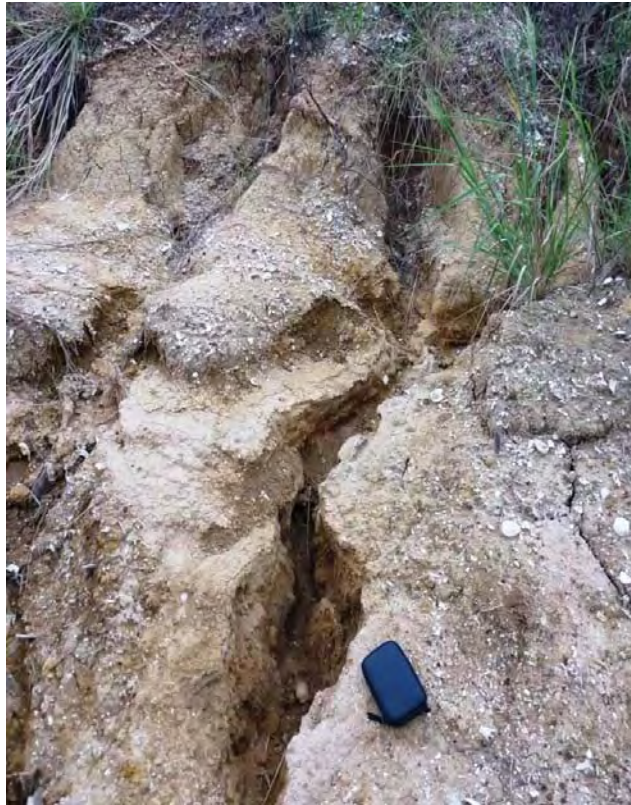
Plate 30 - Bing Bong Spoil Dump. Piping erosion in Eastern embankment

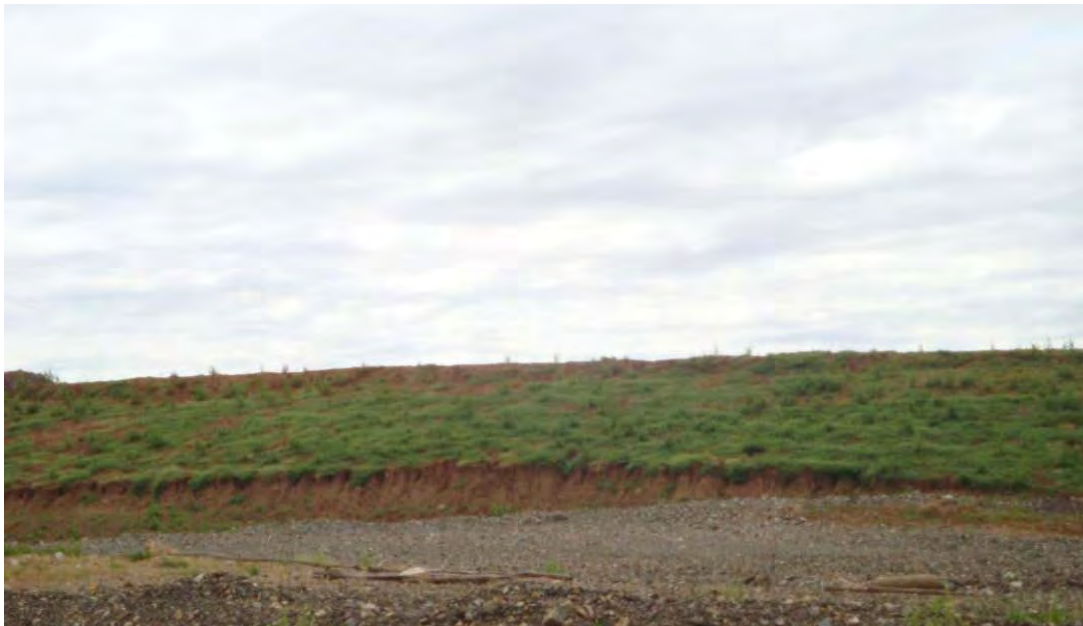
Plate 31 - Scour at the toe of the main Mine levee due to overland flows of the McArthur River during 2009/2010 wet season flooding – (see section 8.8.5)

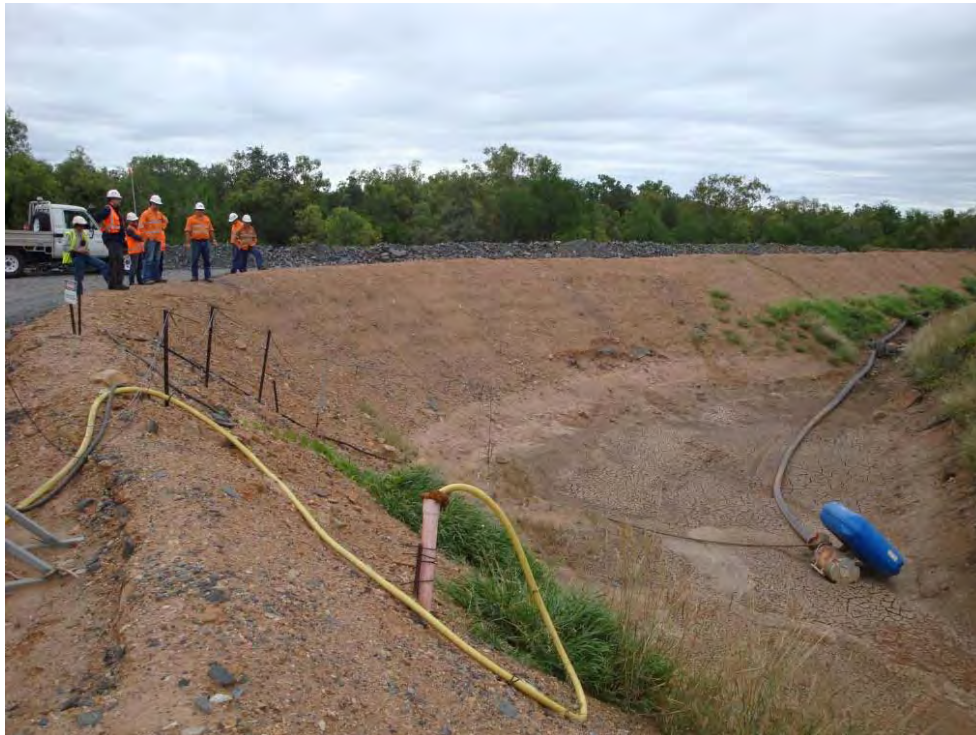
Plate 35 - Reconstructed sump at the west outer corner of the ROM Pad.

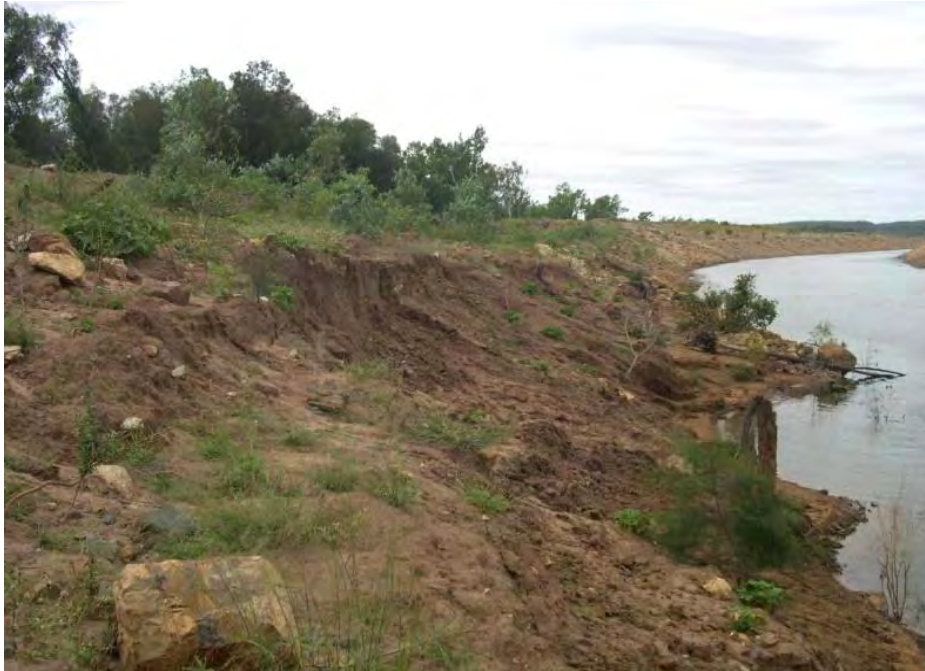
Plate 36 - Example of relatively minor bank erosion in the McArthur River diversion channel.

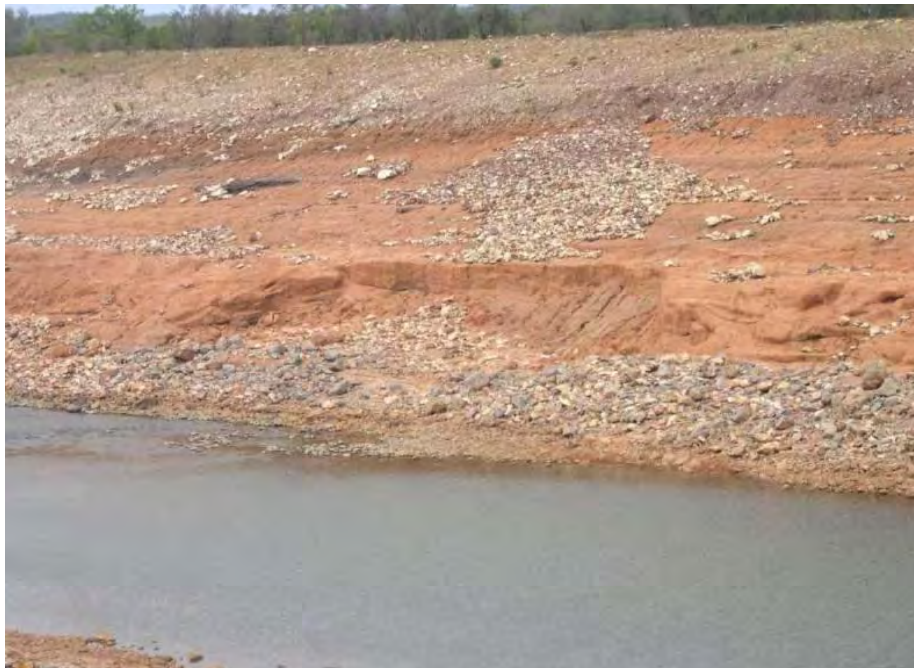
Plate 37 - Relatively minor bank erosion in the McArthur River diversion channel.

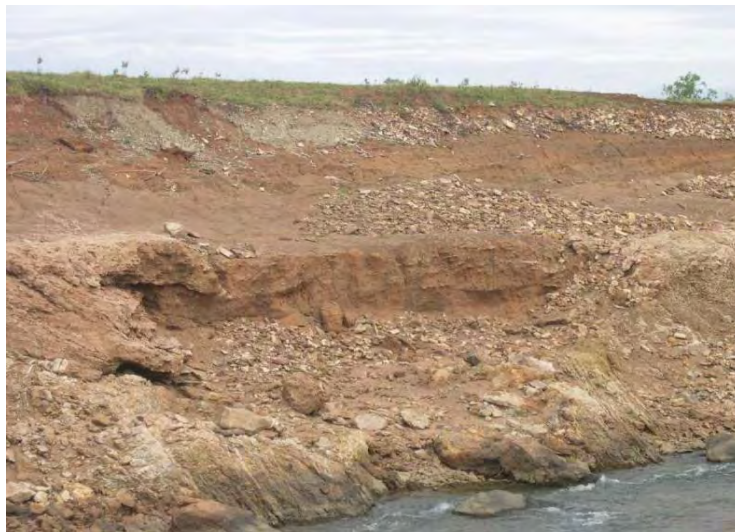
Plate 38 - An example of relatively minor bank erosion in the McArthur River diversion channel.

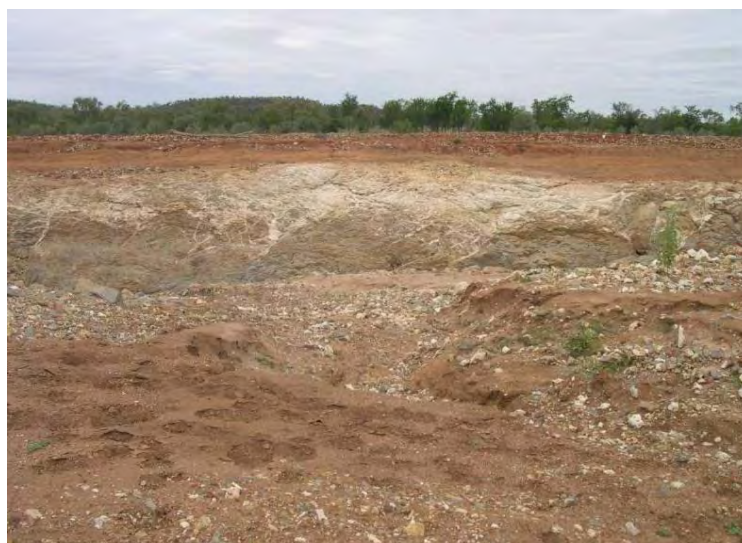
Plate 39 - Local (foreground) erosion at the top of the McArthur River diversion channel bank.

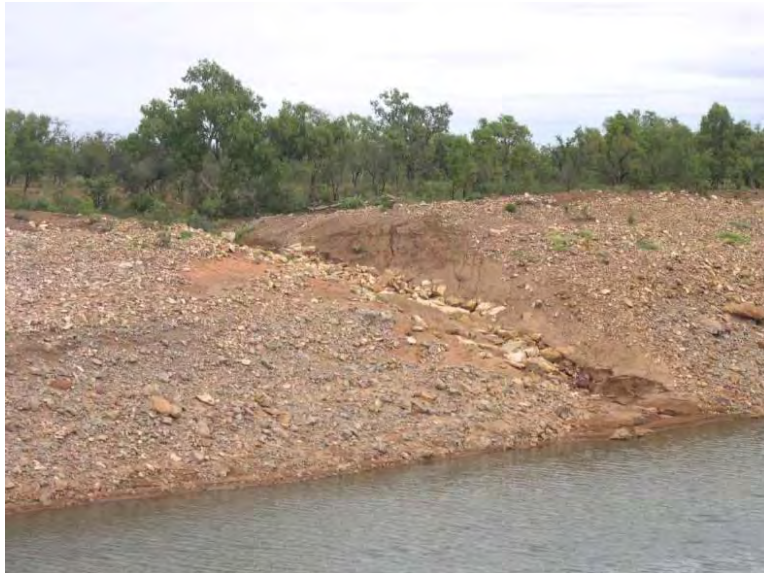
Plate 40 - Evidence of recent scour at one of the tributary chutes. Such locations should be inspected at the end of each wet season to assess the amount of change.

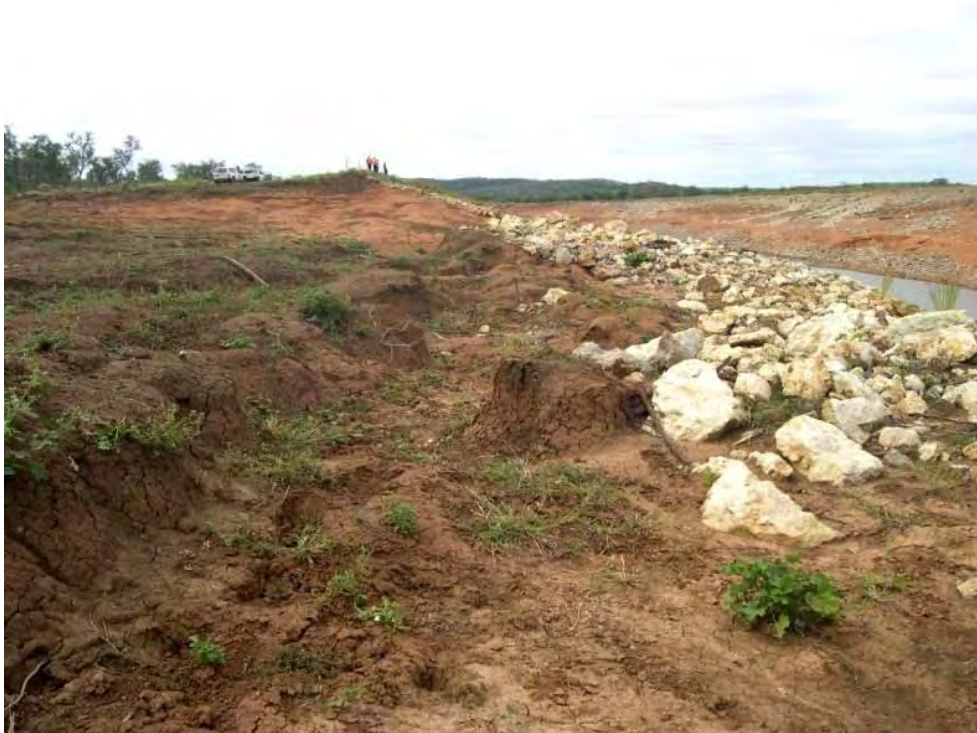
Plate 41 - View of ground conditions at the point where the flowpath from the remnant river channel empties into the diversion channel. There is clear evidence of substantial and broad erosion.

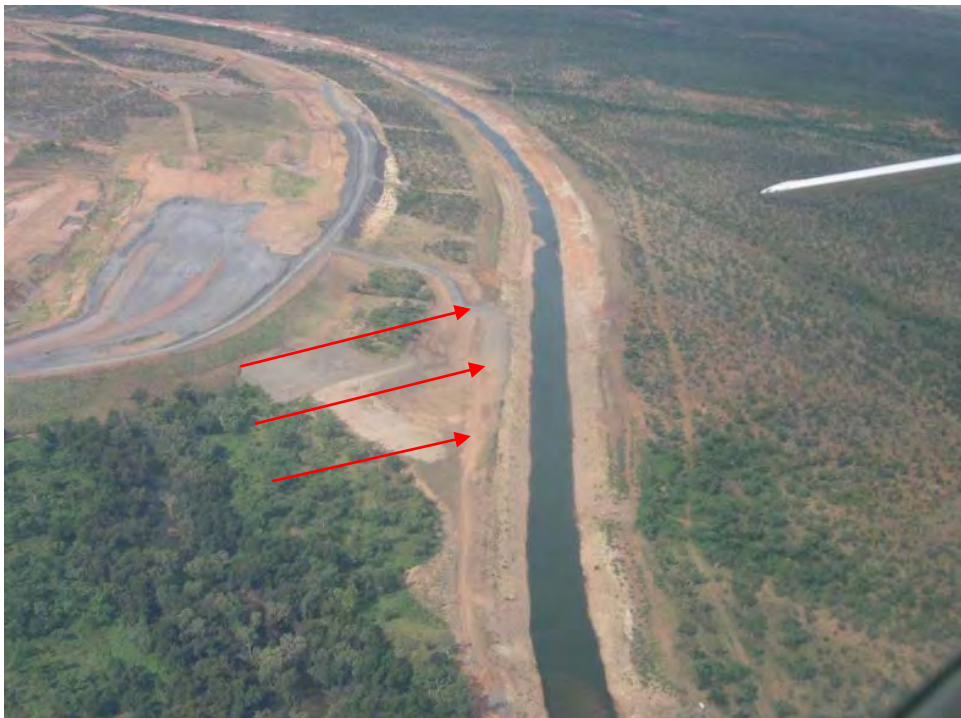
Plate 42 - The broad and denuded flowpath (marked by arrows) between the cut-off remnant river channel (left) and the diversion channel (middle of the photograph) (May 2010).

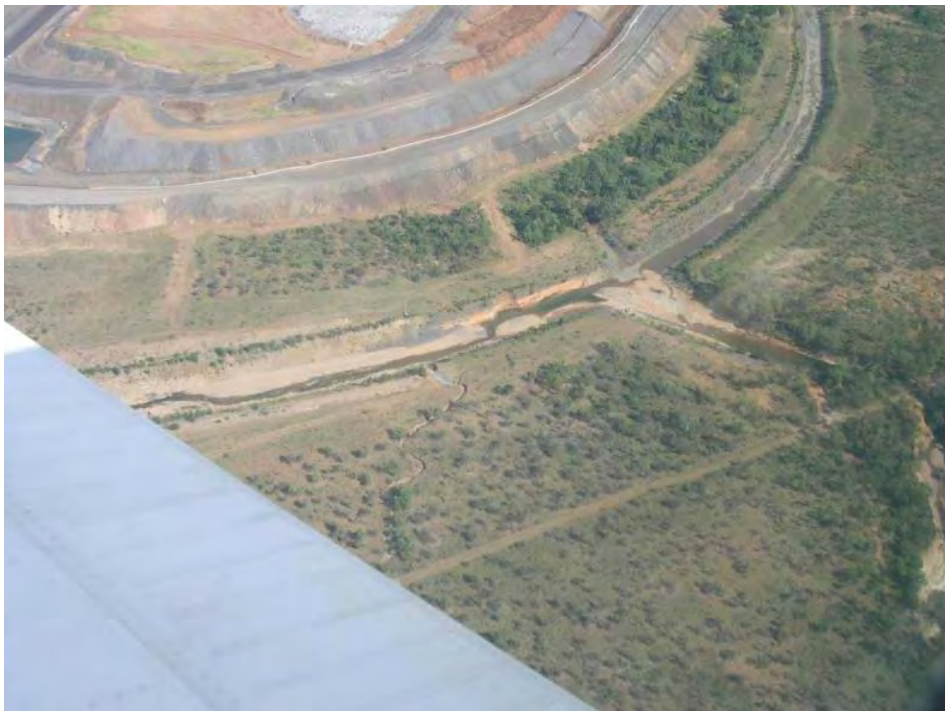
Plate 46 - The scale of erosion of the Barney Creek diversion channel's southern bank opposite the Surprise Creek entry point is clearly visible from the air (in May 2010)

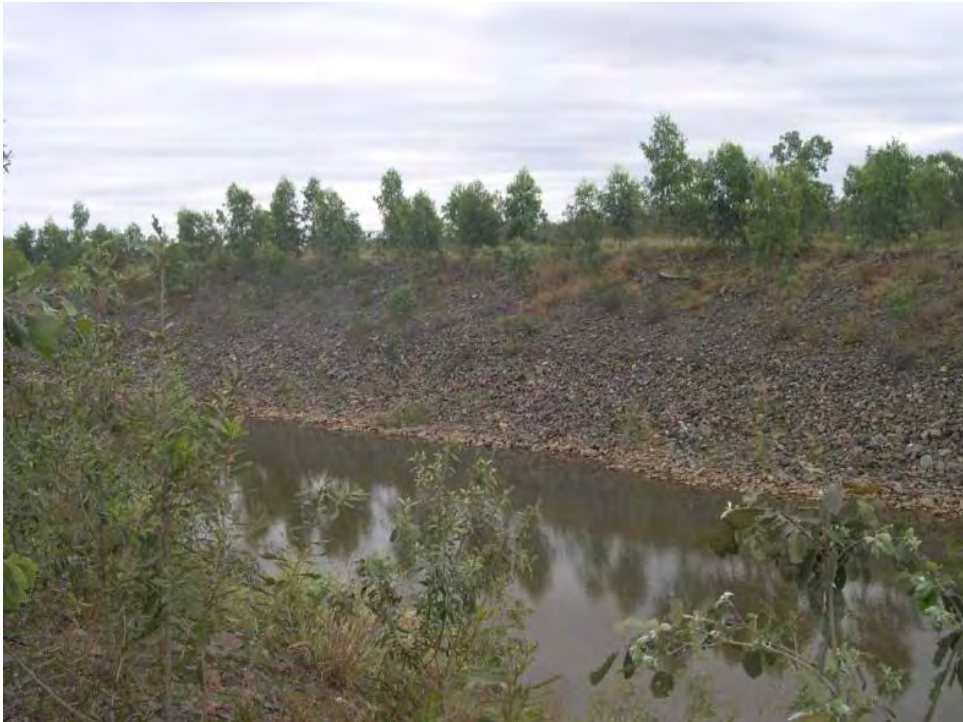
Plate 47 - As reported in the previous Independent Monitor audit report (2009) the paucity of vegetation established on the lower parts of the Barney Creek batter slope (here located just upstream of the Surprise Creek confluence) is clearly evident.
