TODD RIVER RESOURCES

MINING MANAGEMENT PLAN (MMP)

FOR
EXPLORATION OPERATIONS

MOUNT HARDY PROJECT

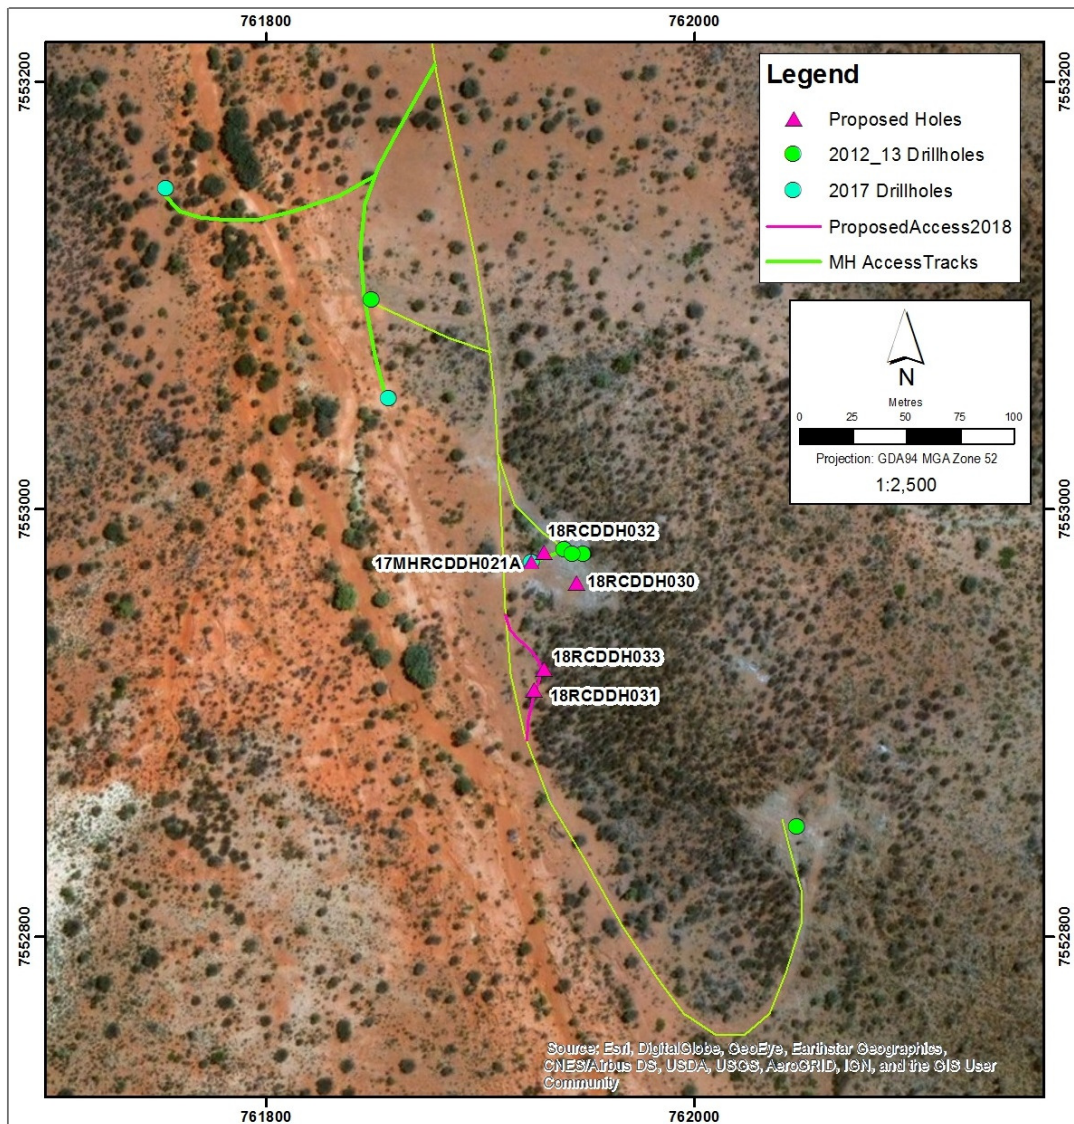
Figure 2: Location of five additional drillholes and new track at Target EM1.

Drilling is currently in progress at Mount Hardy. Five new holes (18RCDDH030-034), and the diamond extension of a sixth hole (18RCDDH021A) were approved for drilling by the DPIR in January 2018 (see table below) and to date four holes have been completed for 1,241m. Drilling of the fifth hole will likely begin on 8 June 2018. Details of these holes, including disturbance is shown in the tables below and Figures 2 and 3.

Hole_ID	Prospect	Easting	Northing	AHD	Azimuth	Dip	Depth
18RCDDH030	EM1	761940	7552963	638	110	-47	245.85
18RCDDH031A	EM1	761930	7552912	638	100	-47	260
18RCDDH032	EM1	761923	7553003	638	101	-62	315.21
18RCDDH033	EM2	764995	7554083	635	119	-65	420.10
18RCDDH021A	EM1	761924	7552975	638	90.9	-73	320
18RCDDH034	EM1	761930	7552925	632	115	-65	420

Target EM1			
Disturbance	Area	Number	Total (m ²)
Pads	20m x 15m	2	600
Sumps	3m x 2m	5	30
Tracks	65m x 2.5m	NA	162.5
		TOTAL	792.5 m²

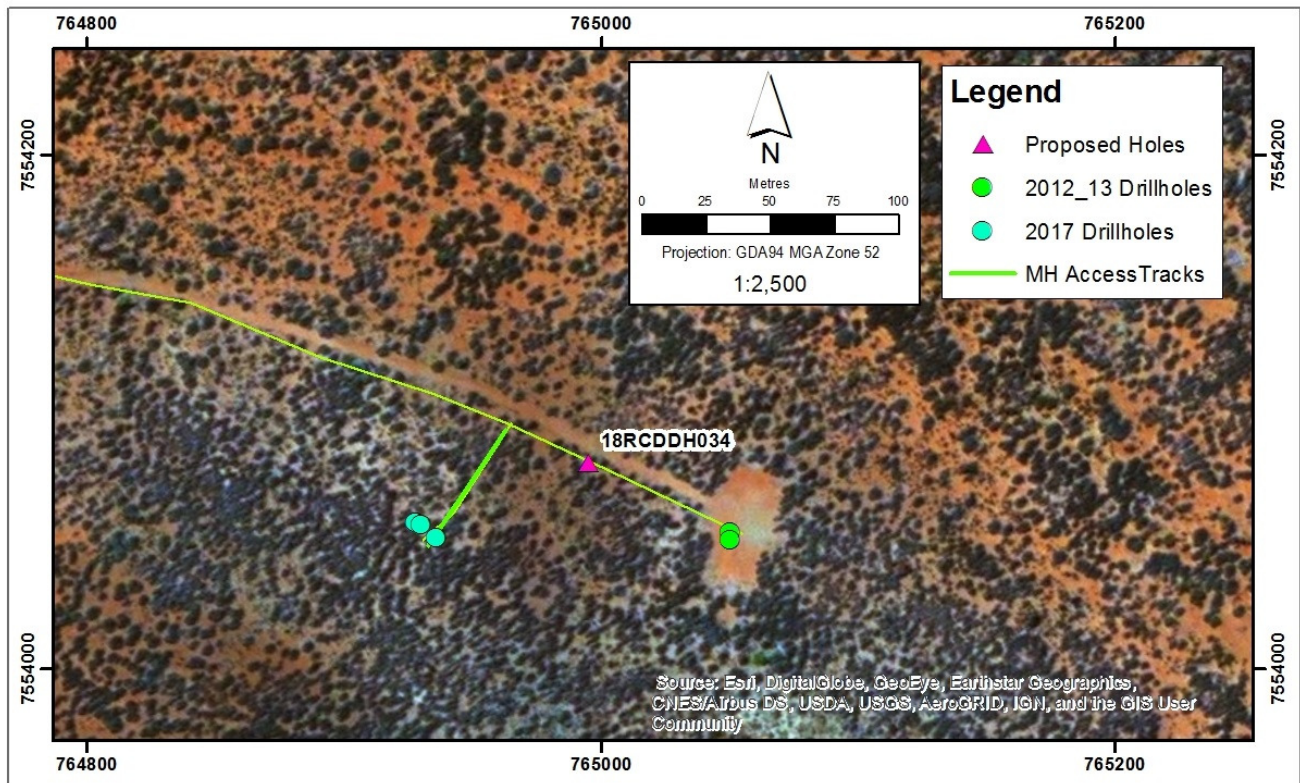
Figure 3: Location of additional drillhole at Target EM2.

Target EM2			
Disturbance	Area	Number	Total (m ²)
Pads	20m x 15m	1	300
Sumps	3m x 2m	1	6
TOTAL			306 m²

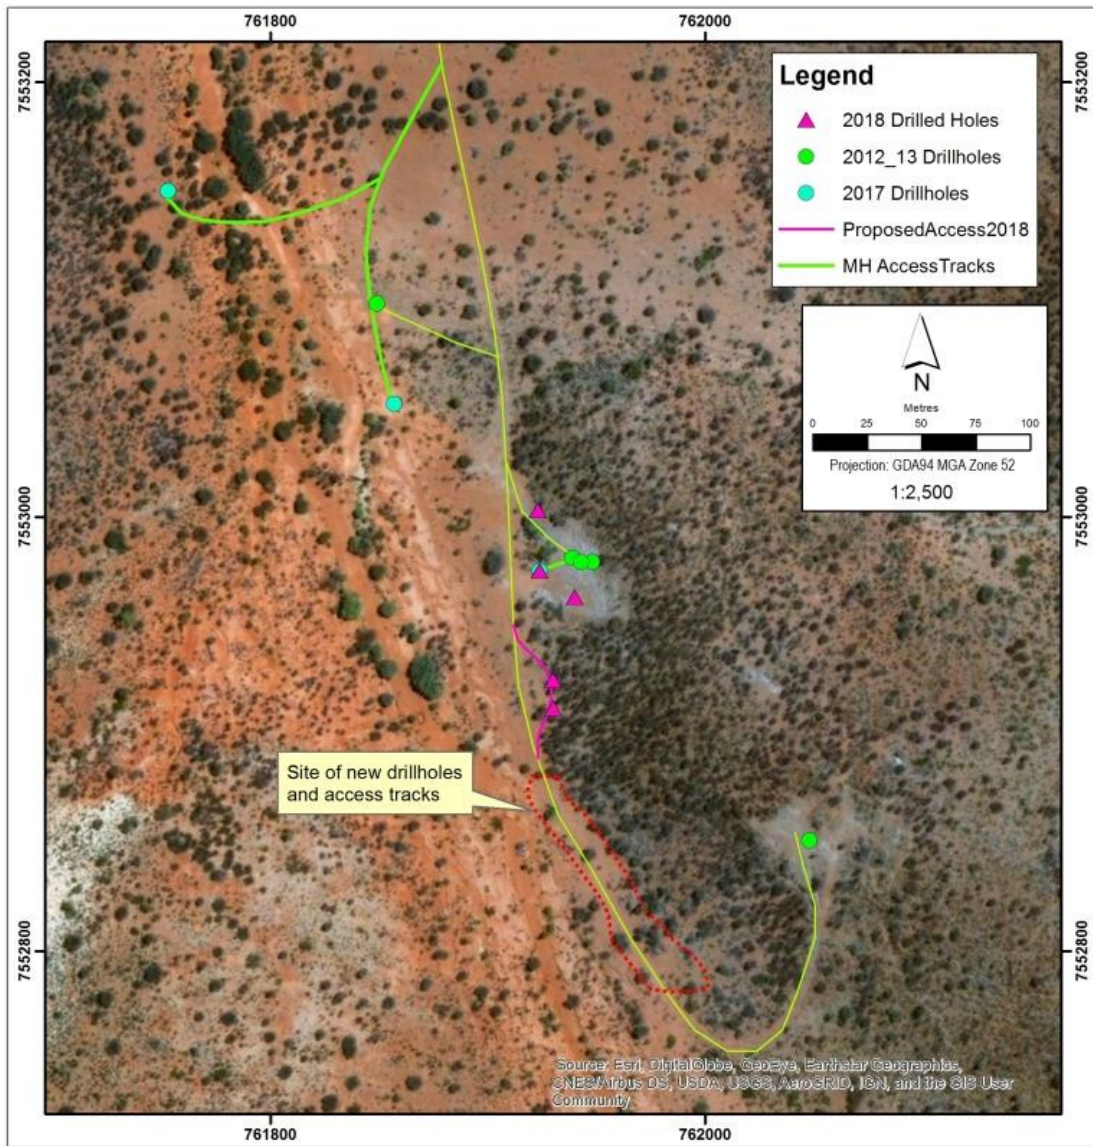
Figure 4: Site of proposed drillholes and access tracks.

Target EM1				
Disturbance	Area	Number	Total (m ²)	Total (Ha)
Pads	20m x 15m	6	1,800	0.18
Sumps	3m x 2m	6	36	0.004
Tracks	200m x 2.5m	NA	500	0.05
TOTAL			2,336m²	0.234 Ha

Mining Interests (i.e. titles)	EL27892	EL28694	EL29219
What time of the year will exploration occur?	Jun/July/Aug 2018	-	-
How long is exploration expected to occur?	8 weeks	-	-
Type of drilling (i.e. RAB, RC, Diamond, aircore)	Diamond	-	-
Is drilling likely to encounter radioactive material?	No	-	-
Number of proposed drill holes	6	-	-
Maximum depth of holes	300m	-	-
No. of drill pads (Length: 20m x Width: 15 m)	6	-	-
Is drilling likely to encounter groundwater? (Y, N, unsure)	Unsure	-	-
Number of sumps (metres)Length: 3 Width: 2 x Depth: 1	6	-	-
Length of line/track clearing (Km: x Width 3 m)	200m	-	-
Camp (Length: 30 x Width: 30 m)	2 (existing)	-	-
Will topsoil be removed for rehabilitation purposes?	Yes	-	-
Disturbance this program on title (ha) if known	0.234	-	-
Previous disturbance yet to be rehabilitated on title (ha) if known	2.41	-	-
Total area disturbed (hectares)	2.64	-	-

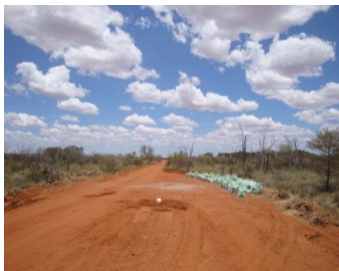
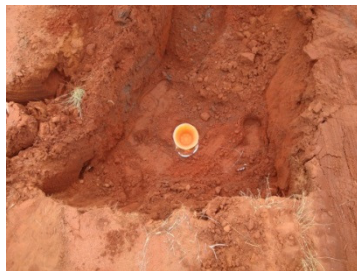
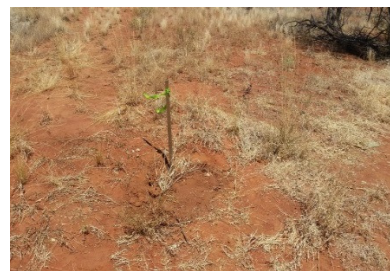
Clarification of drill collar capping and plugging.

Capped at completion of hole. Dug out/cut/plugged during rehab. After rehabilitation.

Disturbance	Rehabilitation Activities	Schedule (Timing)	Closure Objectives / Targets	Monitoring Techniques
Drill holes	Collars cut and plugged with plastic cone >40cm below ground level & mounded with topsoil (also see below).	Drill collars are temporarily capped with a plastic cone at the completion of the hole. The cone is then used to plug the drill collar during rehab. Holes to be rehabbed within 6 months.	All holes safe prior to end of programme and site returned to pre-disturbance condition based on surrounding conditions.	Monitoring stations set up at specified sites and photographs and inspections undertaken annually. Currently three drillsites are monitoring stations. Inspection will specifically target drill hole erosion and subsidence. Remediation will be undertaken if drillhole subsidence or erosion is noted during site monitoring and inspections.
Drill pads	Rubbish collected and removed. Recontoured and respread windrows. Pre-disturbance topography restored. Previously cleared vegetation is spread across the site.	On completion of drill hole. In conjunction with drill hole rehabilitation – within 6 months of programme completion.	Site to return to pre-disturbance condition based on surrounding conditions.	Monitoring stations set up at a number of sites, photographs and inspections undertaken annually. Currently three drillsites are monitoring stations. This will include inspection for weeds, erosion and native vegetation growth. Remediation will be undertaken if erosion is taking place across the drill pad area or if surface water flow has results in gullies forming.
