Exploration Operations Mining Management Plan and Public Report

- Verdant Minerals Ltd
- Ammaroo Phosphate Project
- Authorisation Number: 0609-4
- 2018
- 11/7/2018

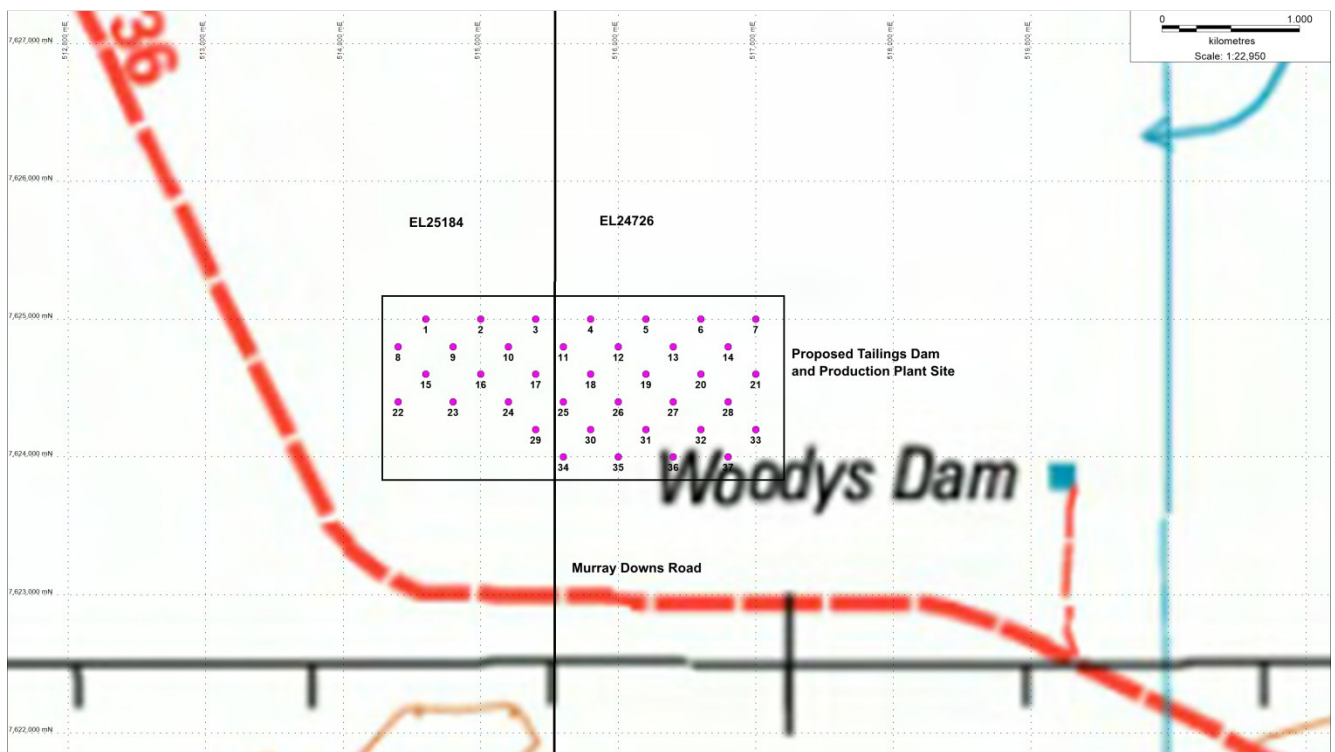
Geotech pits shown in pink. Numbers 14, 15, 17 and 31 were geotech diamond drill holes drilled to 25m. The rest were dug to 4m depth with an excavator.

34 Geotechnical pits were dug to enable sampling of materials for geotechnical testing in the area proposed for a tailings dam, processing plant and ROM pad. Four diamond drill holes were drilled to 25m to test deeper geotechnical conditions.

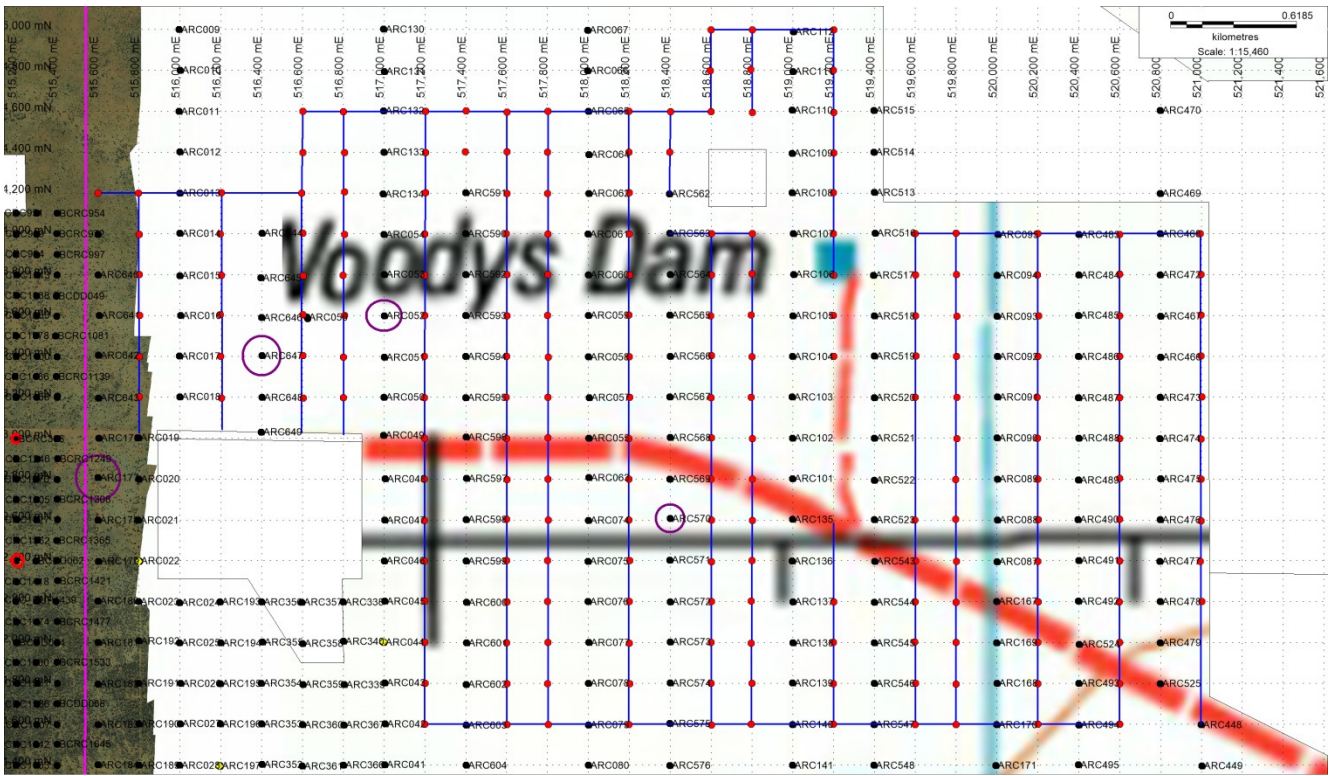
2016 RC drill holes in red and cleared drill access tracks in blue. The two western most circles were the sites of the 2016 bulk sample pits. The other two circled sites were not dug.

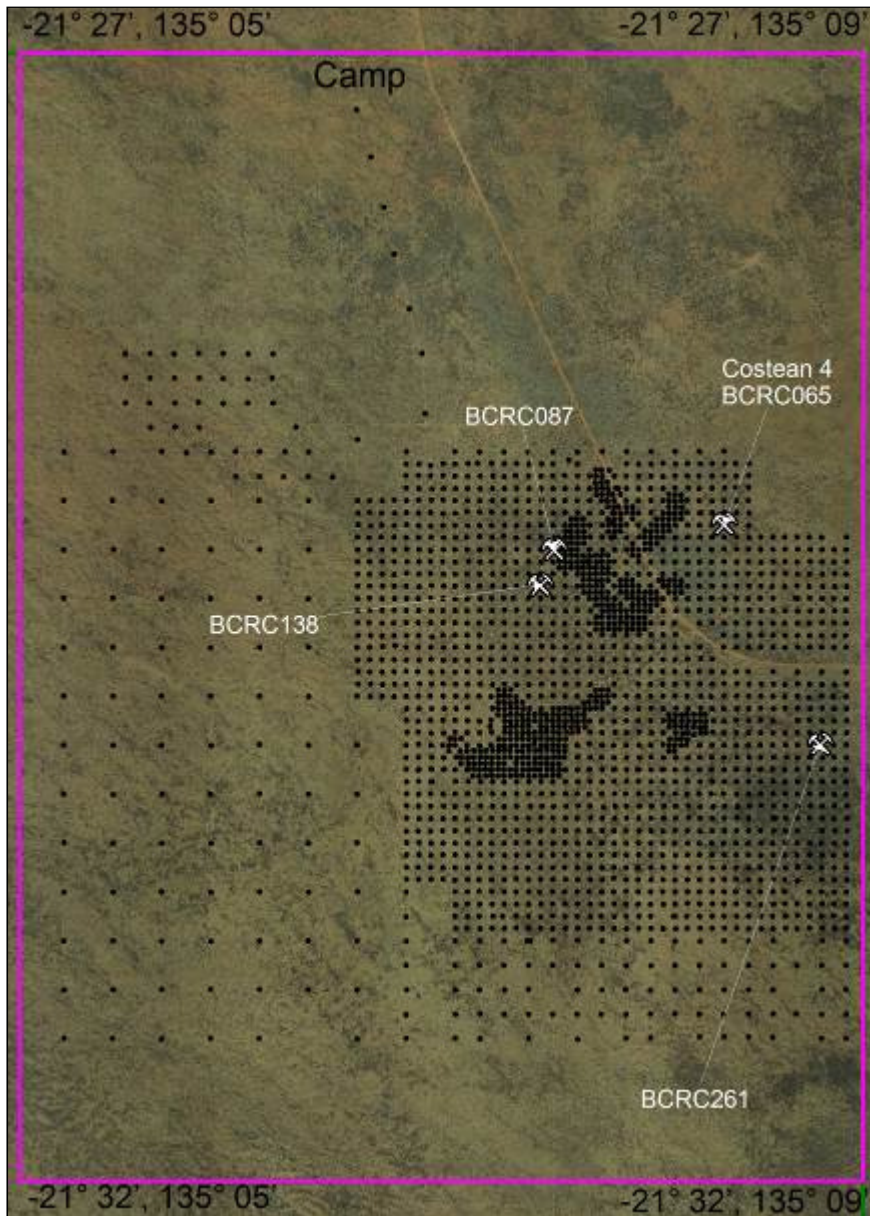
- Drilling completed at Barrow Creek 1 2012, showing costean locations and Mining Lease Application 29463. BCRC087 is Costean 1, BCRC261 is Costean 2, BCRC138 is Costean 3.

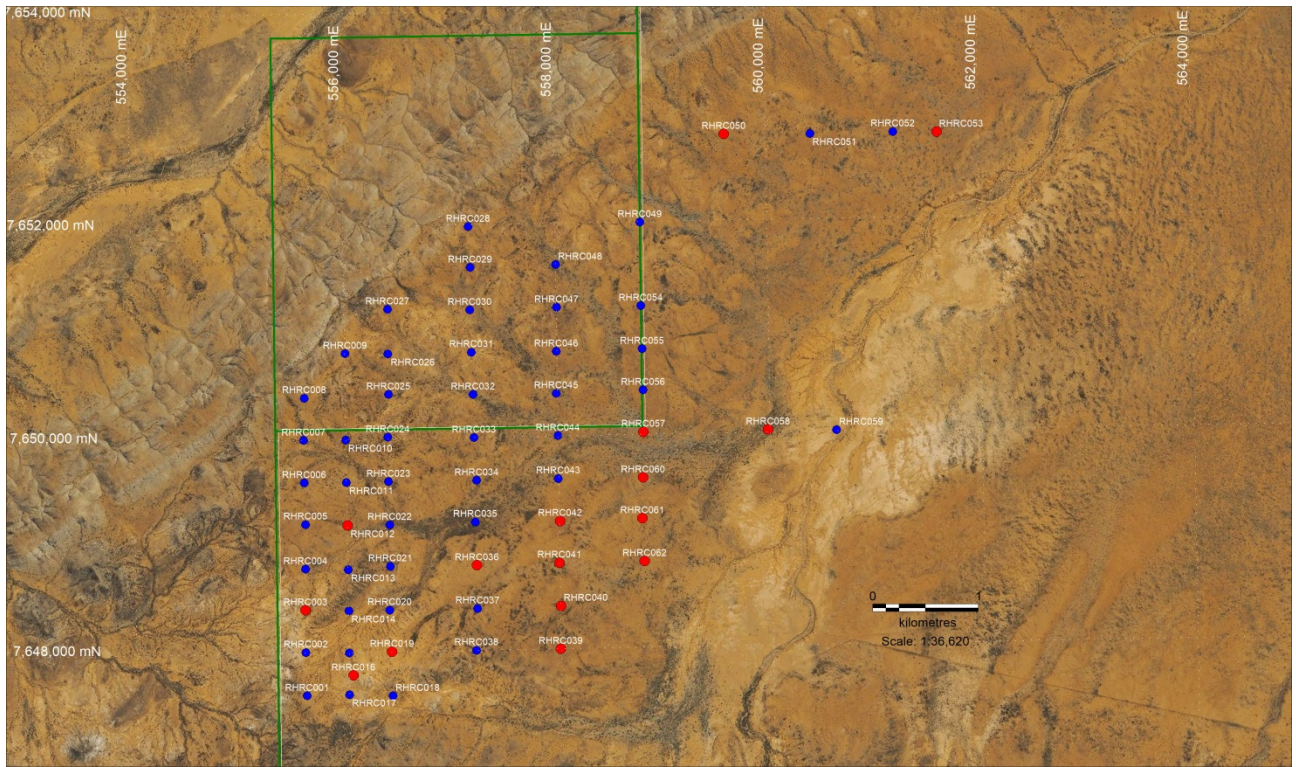
Rockhole RC Drilling 2017. Better phosphate holes are in red showing exploration potential further east.

During 2017 at the Rockhole prospect on Elkedra Station in May and June, a small RC rig mounted on a light 4x4 truck was used to drill 62 holes to a maximum of 44 m for 1,457 m in total. The drill spacing was nominally 400 m x 400 m and 800 m x 400 m with some more broadly-spaced peripheral holes to the east. Two backhoe test pits were dug on EL25184 for geotechnical sampling and then subsequently backfilled.

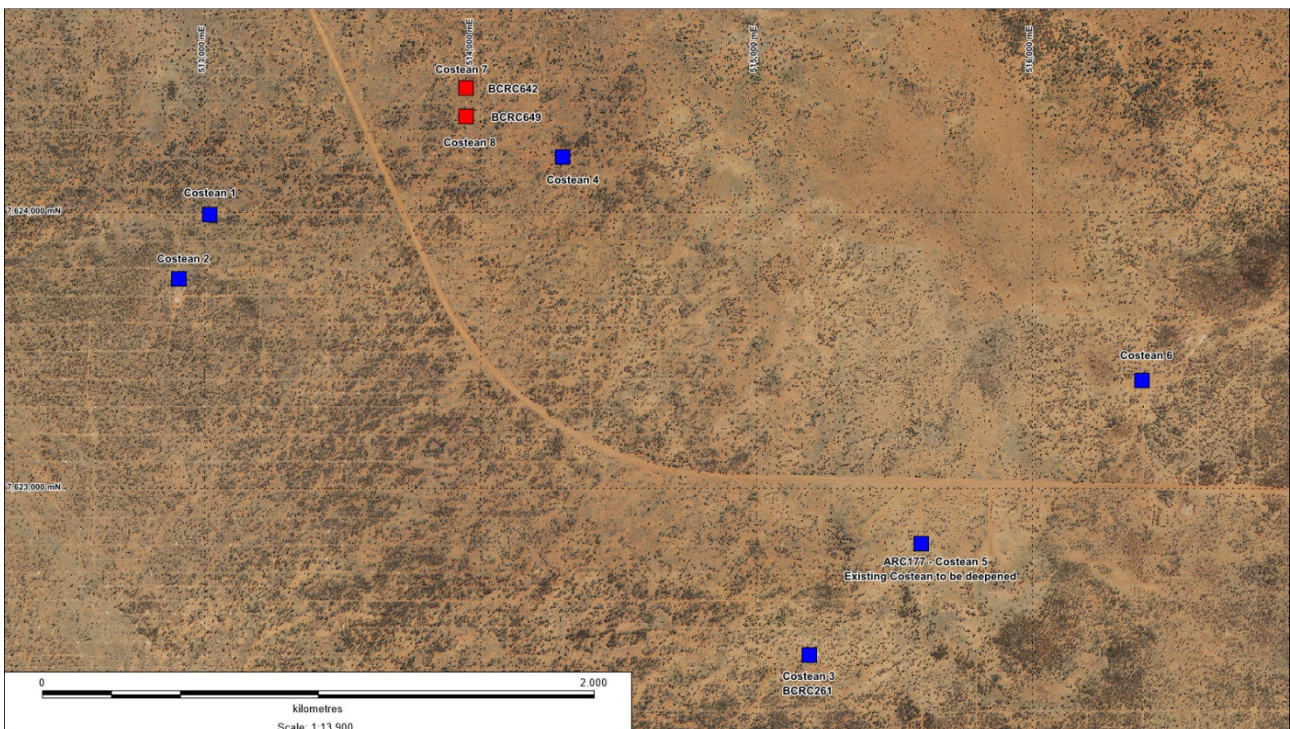
Figure: New costeans in red, existing costeans in blue

Costean Number	Drill Hole Number	Easting	Northing	Area Disturbed	Sample Depth	Tonnage Sampled
Costean 5	ARC177	515600	7622800	80m2 - existing	3-5m	5 -10 tonnes
Costean 7	BCRC642	514000	7624450	48m2 - new	7-9m	5 -10 tonnes
Costean 8	BCRC649	514000	7624350	18m2 - new	2-4m	5 -10 tonnes

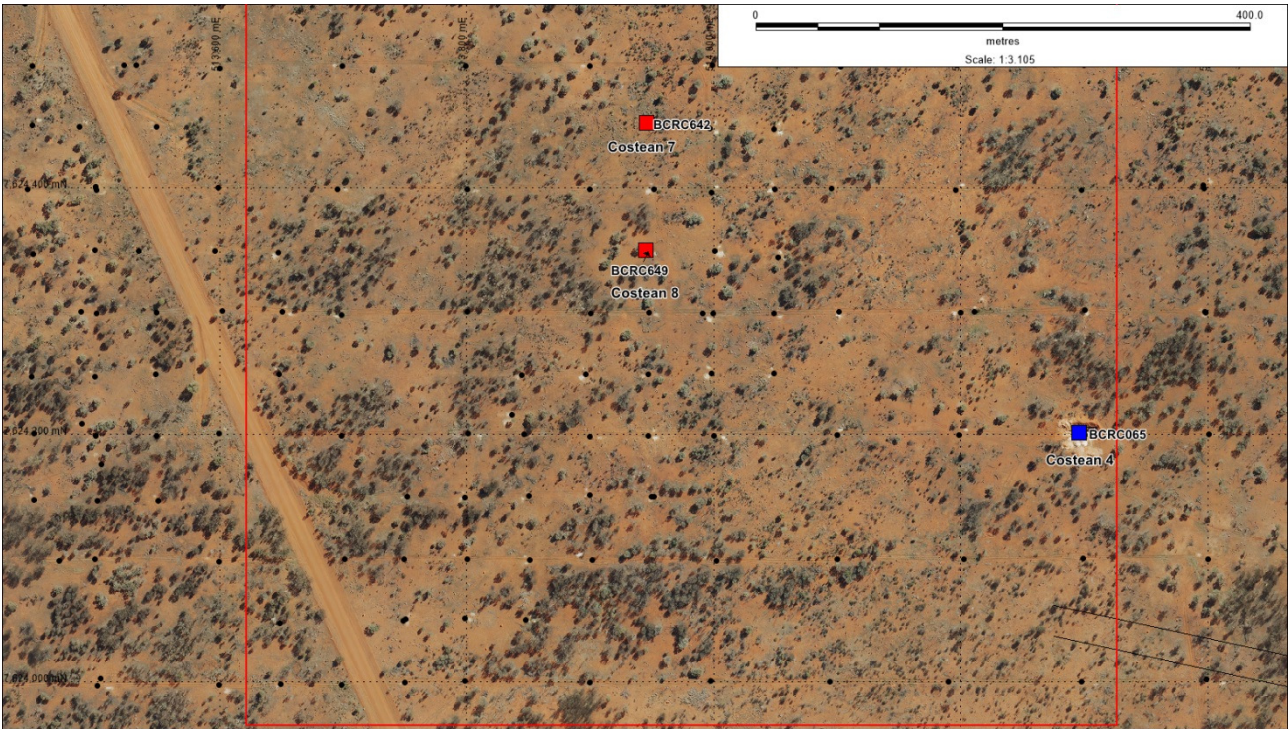
Figure: Proposed new costeans 7 and 8 east of the Murray Downs Road

Dig new Costean (Costean 7 – BCRC642) to 9m depth to retrieve a maximum of 10 tonnes of phosphate rock for processing optimisation test work.

Dig new Costean (Costean 8 –BCRC649) to 4m depth to retrieve a maximum of 10 tonnes of phosphate rock for processing optimisation test work.

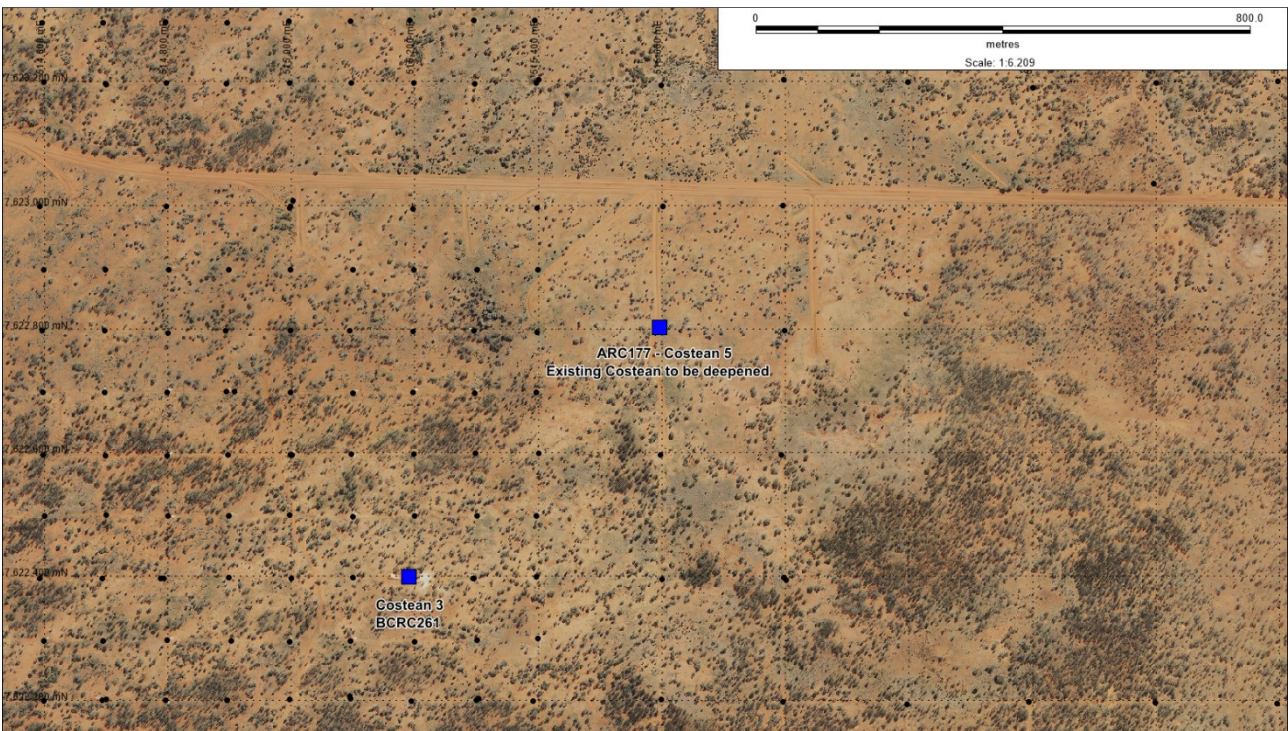
Figure: Costean 5 to be deepened by 1m

Deepen existing Costean 5 (ARC177) by 1m to retrieve a maximum of 10 tonnes of phosphate rock for processing optimisation test work.

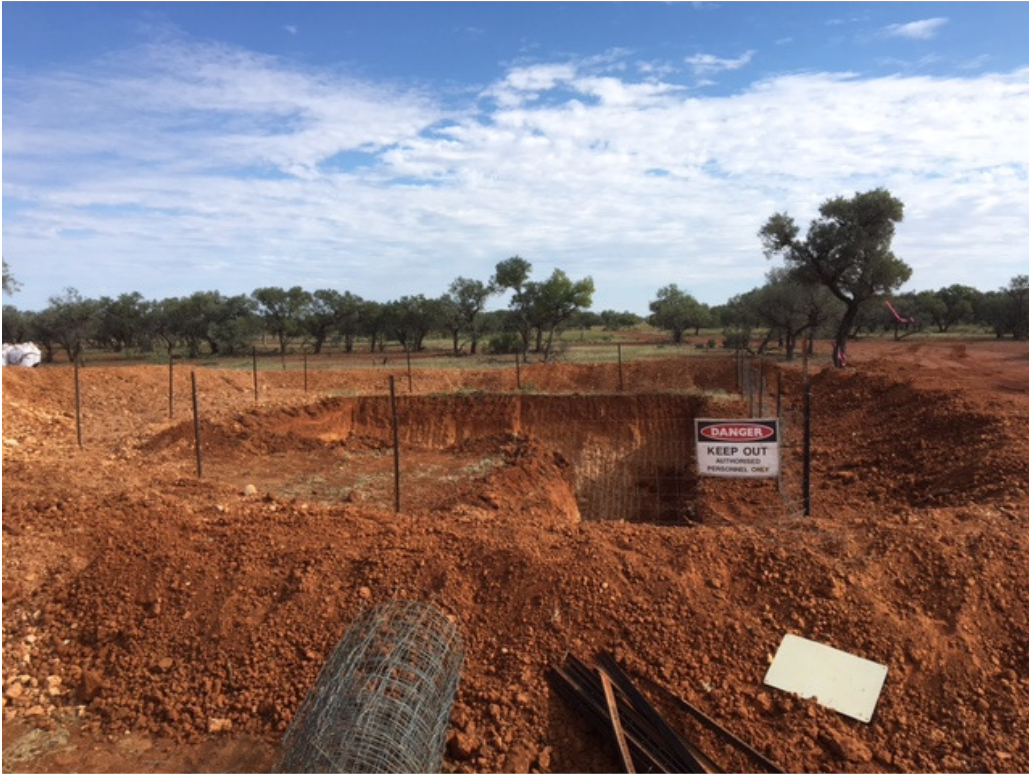
Existing Costean 5 (ARC177) which is to be deepened, sample taken and then backfilled and rehabilitated

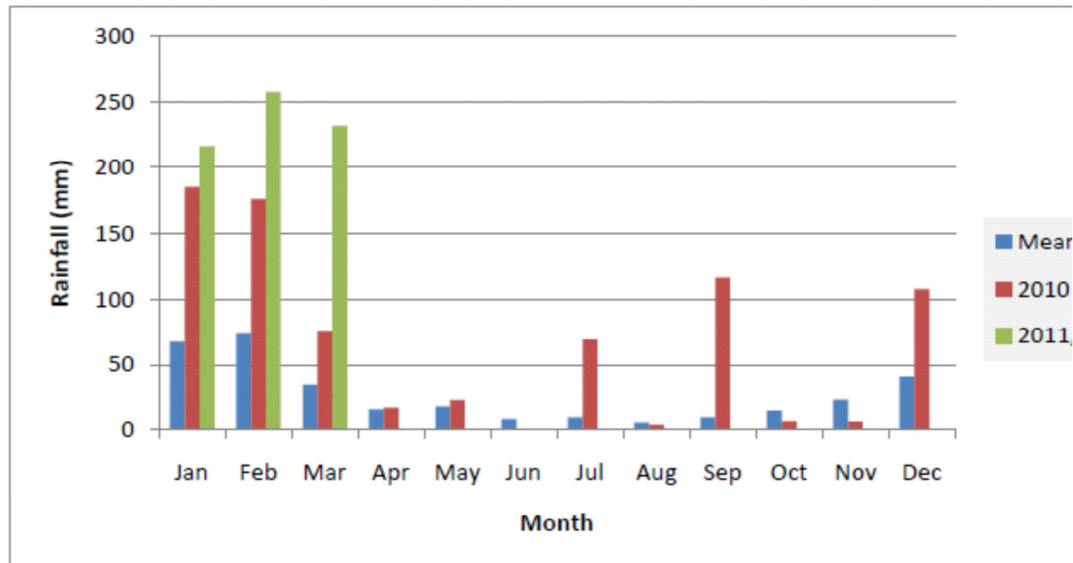
Average rainfall for the project area.

1> Rainfall figures over a 30 year period (1981 – 2010) indicate an annual average rainfall of 383 mm (BOM 2012). However, rainfall is highly variable and unpredictable and annual records range from 86.4 mm to 914 mm. As shown below, much of 2010 and the start of 2011 were atypically wet while the rainfall for 2012 was more typical (Figure 3).

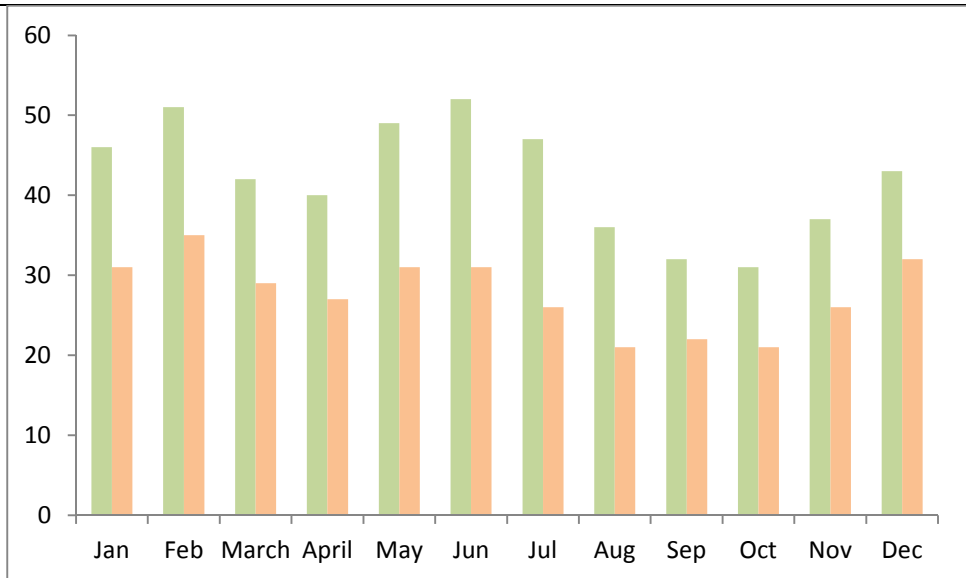
- **Mean monthly relative humidity (%) at 9am (Green) and 3pm (Orange) at Ali Curung, NT (BOM 2013).**

2> The average monthly relative humidity at 9 am (derived from data from 1988 - 2010) fluctuates between 31 to 52 percent with an average of 42 percent. The average monthly relative humidity at 3 pm is about 11-21 percent lower than the 9 am recorded humidity.

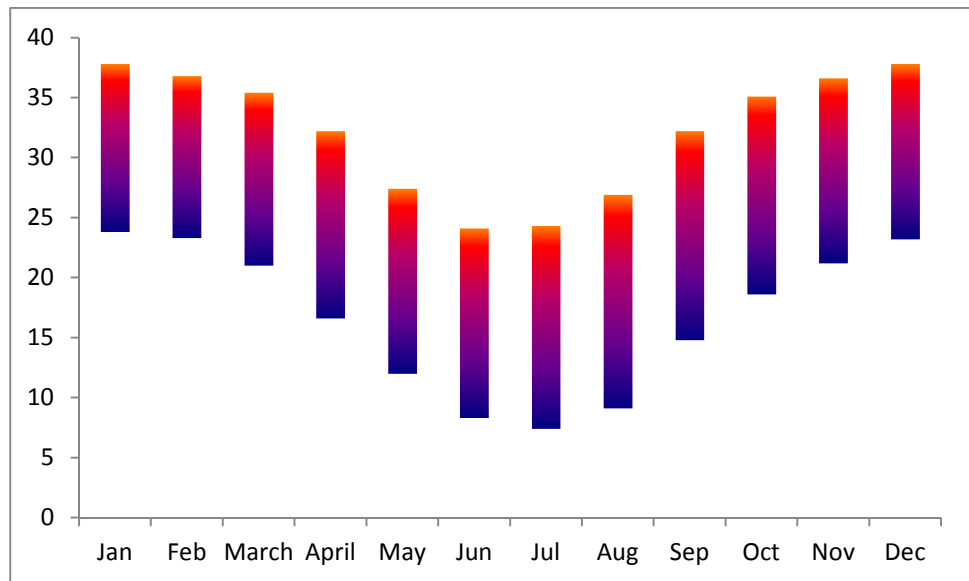
- **Mean maximum (red) and minimum (blue) monthly temperatures (°C) at Ali Curung, NT (BOM 2013).**

4> The mean monthly maximum and minimum temperature over a 30 year period (1981 – 2010) indicate that the summer temperatures can fluctuate between 21 and 38 degrees Celsius and the winter temperatures can flux between 7 and 27 degrees Celsius. Sub-zero temperatures occur occasionally during July and August and there have been instances of surface water freezing at night. [Figure 5](#) shows the mean monthly maximum and minimum temperatures recorded at Ali Curung in 2013.

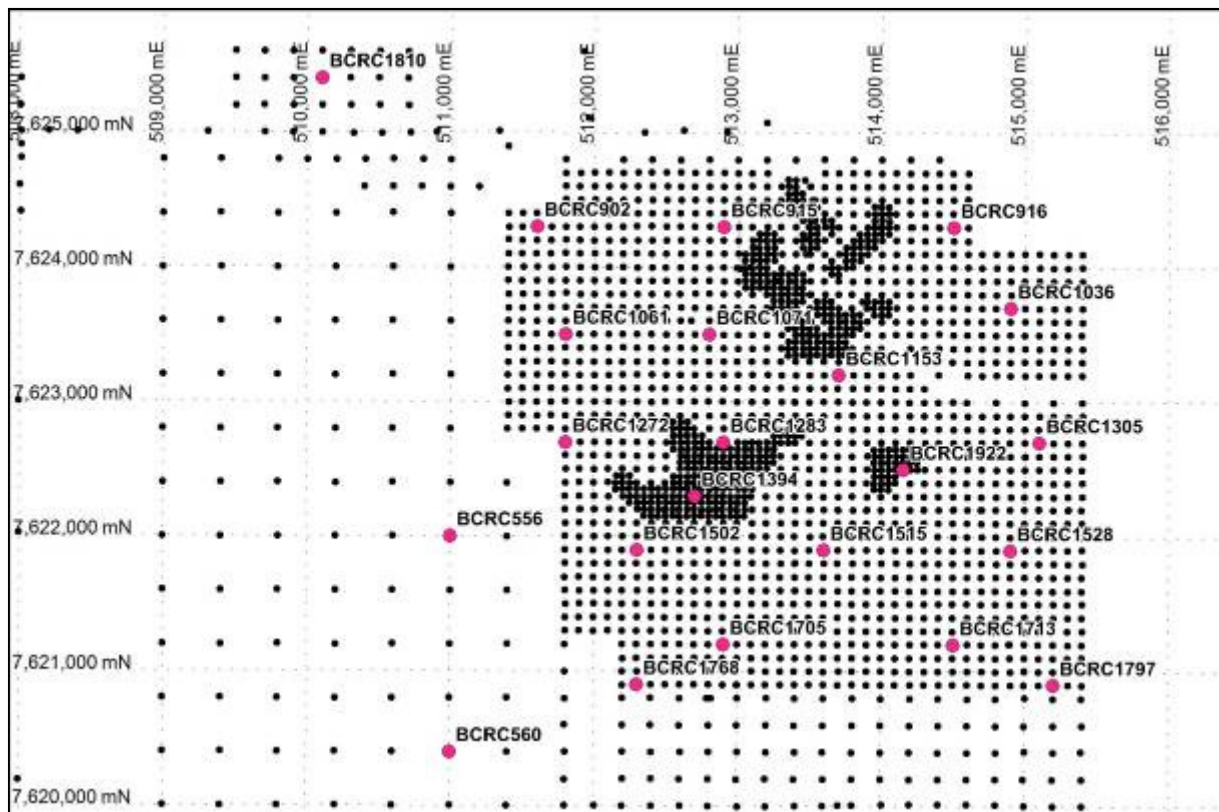
• Location of soil and overburden sampling

Baseline studies and data gathering are being conducted as a precursor to whatever more intensive environment impact studies may be needed in the future. VRM Jungle has undertaken sampling of soil and overburden to test for geochemical elements that will remain in stockpiles that may have the potential to cause damage to the surrounding environment by acid forming and non-acid forming materials. These preliminary results will aid VRM Jungle in planning for management of waste rock dumps and tailings storage facilities in the future.

The figure below shows the locations of sampling and assays and assays were forwarded to VRM Jungle's environmental consultants EcoZ Pty Ltd, for examination and reporting. These results have been received by EcoZ and are being used for future mine planning and discussed in the NOI.

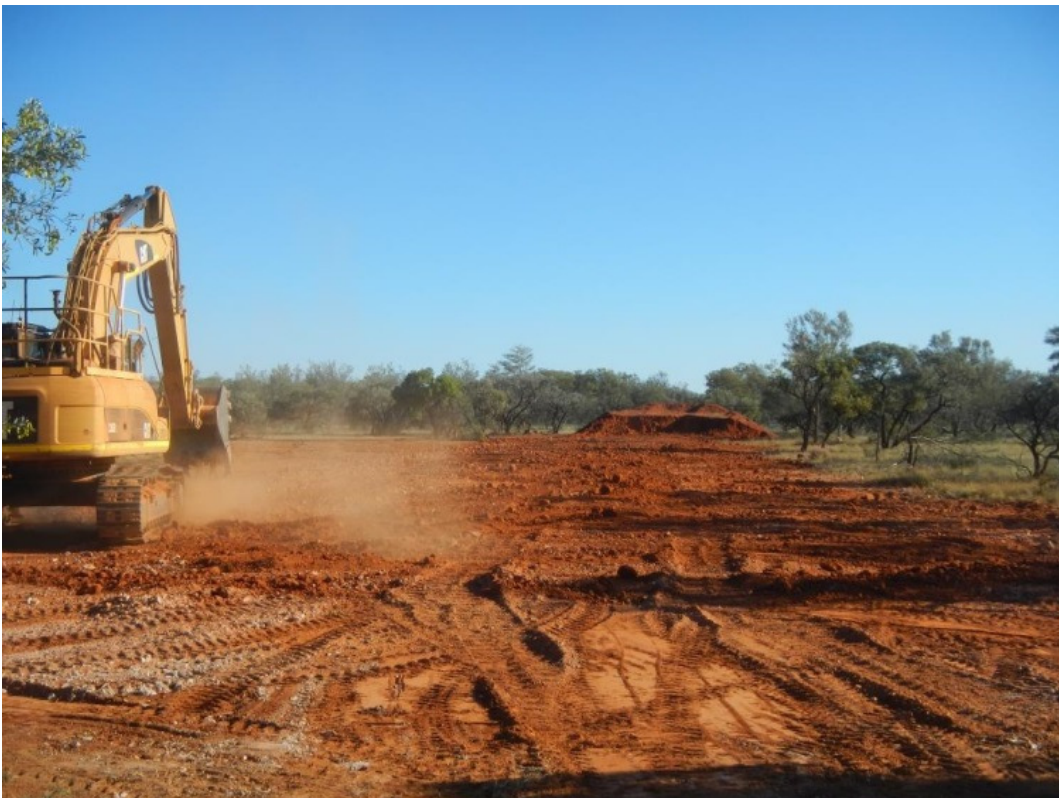
Re-spreading topsoil on BCRC138 Pit 3 on 28/10/2016

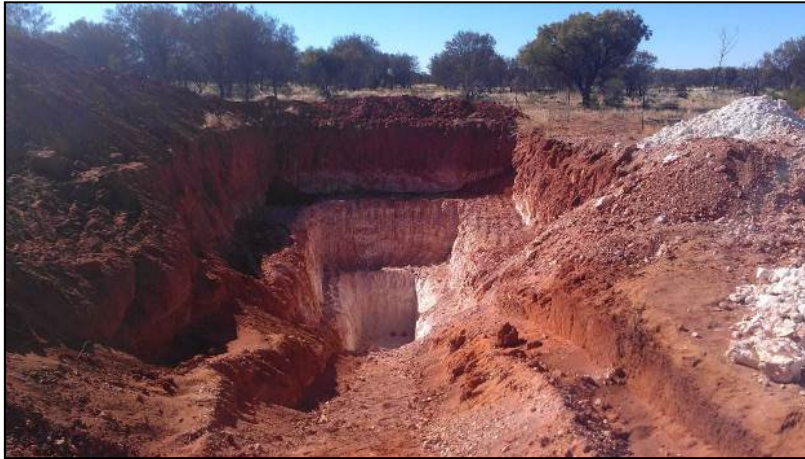
Pit 4 bulk sampled to 7m depth in 2012

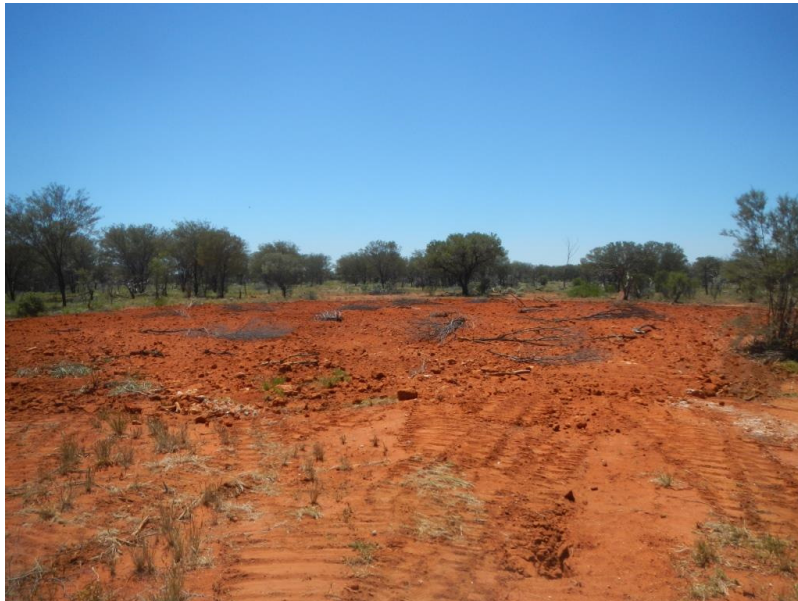
Pit 4 backfilled with topsoil re-spread on 28/10/2016
