# Mining Management Exploration Activities

## Northern Territory of Australia – *Mining Management Act 2001*

<b>Project Name</b> Provide new or existing project name	Tanami Exploration Project
<b>Authorisation Number</b> Insert existing authorisation number, where applicable	0458-04
<b>Operator Name</b> Use ASIC-ABR registered name (if a company), or name of the applicant	Newmont Tanami Pty Ltd
<b>Operator ABN and ACN numbers</b>	ACN 007 688 093 ABN 39 007 688 093
<b>Location and Access Details</b> Include brief description of the location, access details, and distance to nearest town or community	<p>The Newmont Tanami Operations (NTO) are located in the Tanami Desert approximately 550km northwest of Alice Springs along the Tanami Highway. Exploration activities undertaken under the Tanami Exploration Project (TEP) are supported from the Granites (MLS8) and Dead Bullock Soak (DBS, MLS154) mining operations.</p> <p>The Aboriginal Communities of Yuendumu and Lajamanu are the closest 'major' population centres to NTO, located 270km south-east and 350km north of the Granites respectively. The Yarturlu Yarturlu Outstation, which is intermittently occupied, is located approximately 700

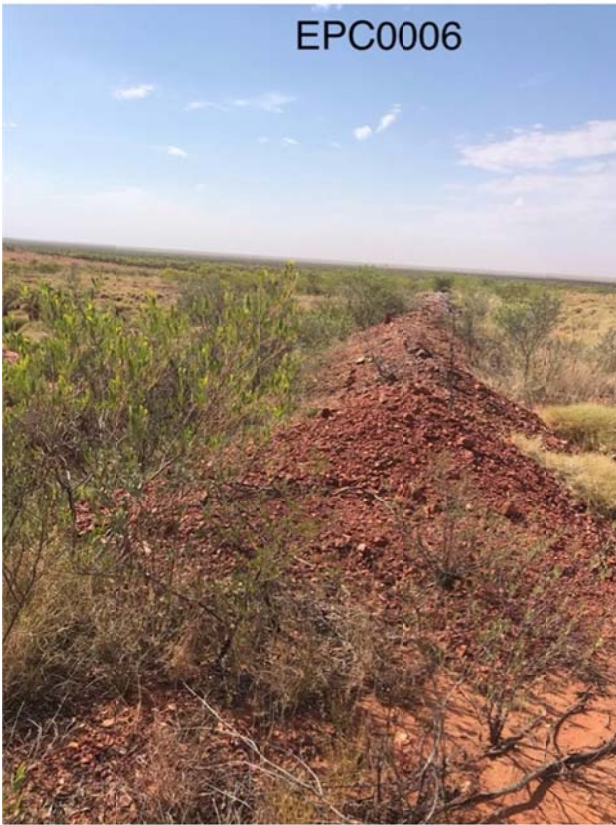
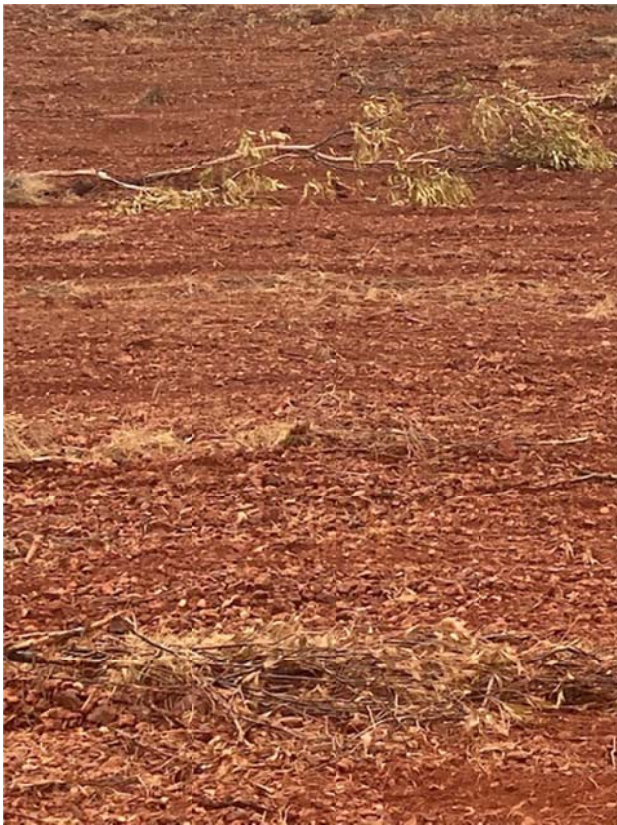
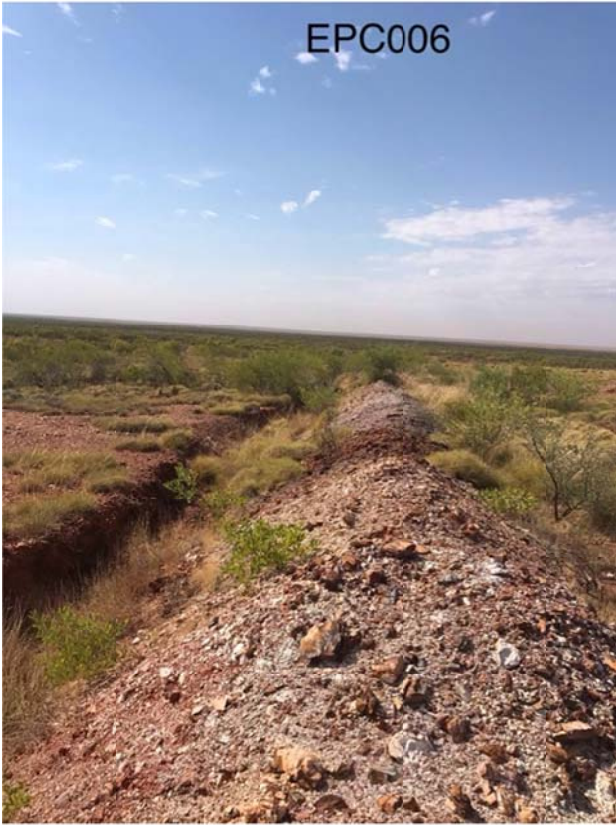
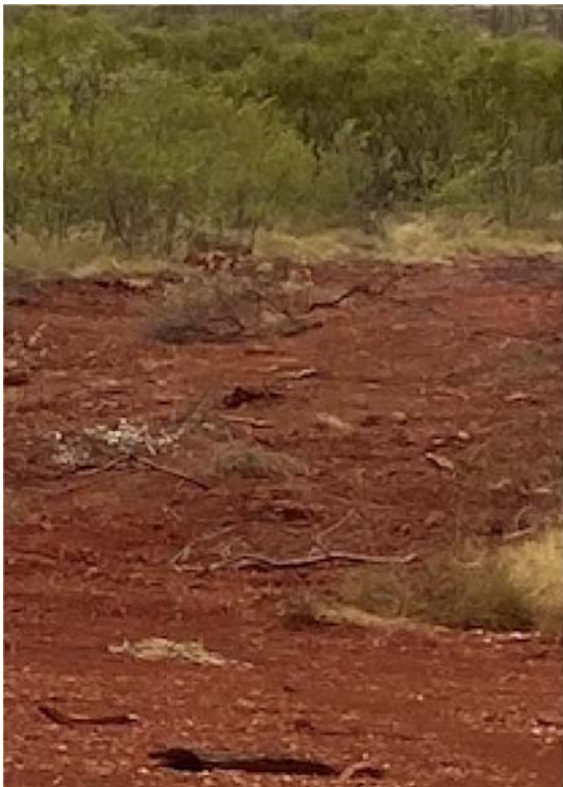
Photographic Record Of Task	
Before	After
<p>EPC0006</p>

<b>Lease</b>	<b>EL23658</b>	<b>Project Area</b>	<b>SITE 1 (30KM NW GRANITES, 10KM N TANAMI RD)</b>		<b>Costean ID</b>	<b>EPC0006</b>
<b>Title: EPC0006 Closure Report</b>						
<b>Pre-Rehab Condition</b>		As per Before photographs. Overgrown, some minor erosion.				
<b>Method Of Work and Equipment Used</b>		Each site was inspected by Dylan Poulson (Yapa Crew member) and myself for cultural significance prior to work commencing.				
		Excavator and skid steer where used. The Costean was backfilled using excavator from the spoil line and the site was levelled, scarified and spread with vegetation where ever possible using the skid steers				
		Where possible all signs of interference where removed such as wheel tracks.				
<b>Hazards / Risks</b>		Trench cave in. Regrowth of vegetation both in the trench and within the spoil. The Yapa Crew assessed that there were no trees of significance within or near this costean.

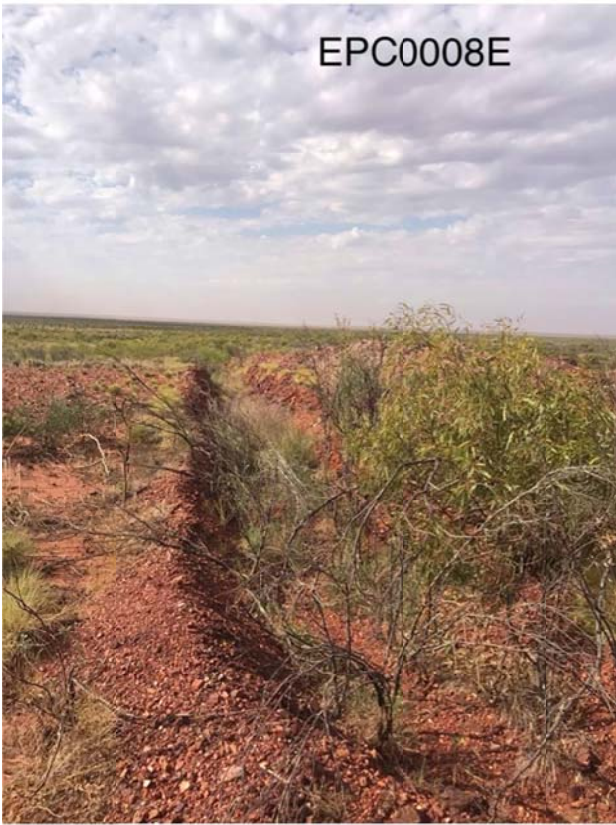
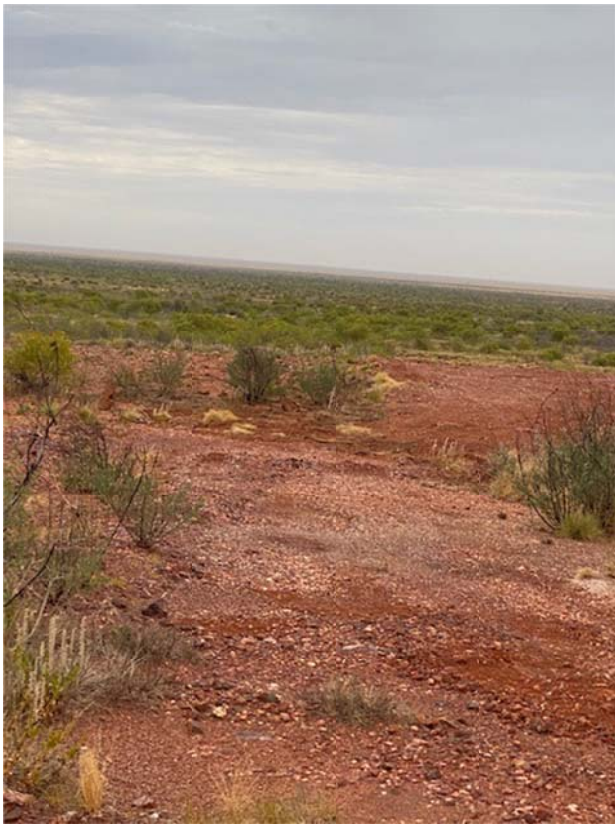
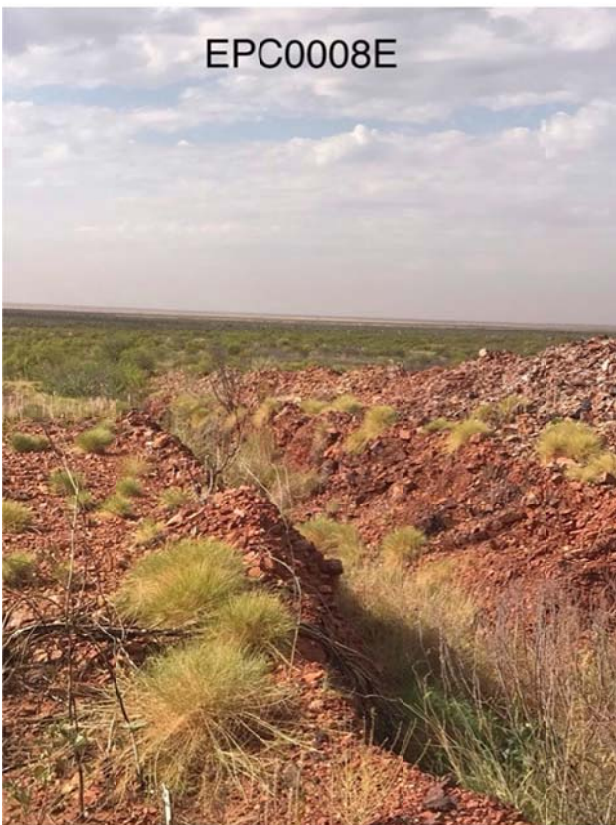
Photographic Record Of Task	
Before	Ater
<p>EPC0008E</p>

<b>Lease</b>	EL23658	<b>Project Area</b>	<b>SITE 1 (30KM NW GRANITES, 10KM N TANAMI RD)</b>		<b>Costean ID</b>	<b>EPC0008E</b>
<b>Title: EPC0008E Closure Report</b>						
<b>Pre-Rehab Condition</b>	As per Before photographs. Overgrown, some minor erosion.					
<b>Method Of Work and Equipment Used</b>	Each site was inspected by Dylan Poulson (Yapa Crew member) and myself for cultural significance prior to work commencing.					
	Excavator and skid steer where used. The Costean was backfilled using excavator from the spoil line and the site was levelled, scarified and spread with vegetation where ever possible using the skid steers					
	Where possible all signs of interference where removed such as wheel tracks.					
<b>Hazards / Risks</b>	Trench cave in. Regrowth of vegetation both in the trench and within the spoil. The Yapa Crew assessed that there were no trees of significance within or near this costean.

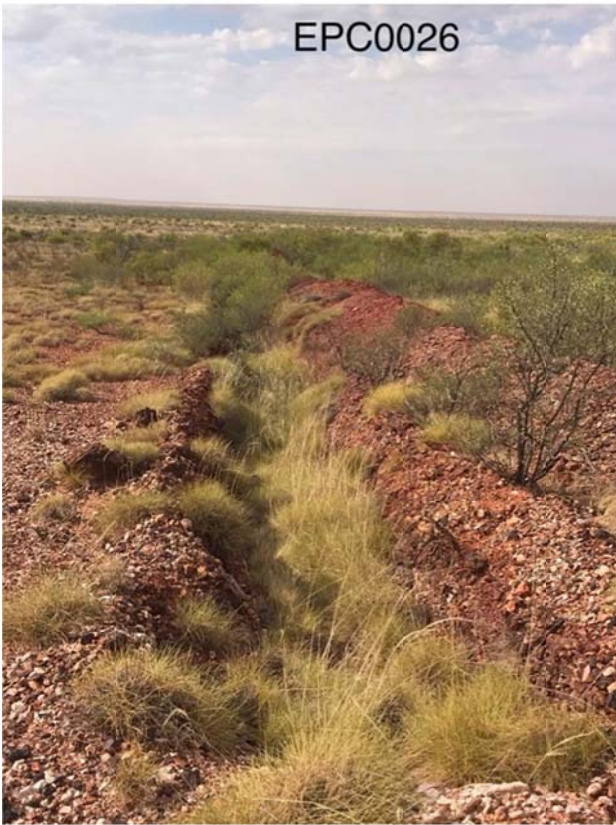
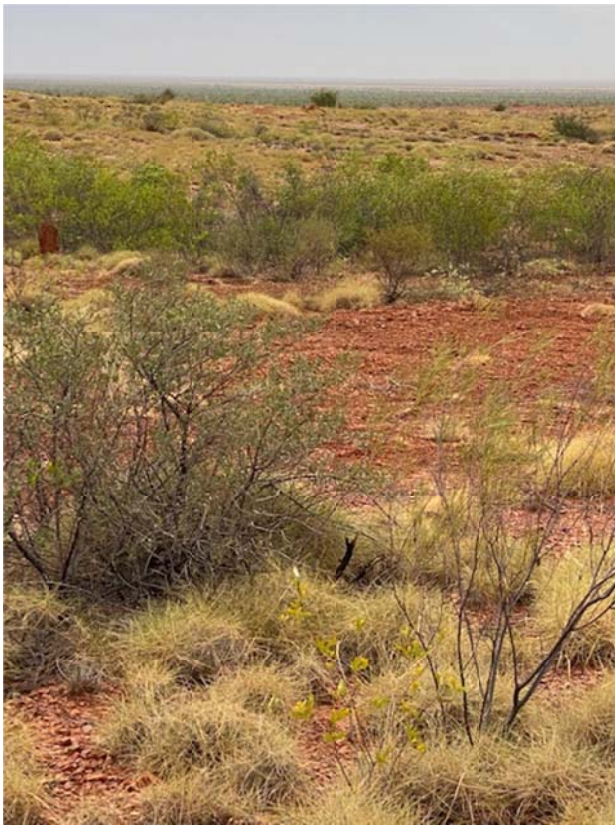
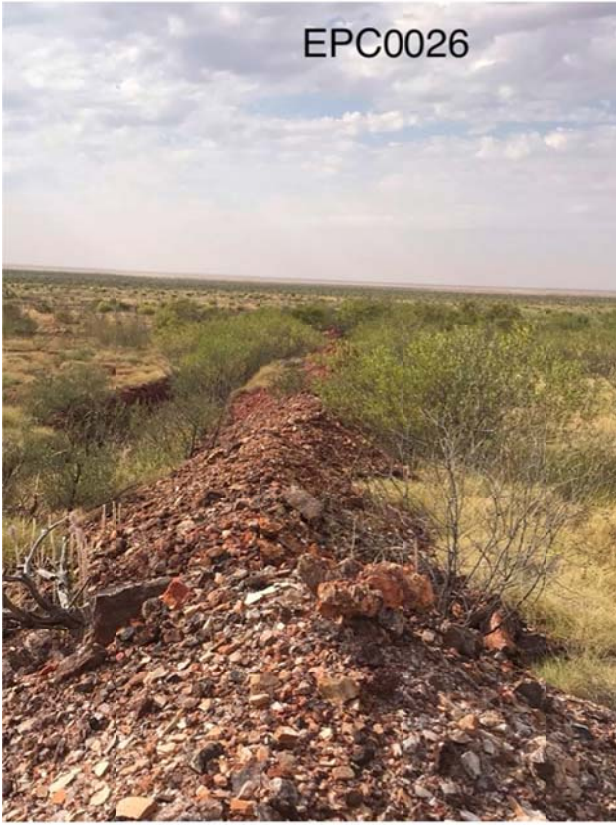
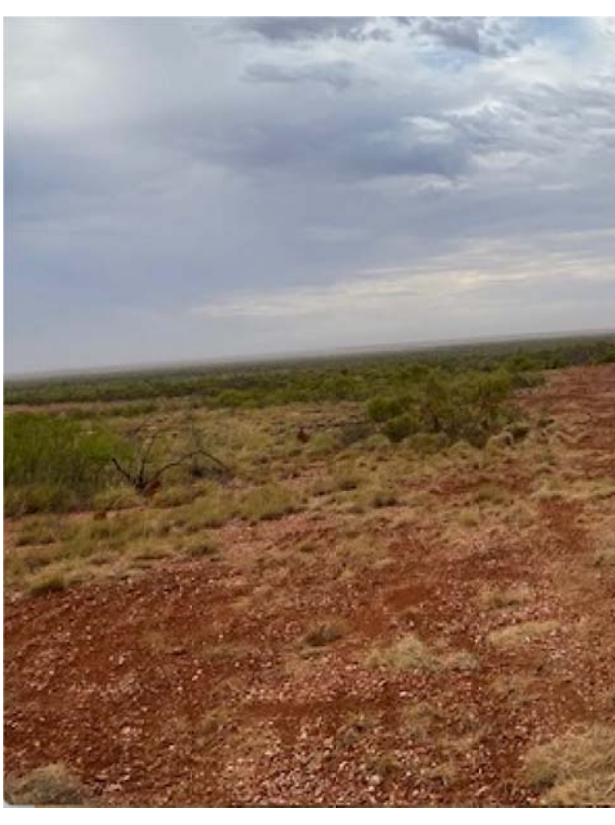
Photographic Record Of Task	
Before	Ater
<p>EPC0026</p>

<b>Lease</b>	EL23658	<b>Project Area</b>	<b>SITE 1 (30KM NW GRANITES, 10KM N TANAMI RD)</b>		<b>Costean ID</b>	<b>EPC0026</b>
<b>Title: EPC0026 Closure Report</b>						
<b>Pre-Rehab Condition</b>	As per Before photographs. Overgrown, some minor erosion.					
<b>Method Of Work and Equipment Used</b>	Each site was inspected by Dylan Poulson (Yapa Crew member) and myself for cultural significance prior to work commencing.					
	Excavator and skid steer where used. The Costean was backfilled using excavator from the spoil line and the site was levelled, scarified and spread with vegetation where ever possible using the skid steers					
	Where possible all signs of interference where removed such as wheel tracks.					
<b>Hazards / Risks</b>	Trench cave in. Regrowth of vegetation both in the trench and within the spoil. The Yapa Crew assessed that there were no trees of significance within or near this costean.
