# Independent Monitor Community Report

2009 Operational Period

Community Report by the Independent Monitor of the  
McArthur River Mine, November 2010

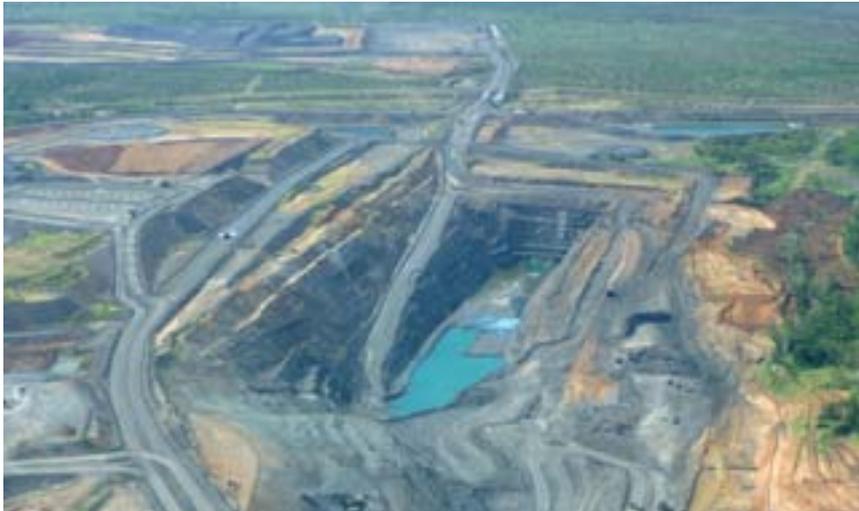
The open cut pit of the McArthur River Mine, as viewed by the Independent Monitor during the May 2010 site inspection.

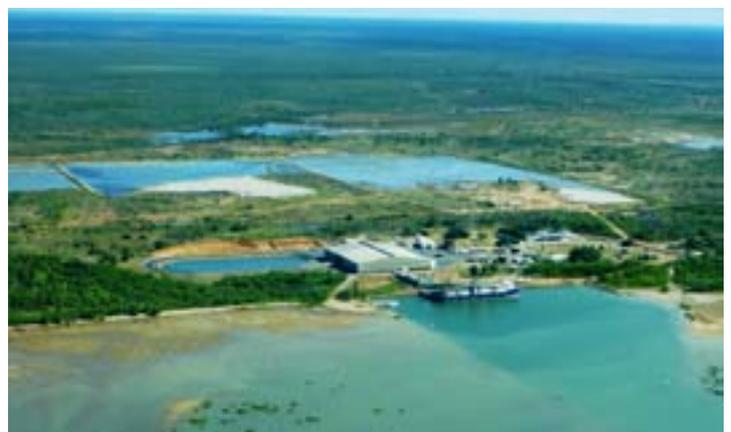
Last year we noticed significant vegetation die-back immediately outside the dredge spoil ponds at the Bing Bong Port Facility. The dredge ponds are built to hold marine sediments (spoil) dredged from the Bing Bong swing basin. It was evident that the vegetation dieback was being caused by saline seepage leaking from the salty spoil, through the degraded pond walls and onto the surrounding plain.

Aerial view of the Bing Bong Port Facility with the Bing Bong Port and concentrate storage shed in the foreground, and the dredge spoil ponds in the background. (May 2010).

Although seepage continues, the spoon drain appears to be successful in re-directing saline seepage back to sea and allowing vegetative regeneration in the previously-affected areas. We will continue to monitor the success of vegetation in this area. Further geotechnical assessments of the dredge spoil walls have also been recommended.

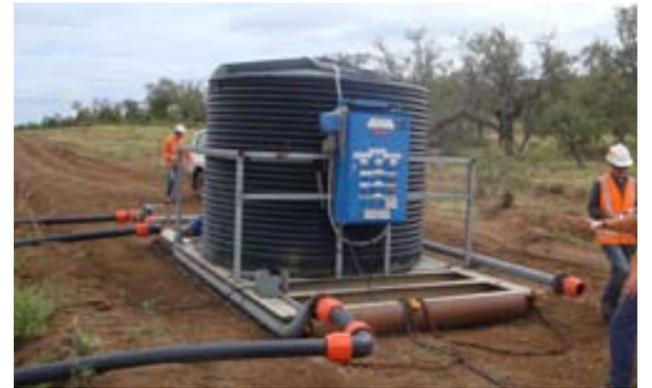
MRM have utilised a new irrigation sled to help establish vegetation along the McArthur River diversion channel over the 2010 dry season (May 2010).

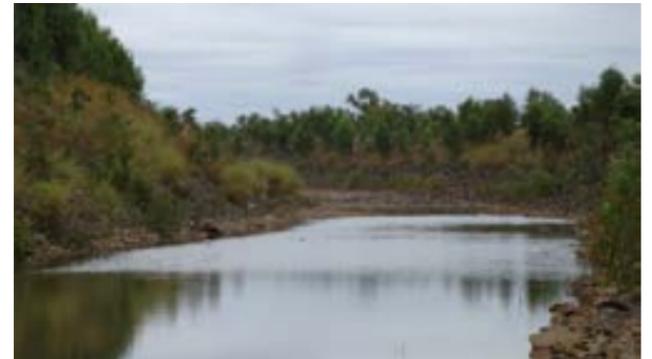
Revegetation of the Barney Creek diversion has continued to be successful this year, with the establishment of a range of trees and grasses.

Revegetation of the Barney Creek diversion channel is going well. Each audit we have observed increasing vegetation establishment at this location (May 2010).

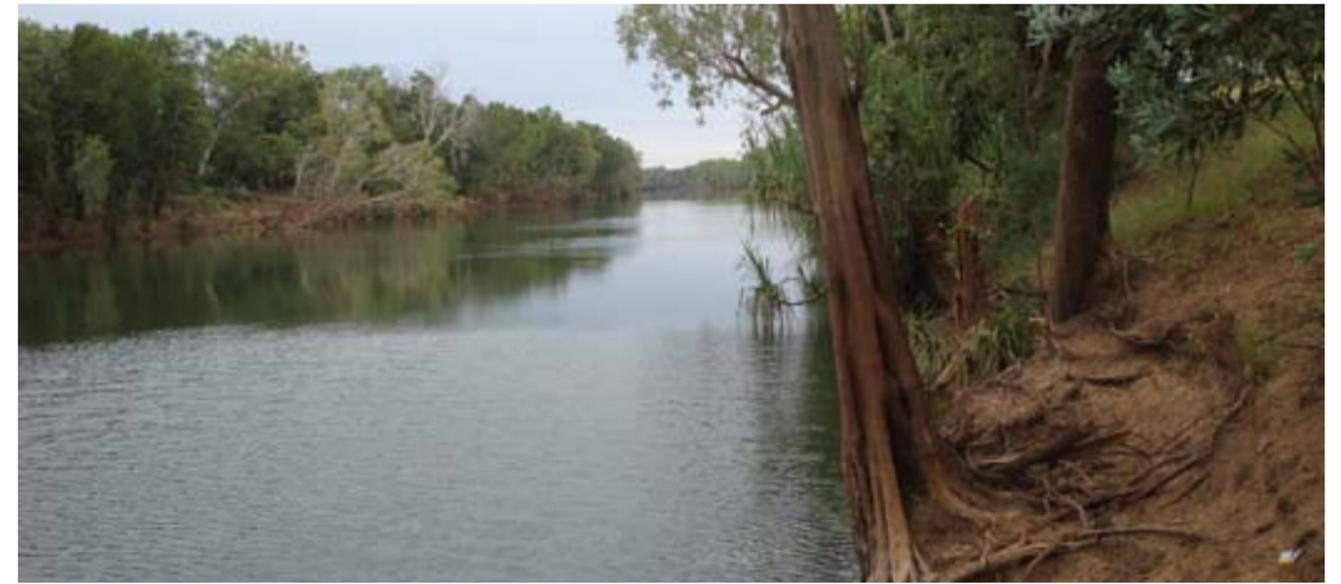
The Independent Monitor inspected a tributary upstream of the McArthur River Diversion called 8-Mile Creek (above). Freshwater Sawfish have been caught and tagged at this location as part of MRM's Freshwater Sawfish monitoring program. (May 2010).

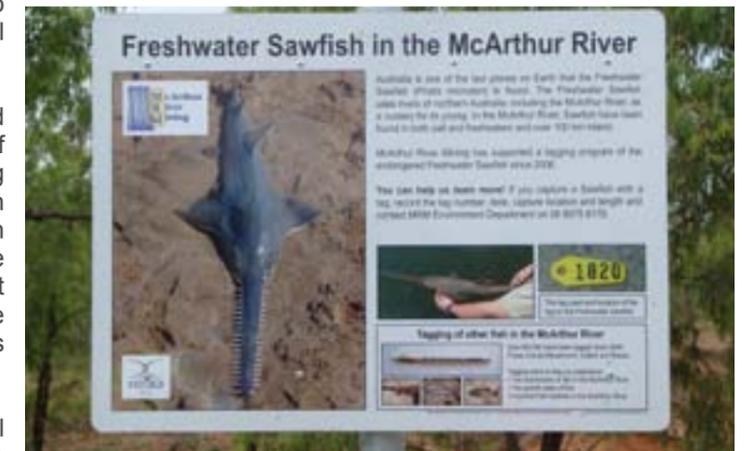
Signs such as this are placed along the McArthur River to encourage fishermen to alert MRM if they catch and release a Freshwater Sawfish in the McArthur River. This helps MRM keep track of sawfish movements and abundance in the McArthur River. (May, 2010).

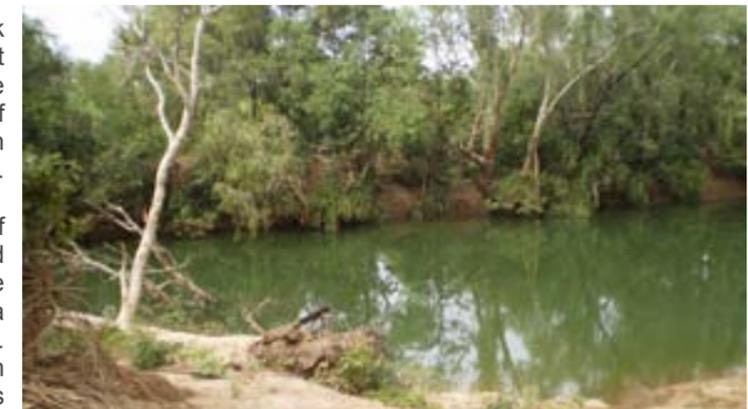
This area of the McArthur River, upstream of the diversion channel is used as an analogue site for riparian flora and fauna monitoring. This area provides an ecological benchmark for the eventual revegetation and rehabilitation of the McArthur River diversion channel. (May, 2010).
