Independent Monitor Community Report

2011 Operational Period

Community Report by the Independent Monitor of the
McArthur River Mine, November 2012

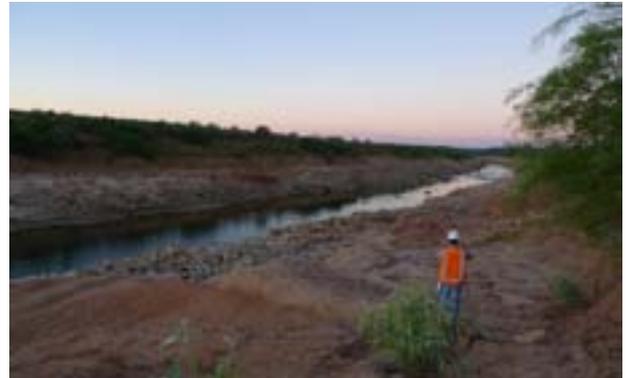
Revegetation of the McArthur River diversion channel has been an ongoing focus of Independent Monitor audits. Revegetation has come a long way over the last five years, but there is still work to be done.

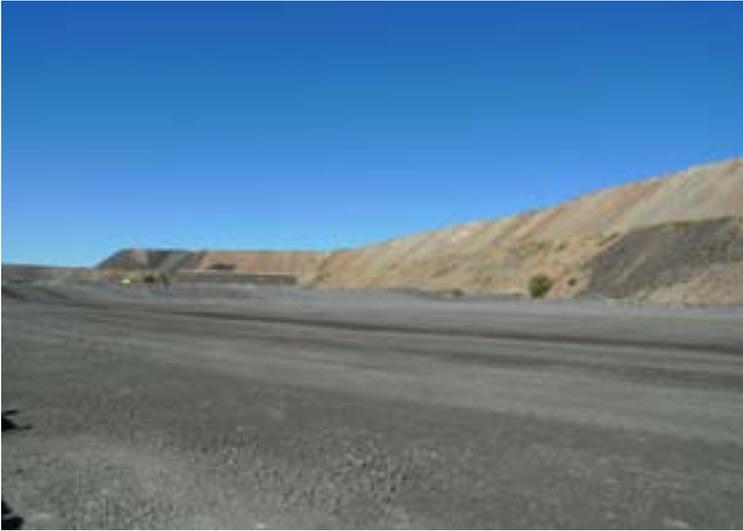
Waste rock placed in the Overburden Emplacement Facility (OEF) is potentially acid forming, and is placed strategically within the OEF according to design, to minimise the future potential for environmental damage.

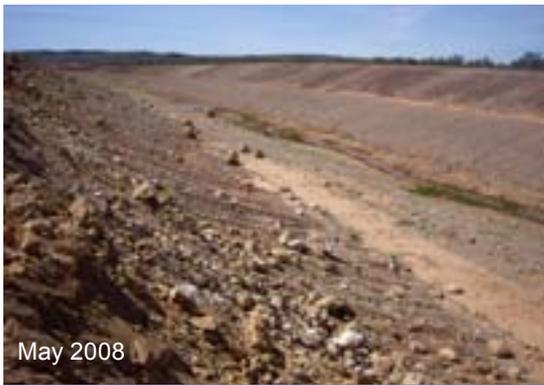
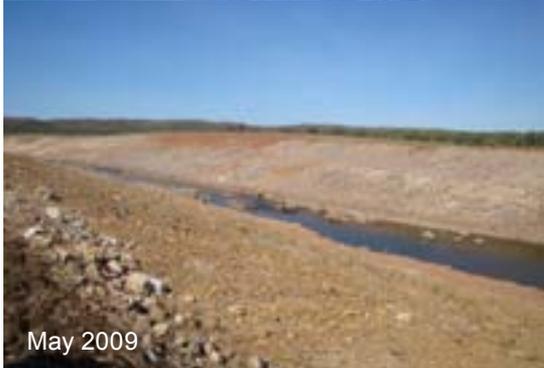
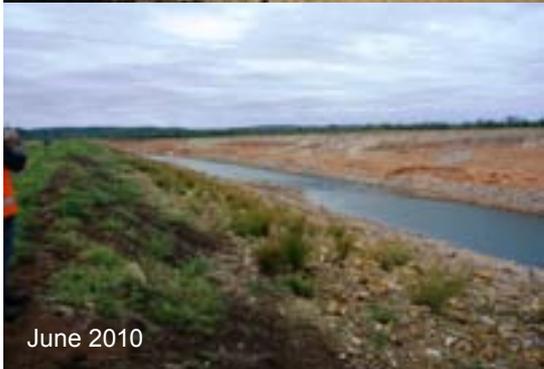
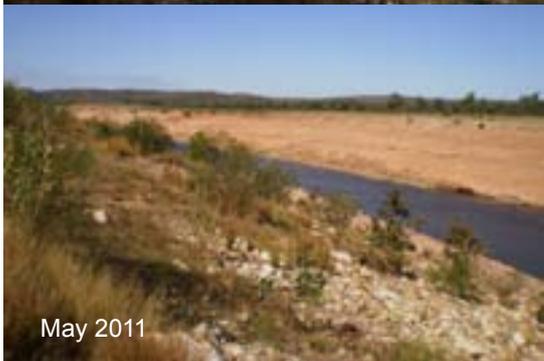
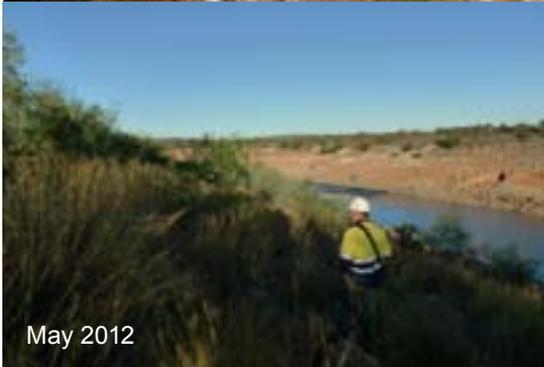
Over the past five years, the IM has observed increasing success of revegetation at the upstream end of the McArthur River diversion channel, as seen in the sequential photographs.

Rehabilitation and monitoring at McArthur River Mine continues to improve since the first Independent Monitor audit was completed in 2008 (see photos left). In May 2012, the Independent Monitor observed significant improvement to the vegetation community along the McArthur River diversion, particularly along the opposite bank where MRM have dedicated substantial efforts in rehabilitation.

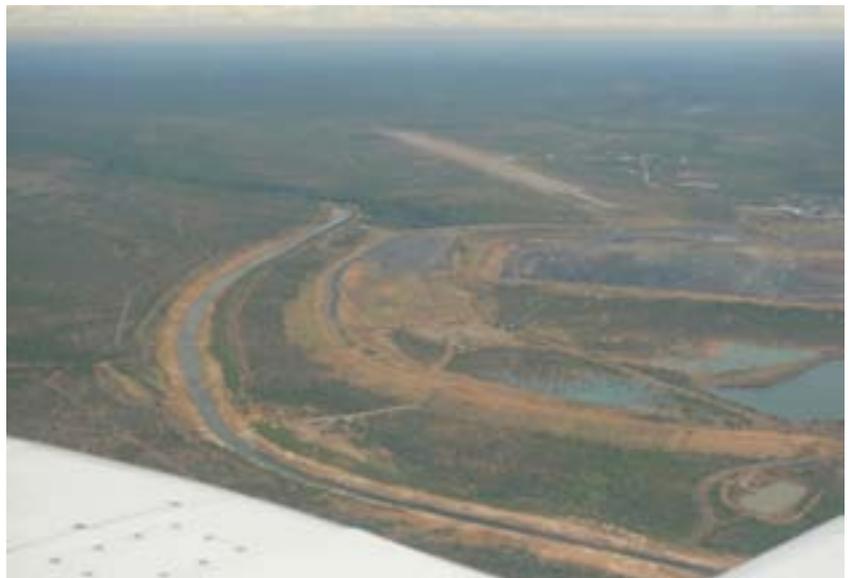
In addition to the water sled irrigation system previously positioned on the mine side bank, a second water sled has been installed on the opposite bank of the diversion. The vegetation has responded positively to this irrigation and the density of plants in the irrigated area has increased noticeably.

Aerial view of the upstream area of the McArthur River diversion taken in May 2012.

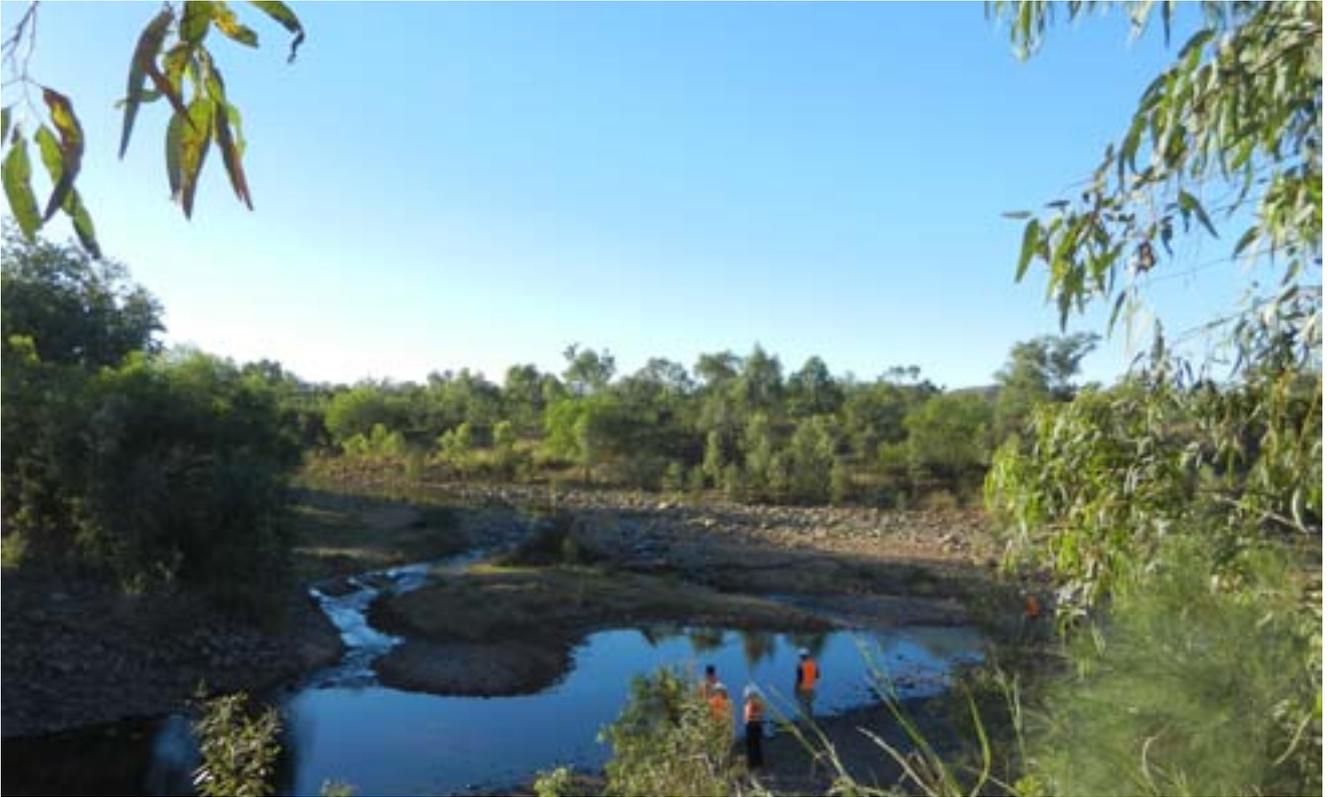
Revegetation along Barney Creek diversion, also showing woody debris in the river bed.

We have recommended that MRM focus on achieving a species diversity which more closely resembles the original river channel, including the key species, Freshwater Mangrove *Barringtonia acutangula* and Native Cane Grass *Chionachne cyathopoda*. These species were again almost absent from tube stock planting in the 2011 Operational period.

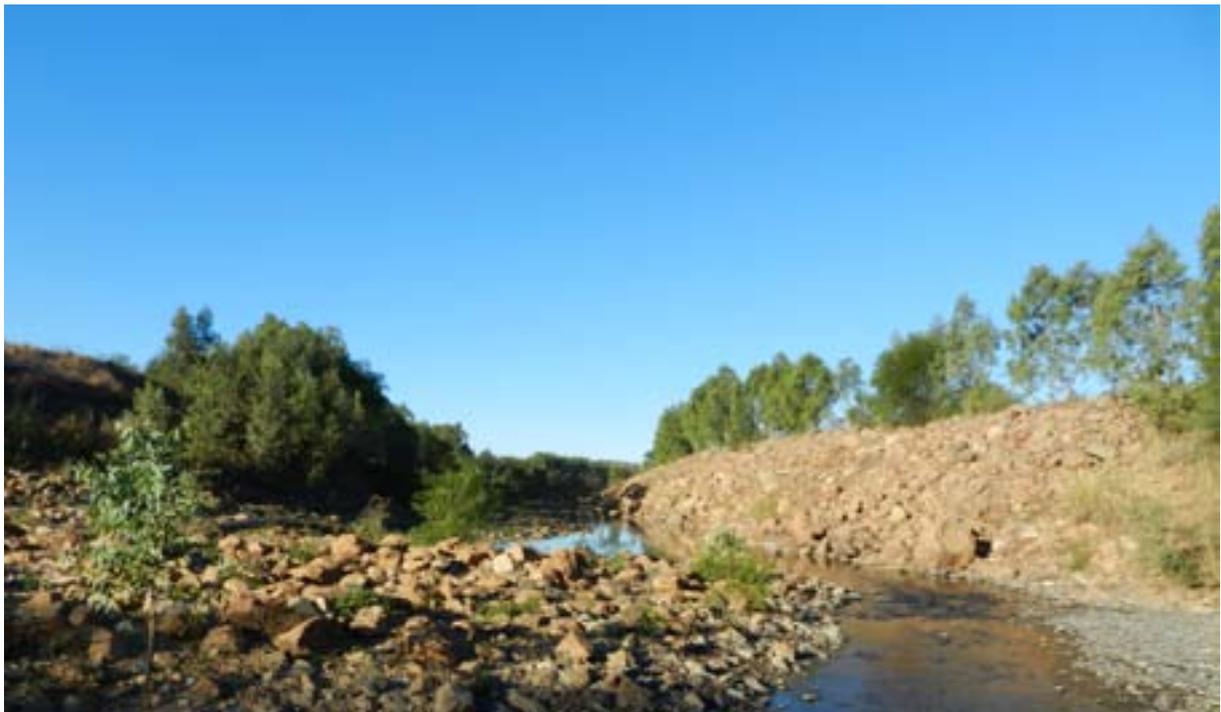
Revegetation along Barney Creek diversion continues to progress well.

The revegetation of the Barney Creek Diversion continues to progress well, exhibiting good vegetation cover with tall *Eucalyptus camaldulensis* observed (over 10 metres tall) and a vegetation community of varying maturities.

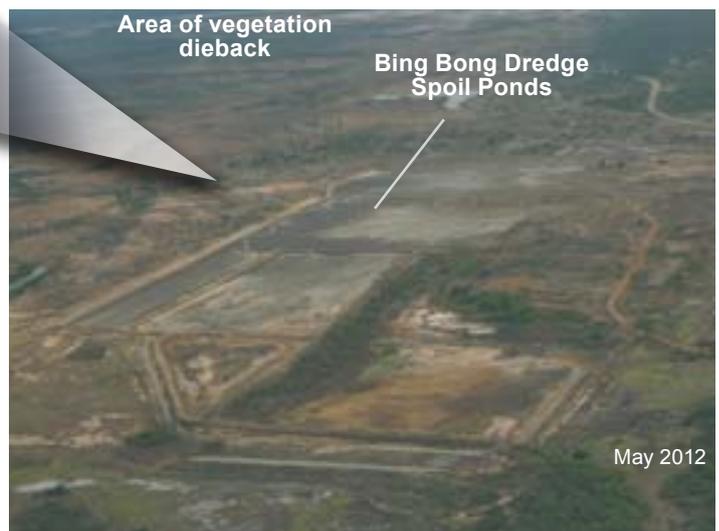
Increased vegetation cover on the Bing Bong dredge spoil was observed during the May 2012 site inspection, although cover in places, particularly in low-lying areas, was still quite sparse. Direct seeding of the dredge spoil ponds occurred during the first half of 2012. Elevated mounds in the spoil ponds have been very successful in allowing grasses to establish and reduce wind erosion and dust. Areas outside of the ponds, close to the spoon drain, were very low in coverage with large areas of salt deposition.

Aerial view of the Bing Bong dredge spoil ponds.

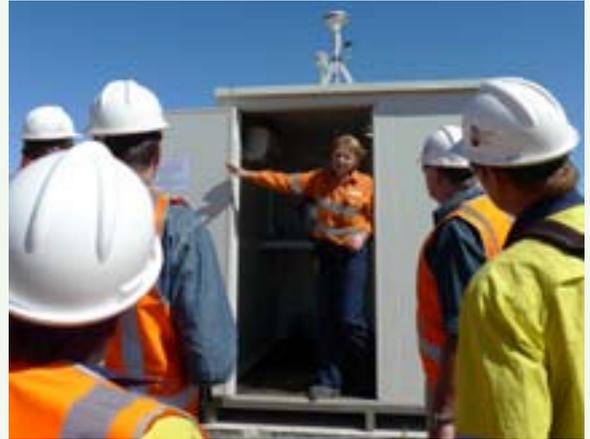
The Independent Monitor inspected a recently-installed real-time air monitoring. Housed in a small shed at the north-western perimeter of TSF Cell 1, this monitoring system has been set up to provide real-time alerts to the Environment team when dust levels exceed criteria. MRM have advised that they are preparing to install a second monitoring shed downwind of the PACRIM crushing area, which has been the primary source of contaminated dust generation.

New real-time air monitoring shed positioned at the upwind perimeter of TSF Cell 1.

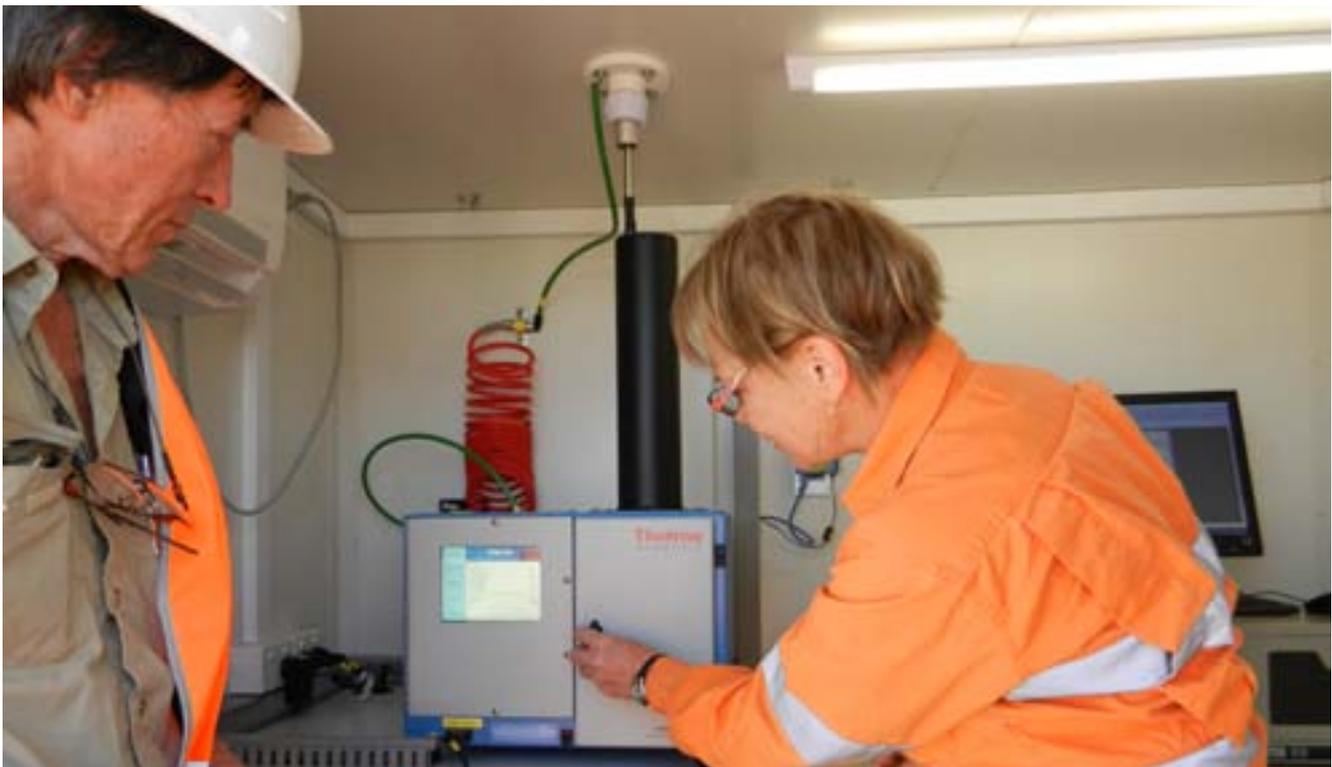
The Independent Monitor team examine the Tailings Storage Facility realtime dust monitoring in May 2012.
