# Independent Monitor **COMMUNITY REPORT**

**McARTHUR RIVER MINE**

November 2015

# Environmental Performance 2014

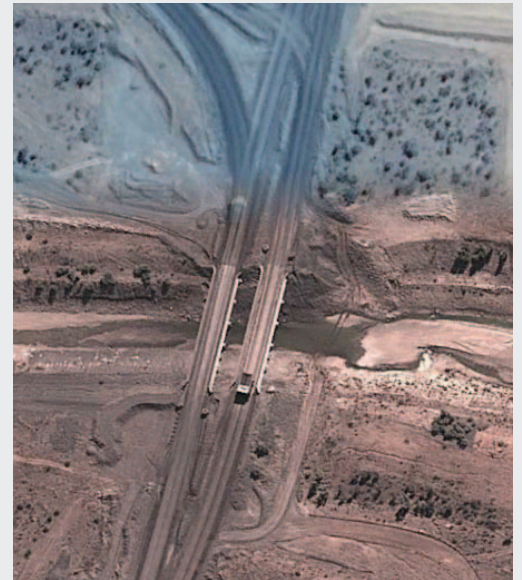
Water sampled adjacent to the bridge contained more lead and zinc than other locations within the mine site, including three lead results exceeding the mine's hardness-modified trigger value.

Streambed sediment collected at this location also contained more metals than other Barney Creek sites, including lead and zinc results 8 and 11 times the Australian soil quality guidelines, respectively.

Satellite image of Barney Creek haul road bridge  
Source: Google Earth.

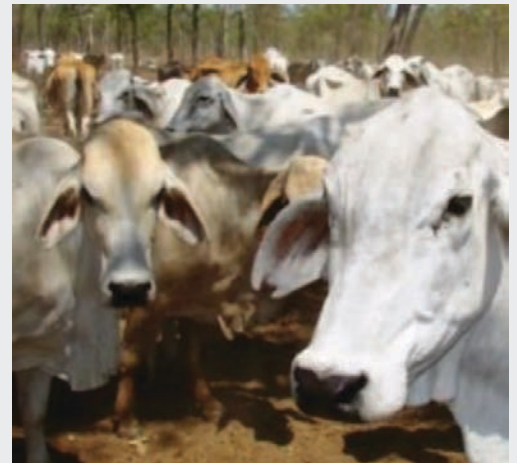
Tissue samples were taken from five cattle found in the vicinity of the mine in mid-2014, with results showing that one of the five had lead content in its kidneys above the maximum level allowable for human consumption (as per Australian food standards).

The IM notes that MRM have repeatedly repaired cattle exclusion fencing around the mine perimeter. Cattle that access the mine site are removed by MRM. Mustering of cattle was conducted inside the fenced area during 2014, and cattle that could not be mustered were culled. Further mustering was conducted in early 2015.

Cattle  
Source: ABC, 2015.

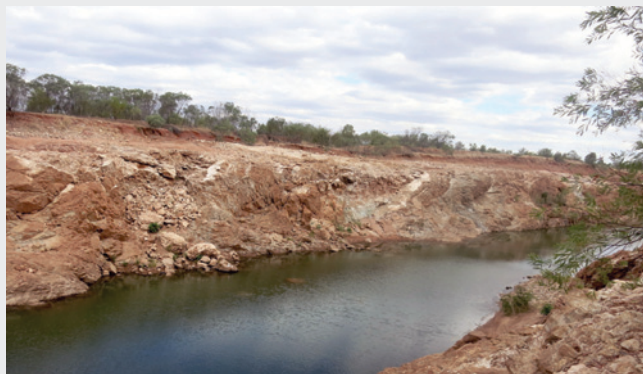
Erosion of the diversion channel during wet seasons continues to be an issue, which MRM are addressing by planting trees and installing large woody debris. MRM will shortly undertake a full condition assessment and erosion mitigation strategy.

Lower section of the McArthur River diversion channel

During 2014, MRM commenced an improved erosion assessment program in its revegetation plots. MRM is undertaking a full landform condition assessment and erosion mitigation strategy for the McArthur River diversion channel, due to be finalised in February 2016.

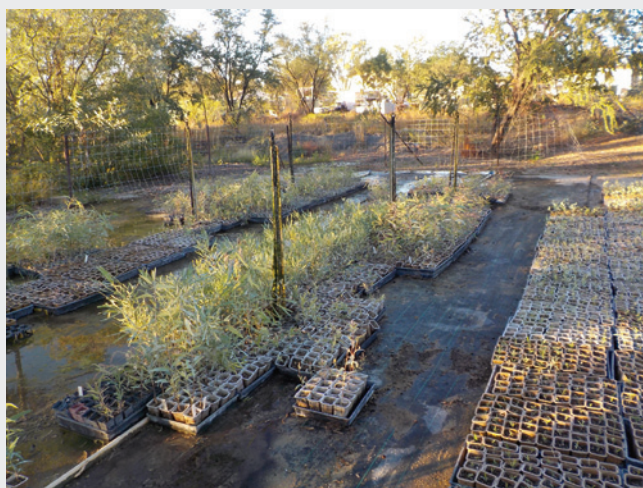
The IM commends MRM for increasing the proportion of plants grown in the on-site nursery to 85% in 2014 (instead of sourcing from off-site).

McArthur River Mine plant nursery in June 2015

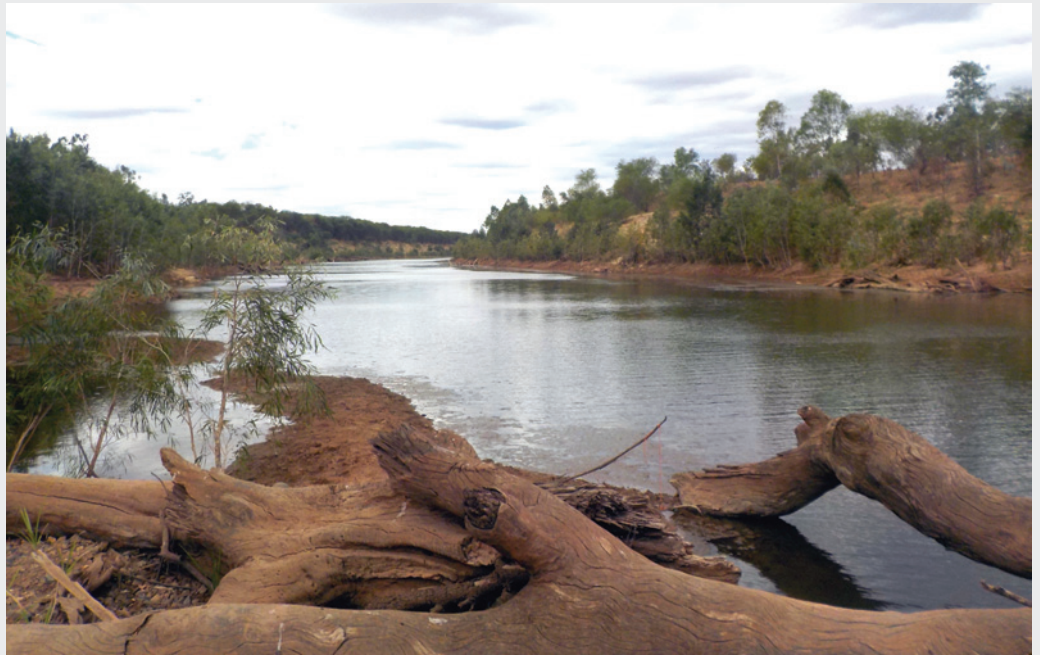
*Advanced revegetation in the upper part of the McArthur River diversion channel, with large woody debris in the foreground.*

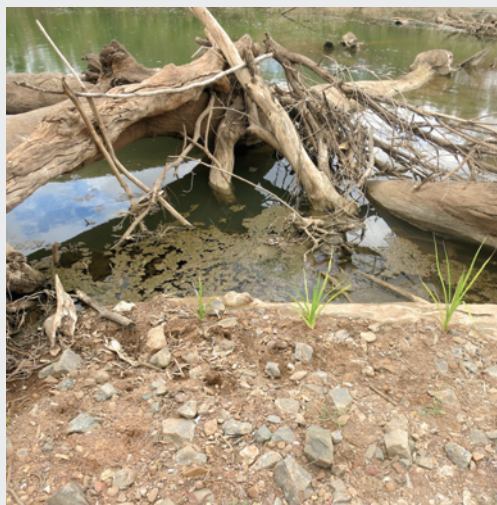
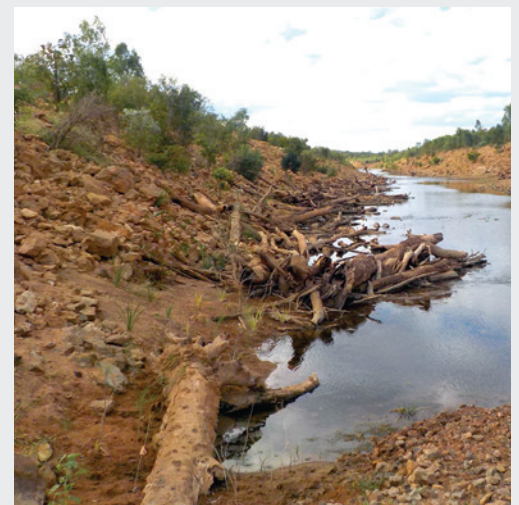
MRM have added a significant amount of large woody debris (LWD) to the diversion channel in 2014. In places, LWD has been partially buried to make sure it survives future floods.

Aquatic surveys identified that LWD installation has had an almost immediate positive effect, with many more fish using these sites as opposed to areas with bare banks. Recent revegetation has included planting within the sediment trapped behind LWD piles.

*Large woody debris in the McArthur River diversion channel: providing fish habitat, protecting new revegetation, stabilising banks and reducing erosion.*

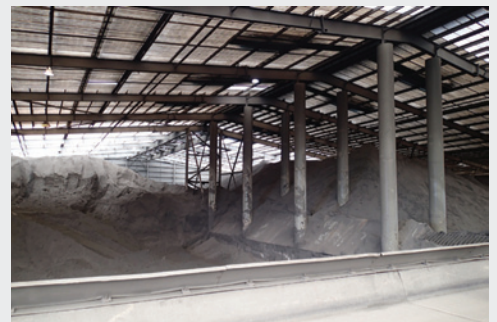
Inside the concentrate shed

During the IM's 2015 visit to Bing Bong Port, it was noted that some of the usual controls were not operational. Doors on the concentrate shed could not be closed and the dust extraction system was not working.

- The doors of the concentrate shed should be repaired so that they can be closed.
- The dust extractor system in the concentrate shed should be repaired.

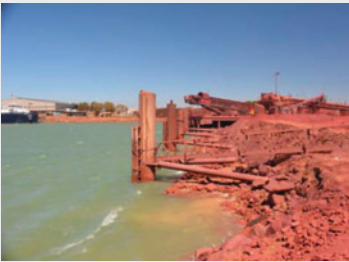
During 2014, a large amount of red dust (from iron ore) was blown across the area to the west of Bing Bong Port. This dust is from the operations of Western Desert Resources (WDR, a separate company to MRM), which involved stockpiling and loading of iron ore onto barges in the port. WDR stopped operating in September 2014.

Red dust at Western Desert Resources' loading facility, with MRM's concentrate shed visible to the left.
