REPORT NO.

209024

INDEPENDENT MONITOR AUDIT OF THE ENVIRONMENTAL PERFORMANCE OF THE MCARTHUR RIVER MINE – 2008 OPERATIONAL PERIOD

ENVIRONMENTAL EARTH SCIENCES VIC
REPORT TO THE DEPARTMENT OF REGIONAL DEVELOPMENT,
PRIMARY INDUSTRY, FISHERIES AND RESOURCES

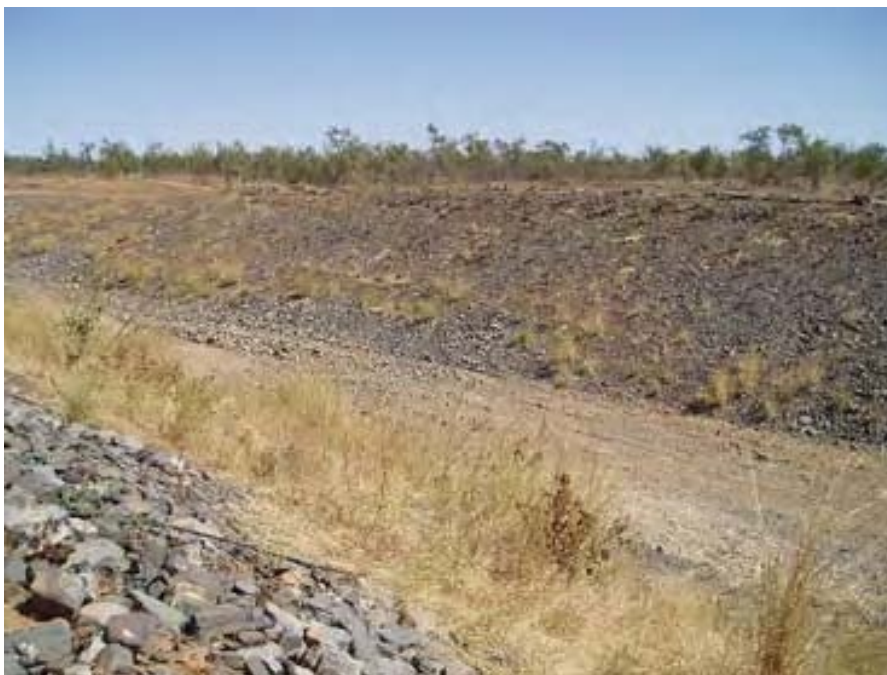
Plate 8 - Barney Creek Ch 500m (July 2008)

It is clear that the photograph portfolios will also assist in broad scale monitoring of the rehabilitation works. For example, a review of the triple July 2008 and March 2009 photographs taken at Barney Creek Ch 500m (see Plate 8 -and Plate 9 - Appendix E) reveals that while the 2009 vegetation at the top of the channel banks is denser and more established, the previous (July 2008) vegetation and soil has been lost from the lower section of the channel bank. Moreover, there is a distinct near horizontal line defining the upper limit of the soil loss, which suggests that the soil loss may be directly related to the passage of a recent flood. While it is noted that the *Rechannel Rehabilitation Plan* (MRM, 2009c) provides details of initial rehabilitation works, there does not appear to be any consideration of works that involve re-working of rehabilitated areas other than “additional infill planting may be required depending on the results of surveys”(MRM, 2009c:6).

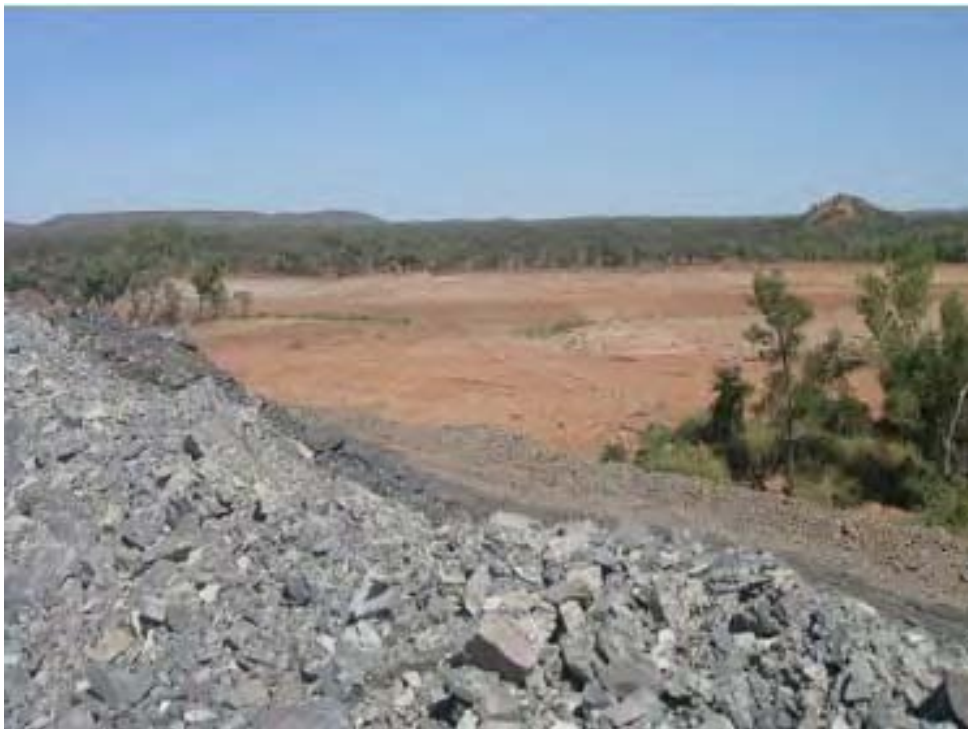
During the June 2009 inspection, MRM personnel referred to the observed passage of some 2008-2009 wet season flood flows spilling from the remnant McArthur River channel (upstream of the main levee wall) and passing overland to the new diversion channel (see Plate 10 - Appendix E). McArthur River Mining verbally reported some accompanying scour as the floodwaters both travelled overland to the diversion channel and spilt (*i.e.* dropped) into the diversion channel. The magnitude of the above event is unclear, however the Independent Monitor considered it unlikely to have been a large (*i.e.* rare) flood. The long-term implications (particularly related to scour) are unclear, however is recommended for on-going monitoring and as-necessary rehabilitation works.

Plate 10 - McArthur River overland flow-path from remnant channel (in right foreground) to diversion channel (in background) (June 2009).

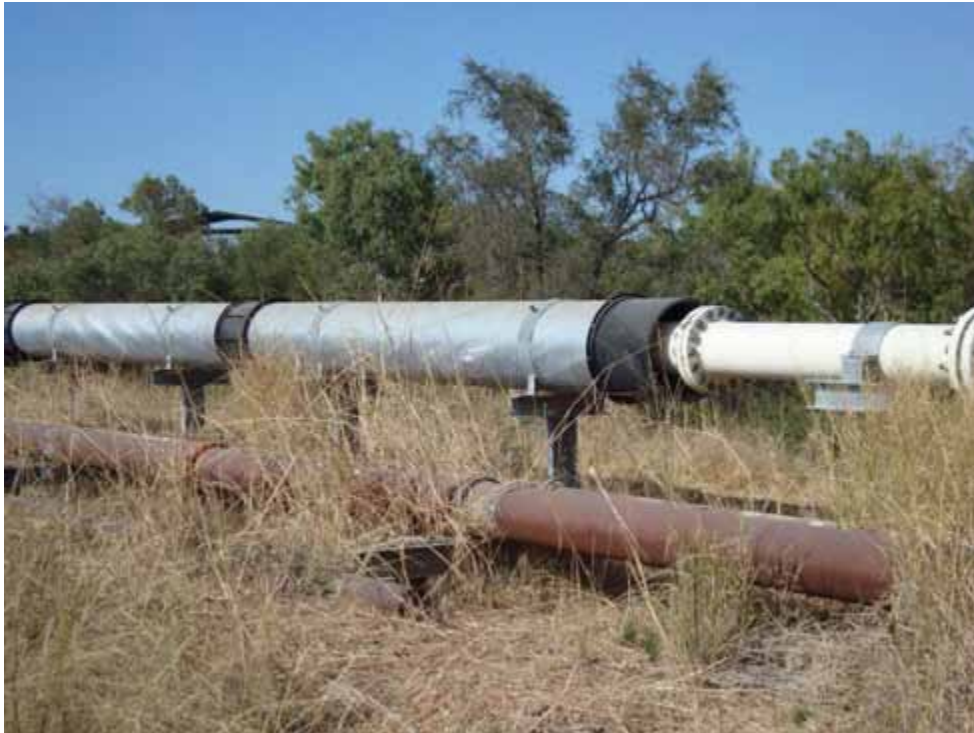
Photograph Plate 11 - Appendix E shows the newly installed (since the 2008 audit period) protection shroud covering the Tailings Storage Facility pipeline over the Barney Creek channel crossing. The shroud, along with the pipeline, slopes towards the channel crossing abutment on the Tailings Storage Facility side, which is the point at which the slurry will run out, should any leaks occur in the pipeline over the crossing.

Plate 11 - TSF abutment of TSF Pipeline Bridge over Barney Creek (June 2009).

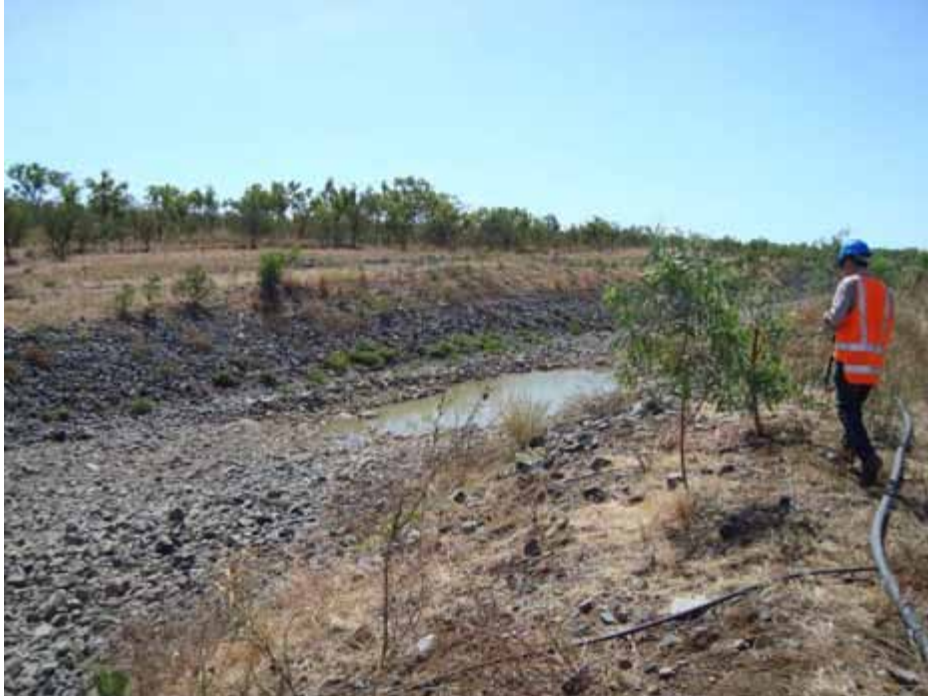
Plate 19 - Barney Creek river diversion works with rock armouring (June 2009).

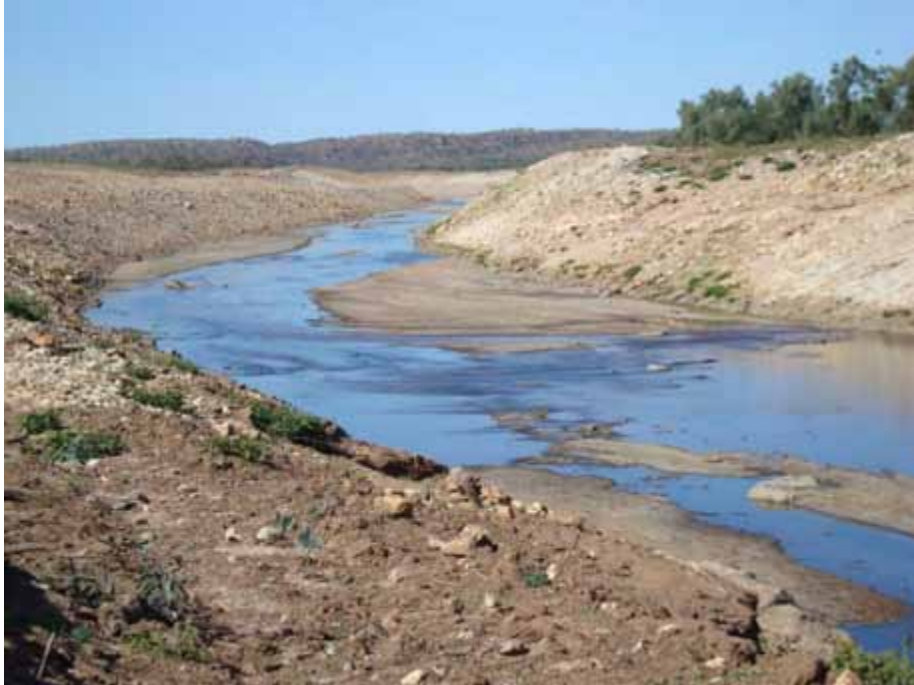
Plate 23 - McArthur River diversion at upstream end (June 2009).

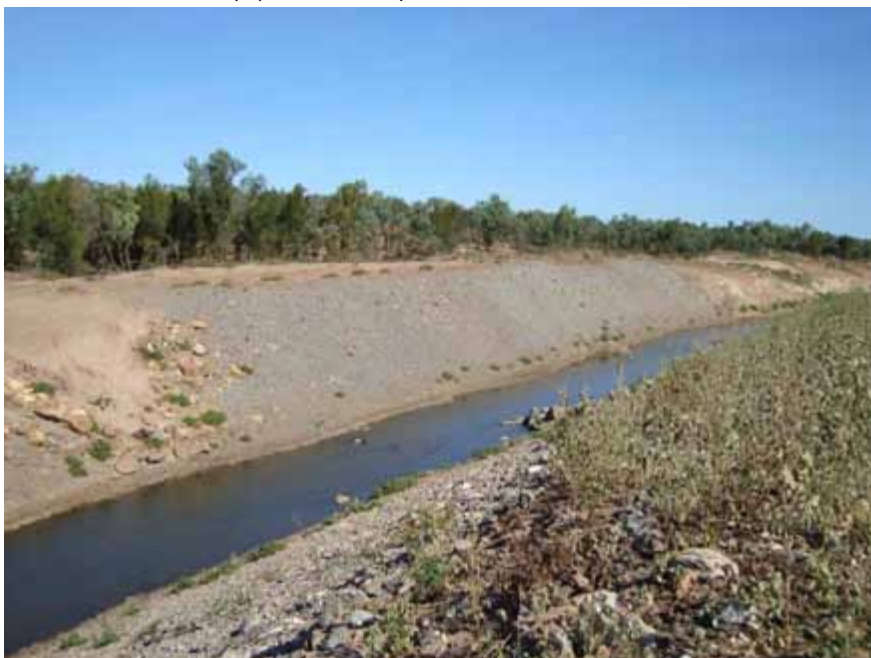
Plate 26 - McArthur River diversion, rock armour where the channel banks have a more soil profile (June 2009).
