# Independent Monitor **COMMUNITY REPORT**

**McARTHUR RIVER MINE**

October 2014

# Environmental Performance 2012-2013

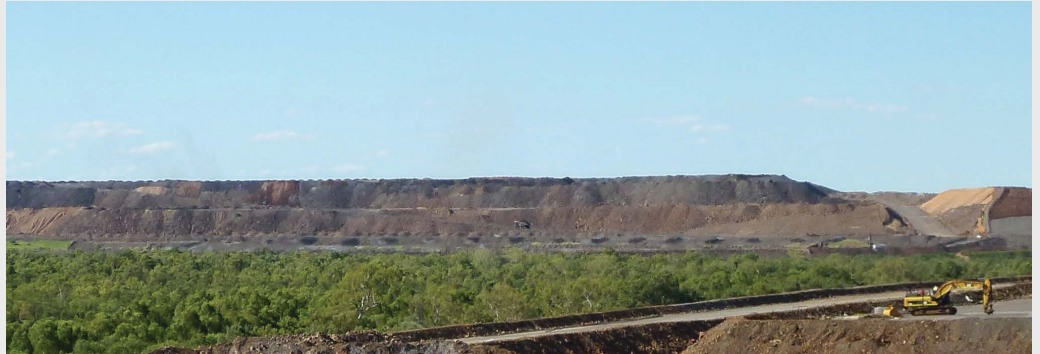
The Northern Overburden Emplacement Facility

Since the last IM report, there has been a major change in the understanding of geochemical risks at McArthur River Mine.

Estimates of the proportion of potentially acid-forming overburden material at the mine have increased from around 30% to over 50%. A further 30% of the overburden is now recognised as having potential for saline and metalliferous drainage.

As such, the IM considers acid, saline and metalliferous drainage the most significant potential environmental issue at McArthur River Mine. MRM is now investigating the implications of reclassification on management of overburden.

Current and future management strategies for overburden now require reassessment, as does the design of the Northern Overburden Emplacement Facility (NOEF).

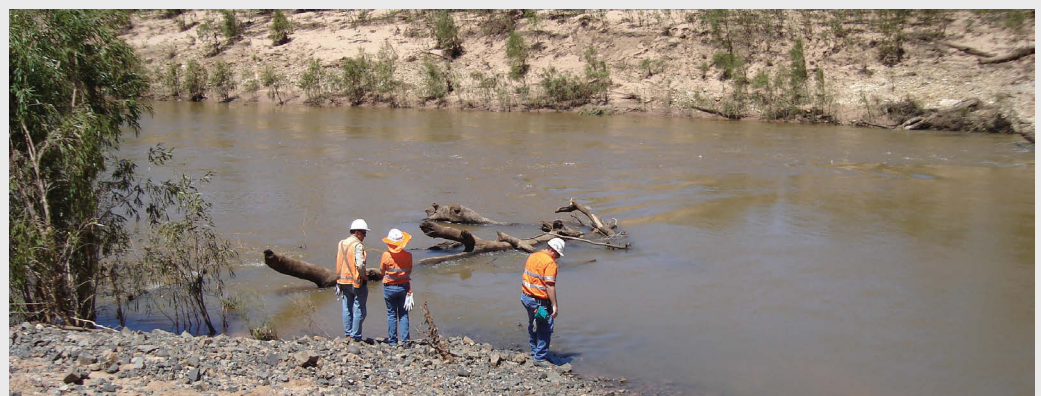
Part of the McArthur River diversion channel, March 2014

Despite these improvements, revegetation of the diversion channel has been slow. Flooding and high flows in the wet season cause erosion and have washed away some previous plantings. Flood damage to fencing has meant that cattle access - with grazing and trampling of plants - continues to be a problem.

The IM recommends review of the current rehabilitation strategy and the schedule to identify how the revegetation of the channel can be accelerated.

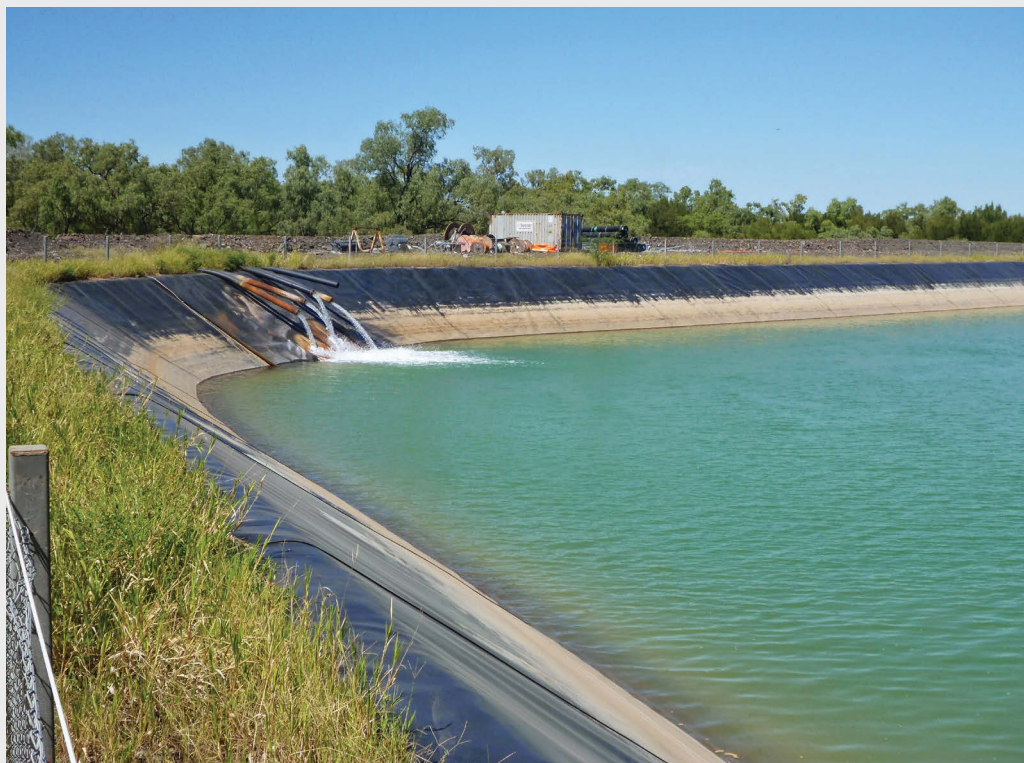
Pete's Pond, which receives dewatering water from the mine pit

There is potential for poor quality seepage or runoff from the TSF and the northern overburden emplacement facility (NOEF), or from dust generated by operations, to reduce water quality in Surprise and/or Barney Creeks. The IM recommends that monitoring programs be reviewed to ensure early warning of such impacts.

Water quality of the mine pit lake after mine closure should also be assessed, as seepage from the pit has potential to impact groundwater and adjacent ecosystems.
