**INDEPENDENT MONITOR AUDIT REPORT –
ENVIRONMENTAL PERFORMANCE OF THE MCARTHUR
RIVER MINE – 2009 OPERATIONAL PERIOD**

**ENVIRONMENTAL EARTH SCIENCES VIC
REPORT TO THE DEPARTMENT OF RESOURCES**

AUGUST 2010

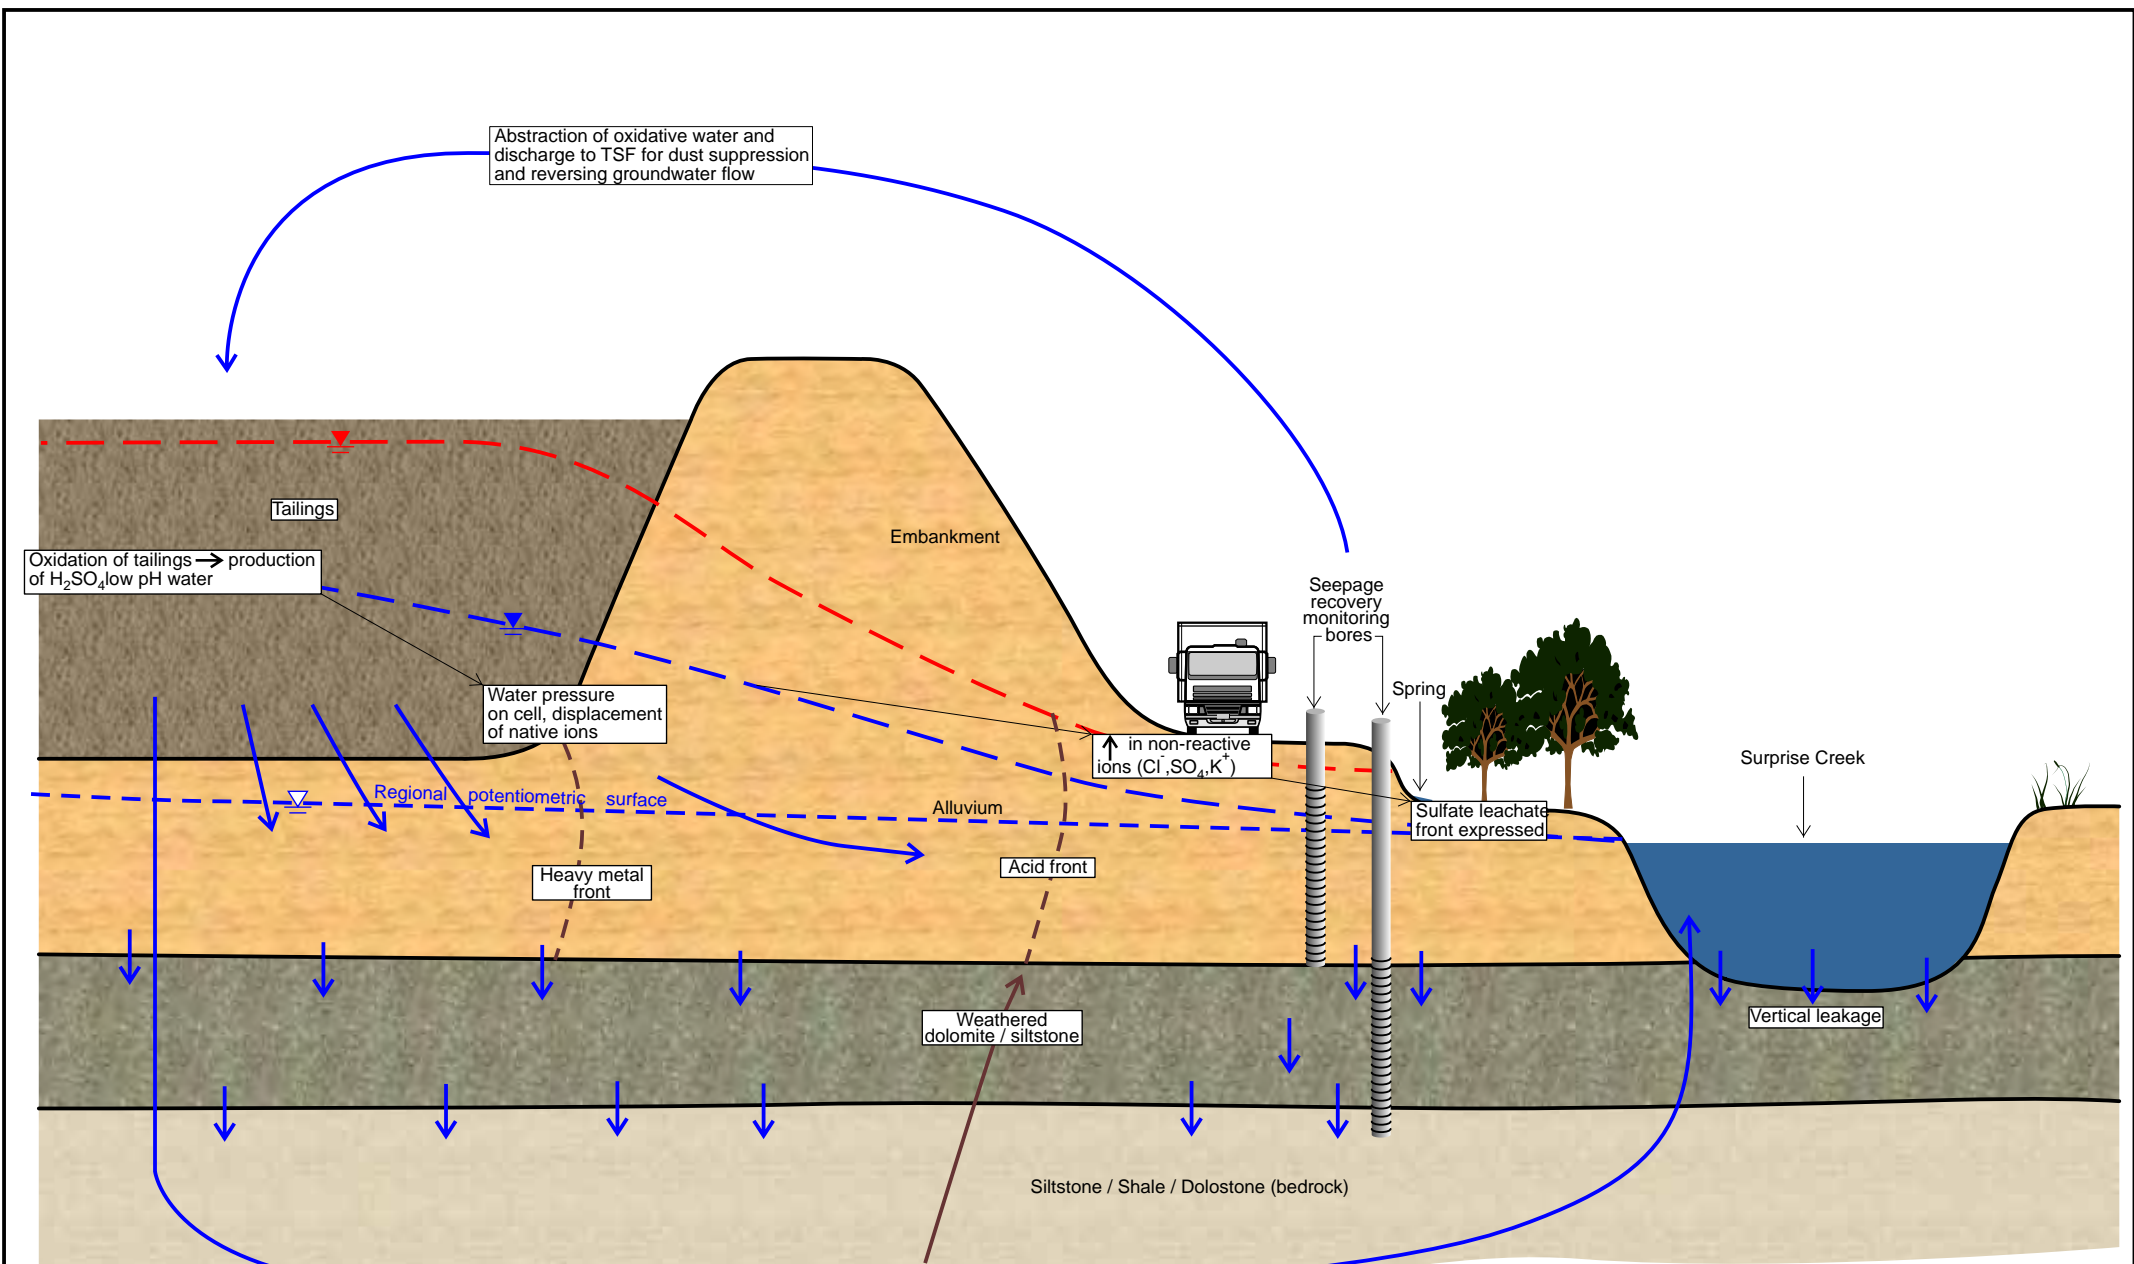
Title: Conceptual Geochemical Model of Seepage Migration	
	Location: McArthur River Mine Northern Territory

A conceptual model of seepage migration is presented in Figure 3.

The following works have been undertaken by MRM to mitigate and investigate leachate seepage from the Tailings Storage Facility (Figure 3):

- URS completed a site inspection in February 2010 and report (dated 29 March 2010) (URS, 2010a), aimed at providing final solutions to seepage issues. URS reported that the primary issue concerning the Tailings Storage Facility is the excess amount of liquor being stored at the surface of the Tailings Storage Facility, which is likely to be causing saturation of the dam walls. URS note that the Tailings Storage Facility was not designed to be a water retention dam. URS recommended that the volume of water in the Tailings Storage Facility be reduced to remove the source of infiltration, and leachate should be prevented from reaching Surprise Creek. Recommendations for such mitigation includes:

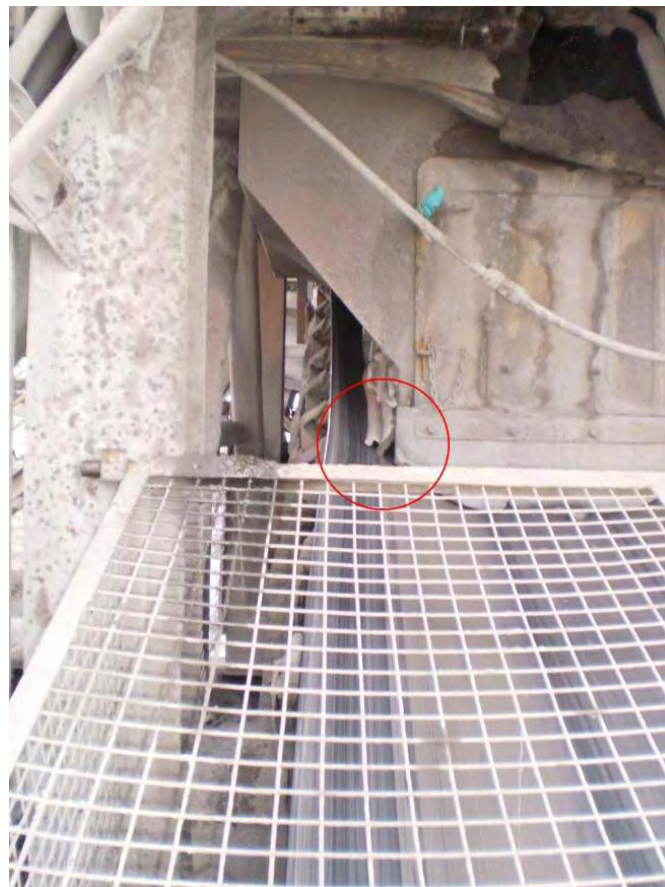
Plate 5 - Pacrim conveyor with double-lipped lining (circled) to aid dust suppression.

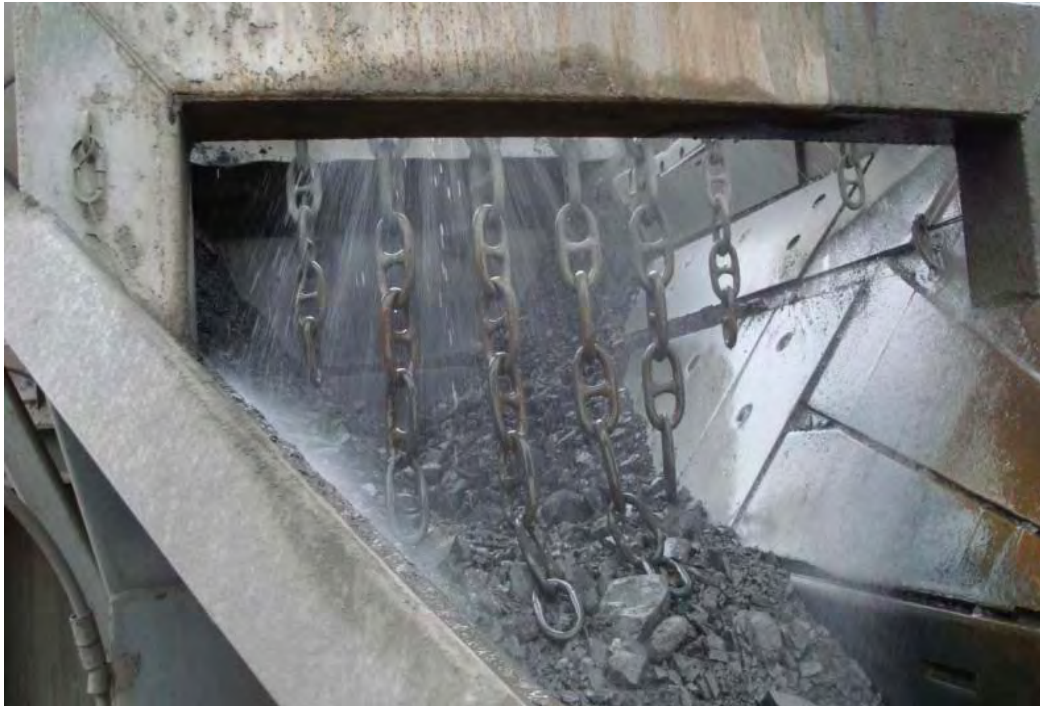
Plate 6 - Water sprays applied to ore within crushing machinery for dust suppression.

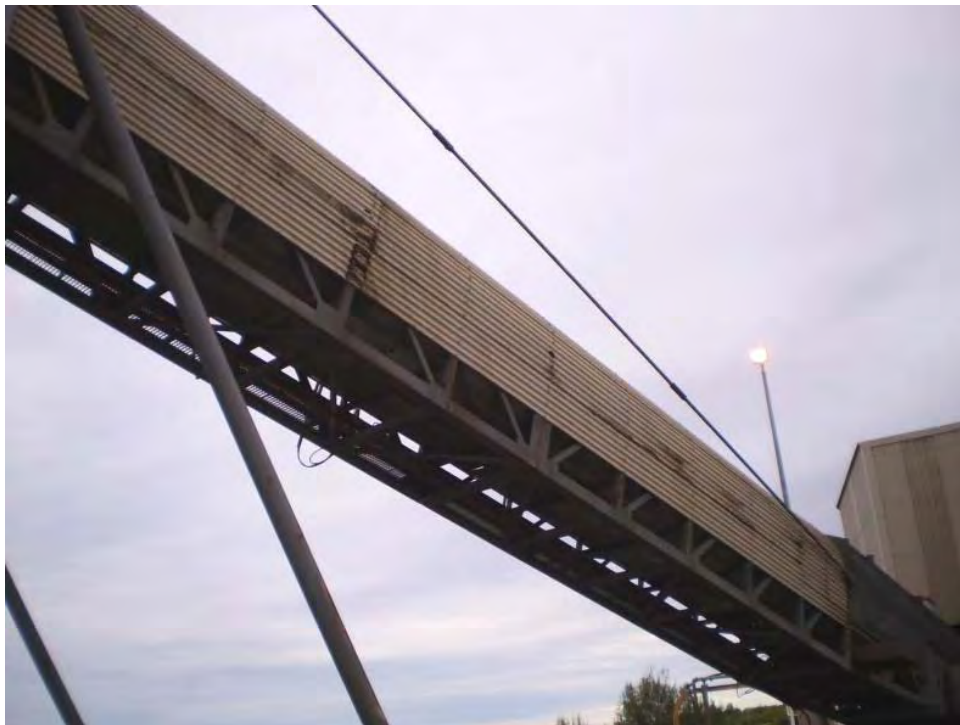
Plate 7 - Enclosed load-out conveyor at Bing Bong Port.

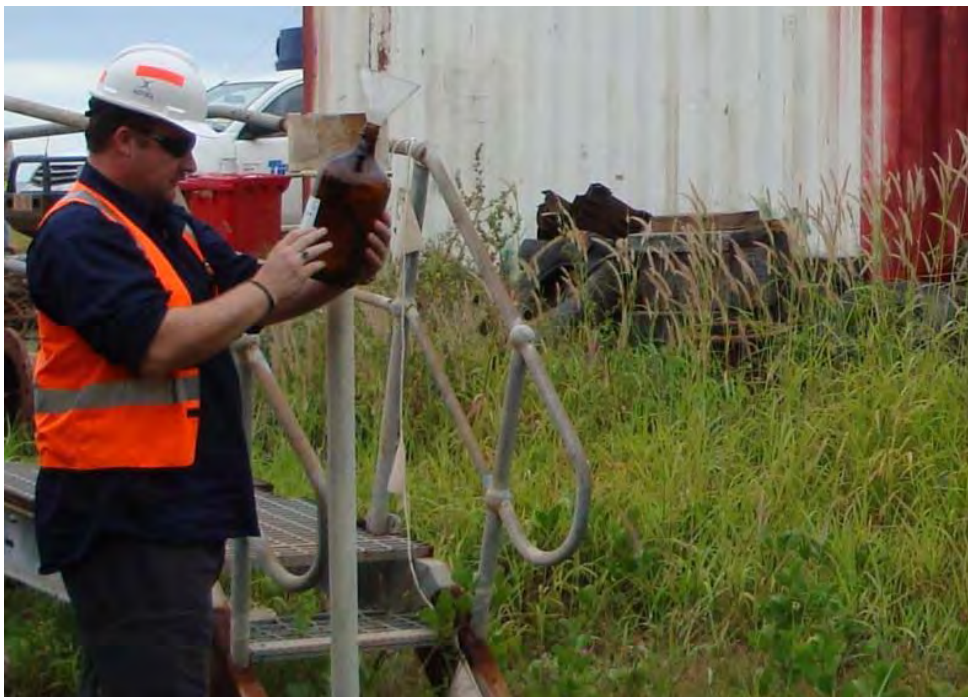
Plate 8 - An Independent Monitor team member inspecting a dust sampling gauge at the Bing Bong Port facility.

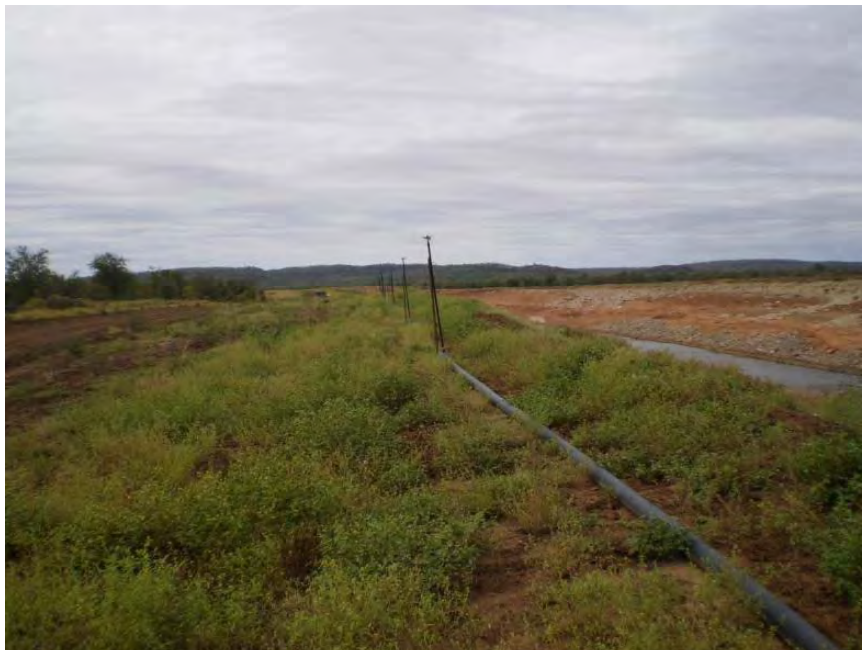
Plate 9 - New Irrigation system at the upstream section of the McArthur River diversion.

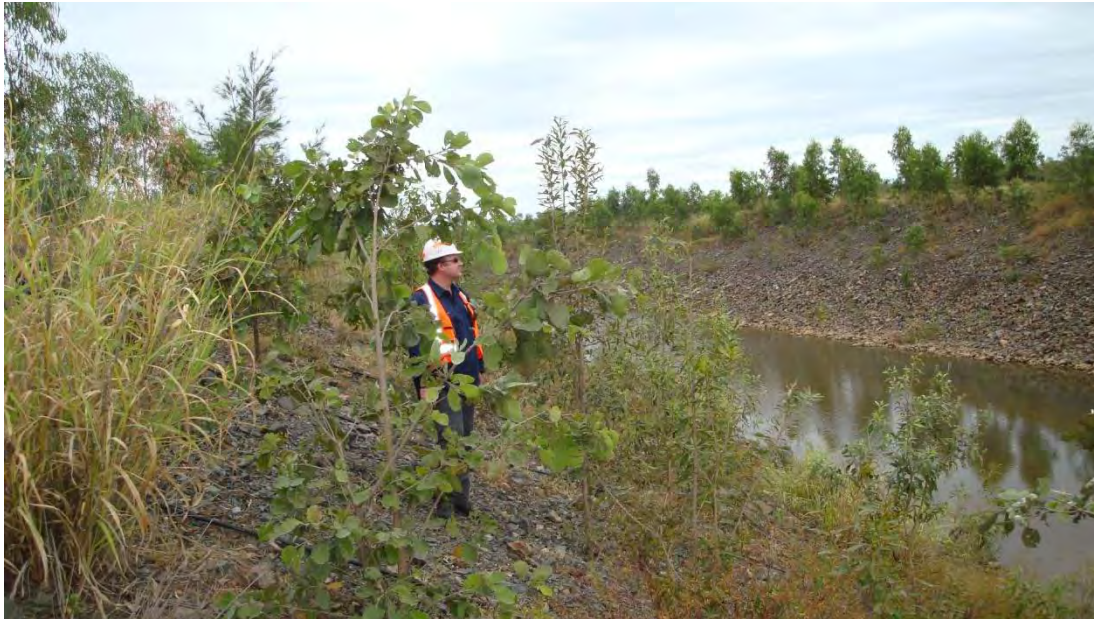
Plate 10 - Revegetation at Barney Creek Diversion Channel.

It is acknowledged that rehabilitation efforts by MRM staff are challenged by great seasonal variation and the large scale of the operation. However, MRM must persevere in adhering to its commitments to fully revegetate the diversion channel as a suitable riparian habitat corridor. The following recommendations have been made for consideration:

- specific monitoring targeting preferred rehabilitation species along the McArthur River diversion will indicate whether rehabilitation is developing in the desired direction. The current monitoring program is thorough within plots however plots are considerably distant to each other;

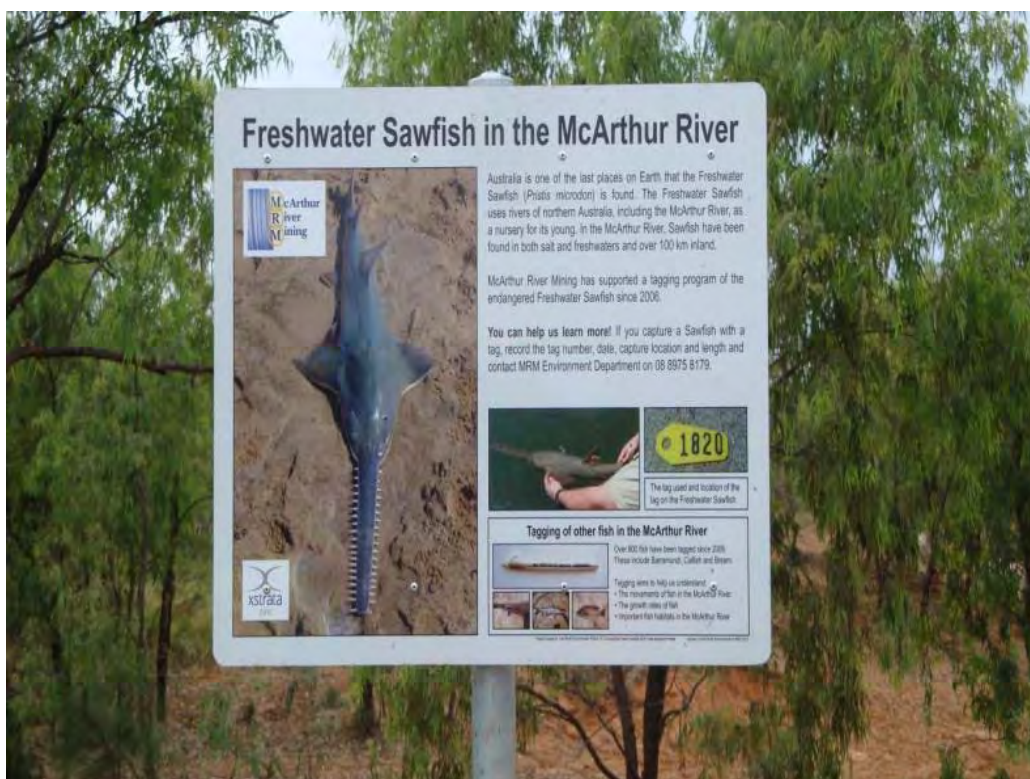
Fish surveys around the mine site, including heavy metal analysis of fish tissue were to be collected and analysed as per the 2008/2009 MM, are reported in Indo-Pacific Environmental reports (2010a; 2010b). Further, sawfish observed as part of the 2010 Fish Monitoring Program (see Plate 12 -) were found to be using the diversion channel to reach upstream waterholes after a large wet season event.

Plate 12 - Tagging of Sawfish forms part of the environmental monitoring program

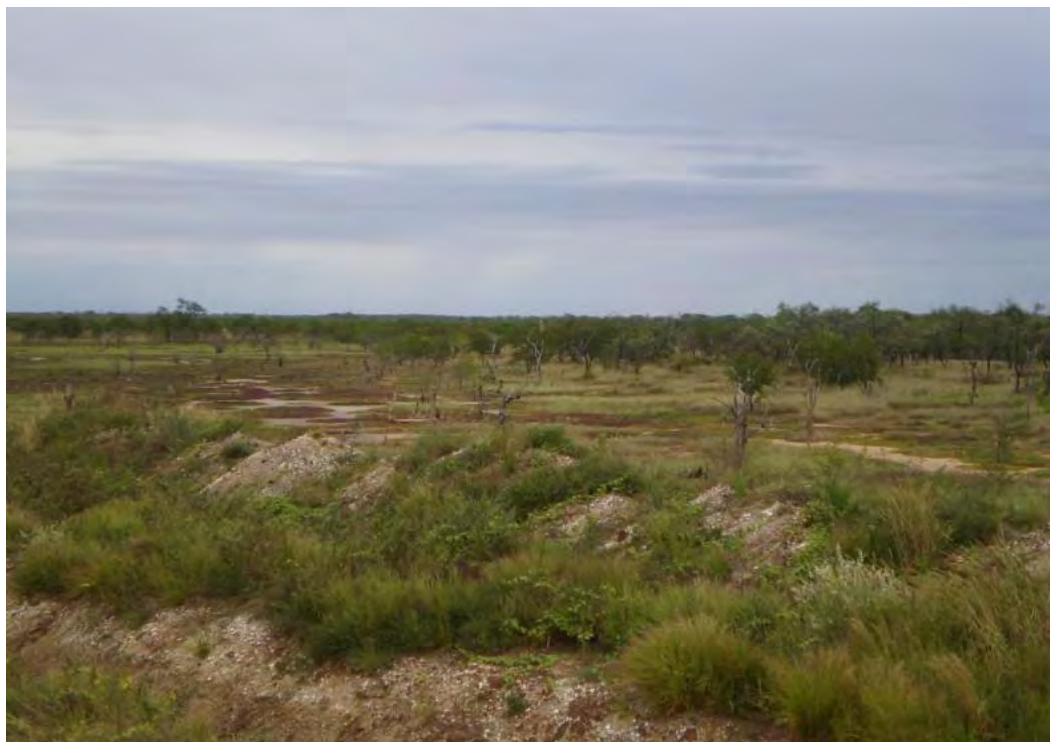
The Independent Monitor's previous audit report highlighted the issue of saline seepage that was observed to be draining from the walls of the dredge spoil ponds and affecting vegetation within the surrounding area. The Independent Monitor inspected rectification works at the dredge spoil ponds in May 2010, which include a spoon drain surrounding the ponds (See Plate 13 -). This drain appears to have been successful at redirecting dredge seepage to sea rather than to the surrounding mud flat. The Independent Monitor is satisfied that this is a positive outcome for flora surrounding the spoil (See Plate 14 - Plate 15 -) and has probably halted further vegetation dieback. Accompanying documentation and photographs were provided to the Independent Monitor in the 2010 Bing Bong Dredge Spoil Report (MRM, 2010d).

Plate 14 - Vegetation recovery outside of the dredge spoil area.

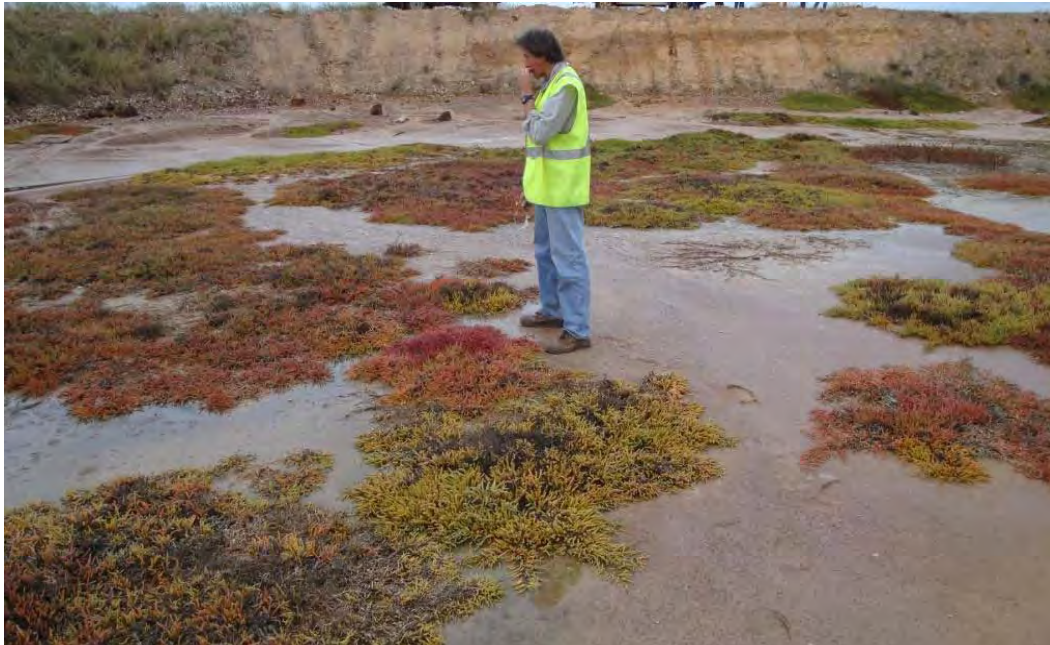
Plate 15 - Independent Monitor team member inspecting succulent recolonisation between the outer wall of the spoil dump and the outer spoon drain.

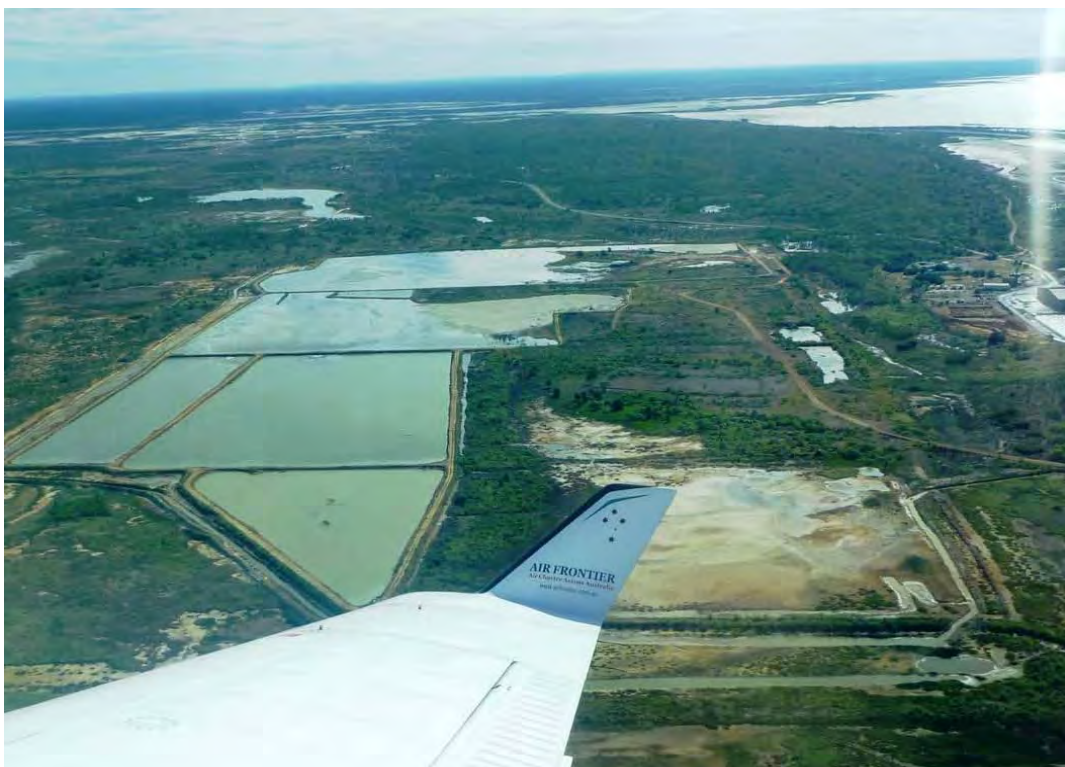
The Bing Bong Spoil Dump (see Plate 27 -) was inspected and since the previous audit, numerous works have been completed to reduce the environmental impact of the spoil dump on the wider area, including:

Seepage through and under the embankment was witnessed in a number of locations, and some sections of the embankment were witnessed to have piping and longitudinal cracking consistent with embankment instability and localised failure (see Plate 28 -Plate 29 -Plate 30 -). The Spoil Dump is also storing water with no freeboard between the crest of the embankment and the water stored within the spoil dump. This leaves the embankment vulnerable to overtopping during a heavy rainfall event that may lead to a failure of the Spoil Dump embankment due to washout.

Plate 27 - Bing Bong Spoil Dump – Aerial view looking west.

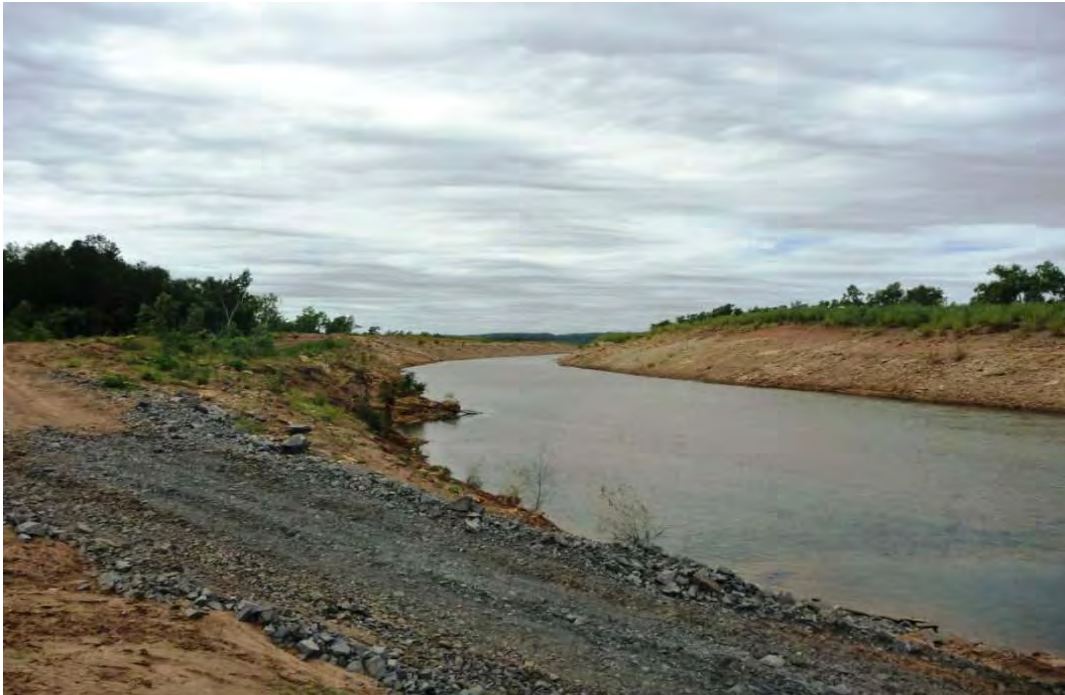
Plate 32 - Looking downstream along the McArthur River diversion channel from the ford.

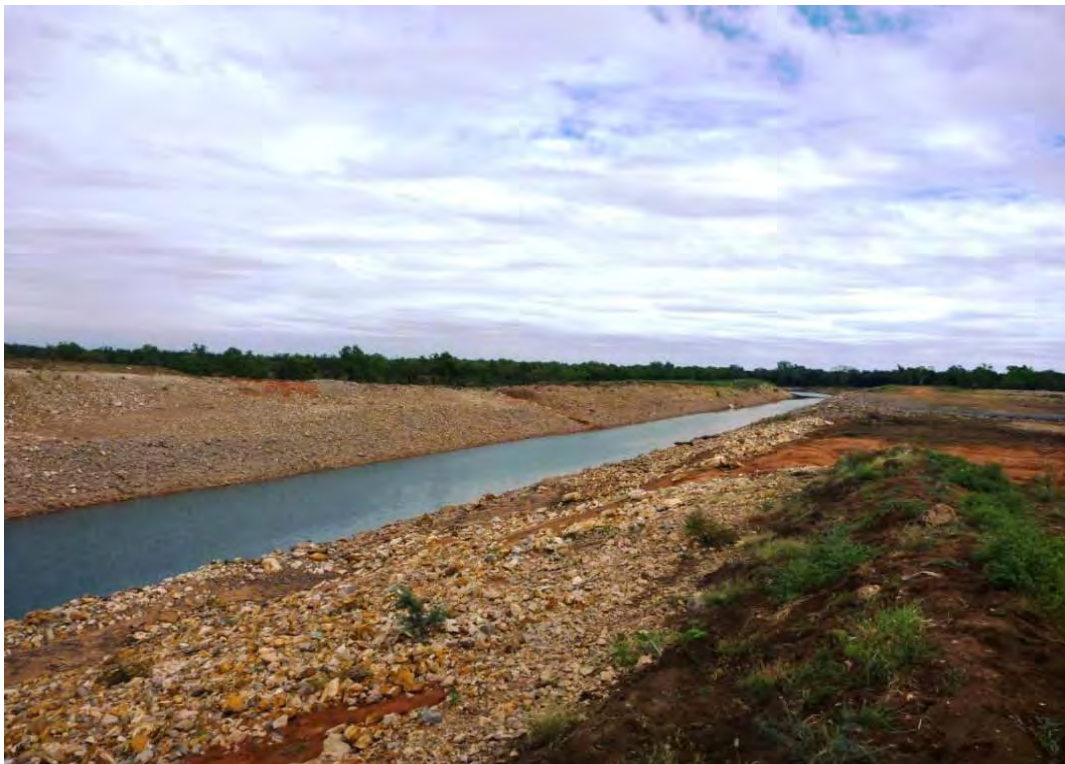
Plate 33 - Looking upstream along the McArthur River diversion channel, towards the ford.

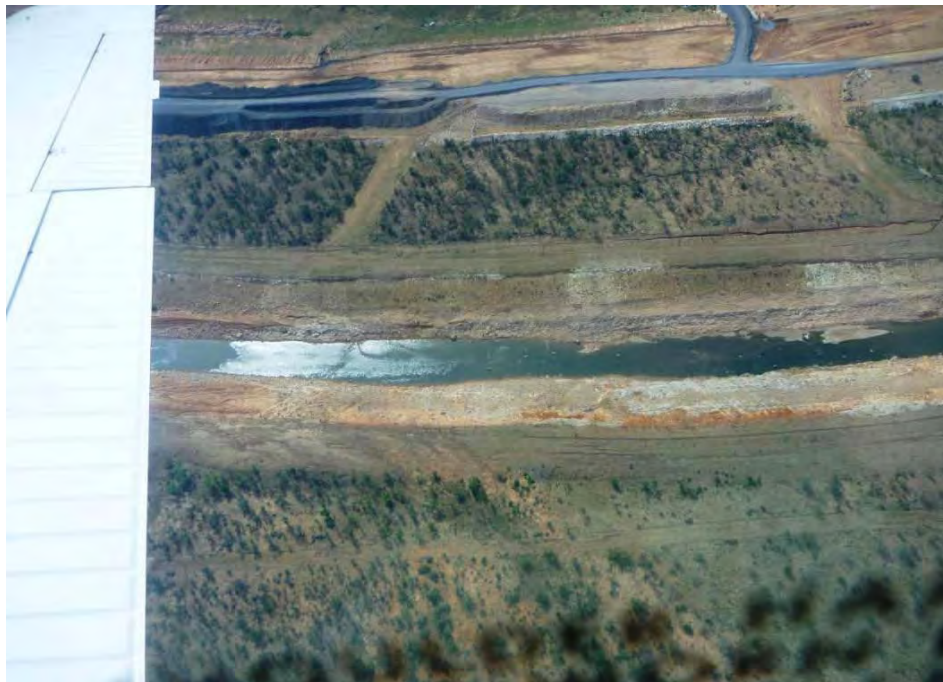
Plate 34 - View of McArthur River diversion channel from the air.

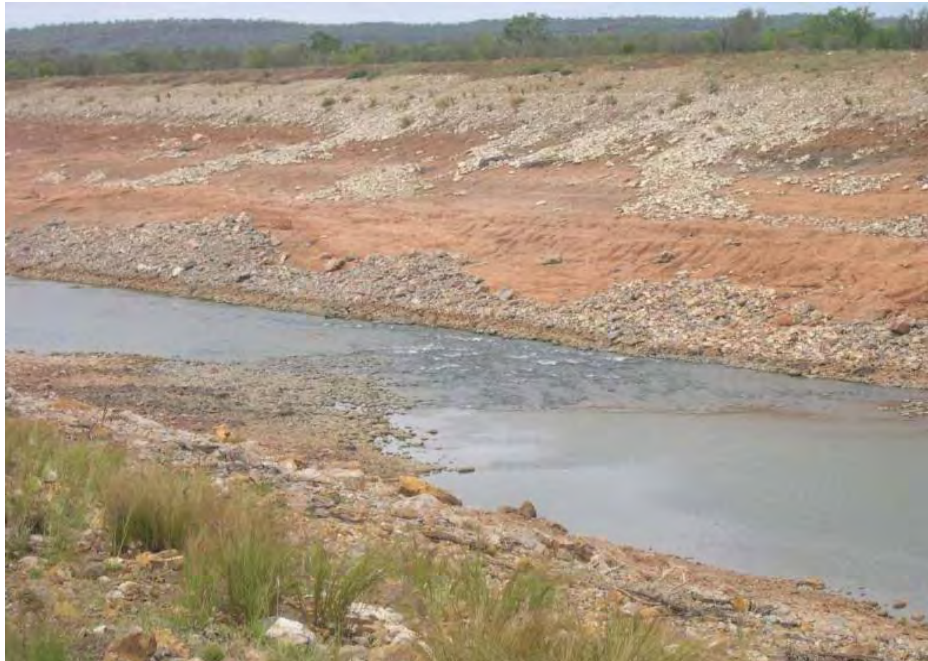
During the June 2009 Independent Monitor inspection it could be clearly seen that the river low flow regime was creating a naturally meandering low flow 'channel' along the flattish base of the diversion channel. Due to the higher than normal river flows at the time of the May 2010 inspection similar patterns were unable to be observed. However, the river flow was shallow enough to allow some of the riffle locations to be observed (Plate 44 -).

Plate 44 - View of one of the riffle zones in the McArthur River diversion channel

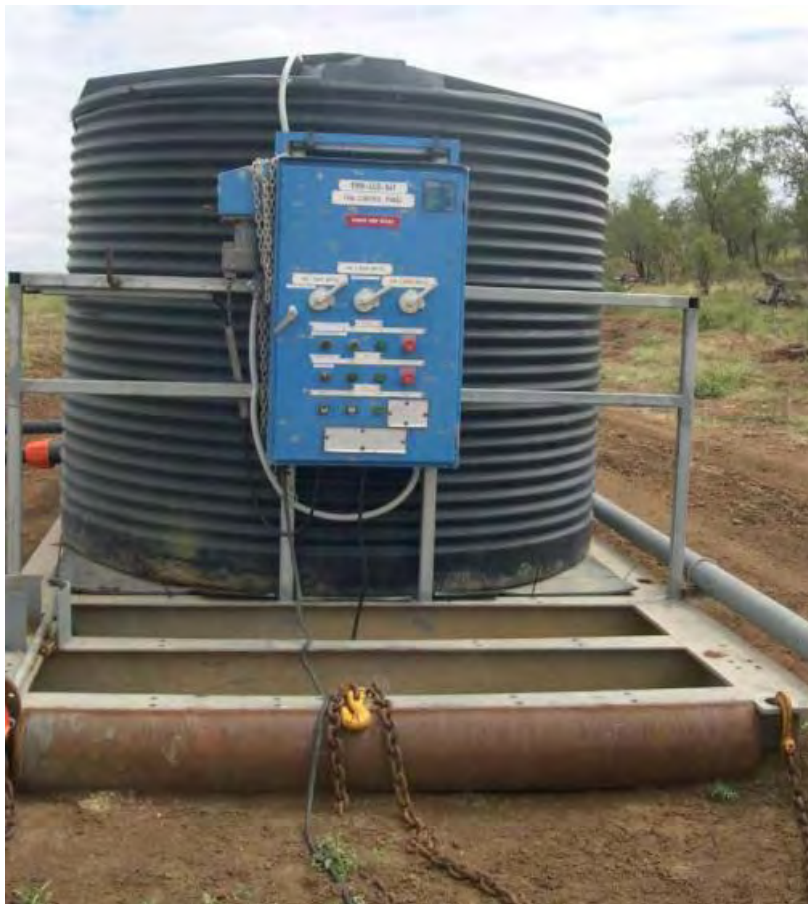
MRM have instigated the use of a water irrigation sled to aid vegetation establishment along the McArthur River diversion channel over the dry season. Drip irrigation systems (as used along the Barney Creek diversion) cannot be used along the McArthur River diversion, due to the damage that would ultimately be caused by the high volume/velocity floods that pass through the area. The irrigation sled can be dragged along the top of bank as required, with each setup feeding water to the requisite 400 metres of plantings (see Plate 45 -)

Plate 45 - The new irrigation sled structure which is now used for the irrigation of the river diversion channel rehabilitation works

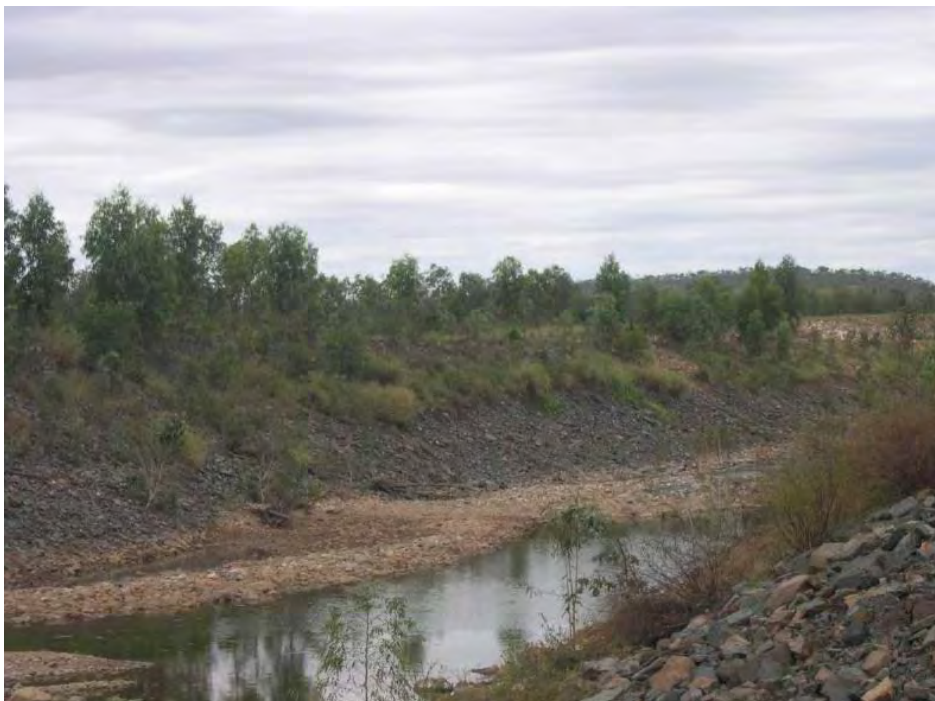
The vegetation density and height, particularly at the top of the channel banks and in the southern overbank area, were noticeably greater than a year earlier. However, we note the the presence of less vegetation in the lower bank batters is likely to be due to flood time erosion of soil material and the presence of young plants (see Plate 47 -Plate 48 -).

Plate 48 - Barney Creek channel, just downstream of the Surprise Creek confluence.
